**Report to the Toowoomba Regional Council**

**On slope instabilities in the Toowoomba escarpment**

**FANTAIL and FIRETAIL TRACKS**

**21 November 2011**

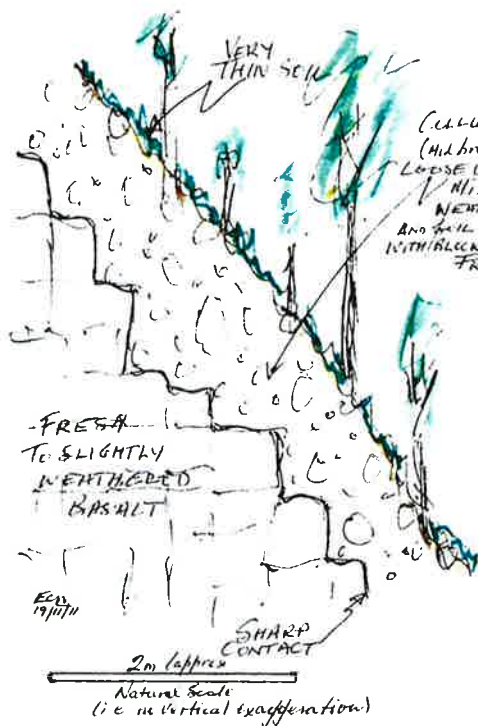
**Figure 2**  
General representation of geological features along the Fantail Track

The Fantail Track follows a zigzag route on the steep slope between this lookout and the firetrail below. The main geological character of this slope is shown in Figure 2: varying thickness (0 - 2m) of colluvium mantles the generally fresh to slightly weathered basalt of the solid geology.

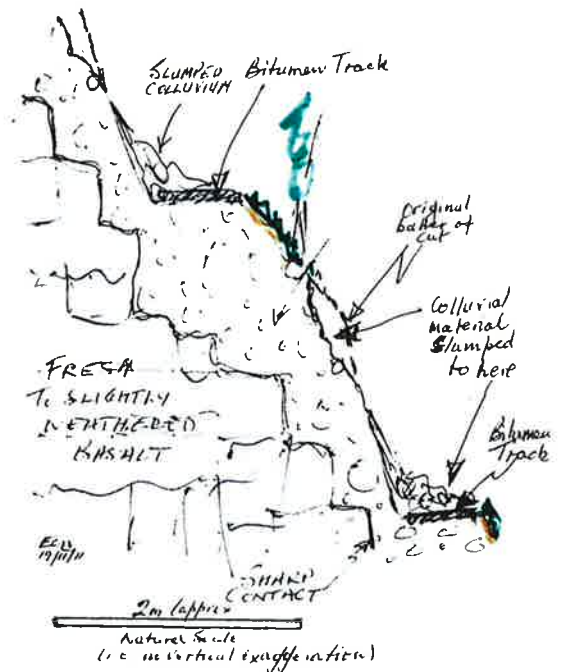
**Figure 3**  
Effects of track construction on the geology on the Fantail Track

The effect of track construction on the geology and its effect on slope stability is shown in Figure 3. The mantling colluvium is highly permeable and porous. When exposed to extremely heavy rain, it quickly takes in water; this makes the colluvium heavier and lubricates grain contacts. This renders it subject to slip by mass movement. The slips are chiefly a response to the local steepening resulting from the actual construction of the track; most are minor, however some have involved blocks (up to 1 metre long), which had been incorporated in the colluvial mantle. The slips involve the transfer of colluvial debris onto the track from above; this has left a scar, which may extend up slope to the next higher zigzag leg of the track. Damage to the bitumen surface of the track was not observed, neither on its outer edge by slips below or by material which has slumped from above onto the track.

So clearly the bitumen surface of the track has mitigated against large slip, as it has provided an impermeable surface which has encouraged runoff, thus reducing infiltration of water into the underlying colluvium. The bitumen has also provided added coherence to the elements of the track.

The character of the slips indicates that on the whole their movement was slow. This would have happened at, or shortly after, times of peak intake of water (*i.e.* during periods of heavy rainfall) into the mantling colluvium, thus at a time when the track would be less likely to be in use.

Observation of track usage (despite its closure) suggests that for the relatively experienced walker the condition of the track does not present any difficulty. Consequently as it stands at present it is adequate to be used, subject to the following:

- (a) regrading the track to a higher grade of difficulty thus dissuading unsuitable walkers; and
  - (b) advice to walkers not to use this track during heavy rain or if heavy rain is anticipated.
- Also, some cosmetic maintenance would be acceptable to walkers.

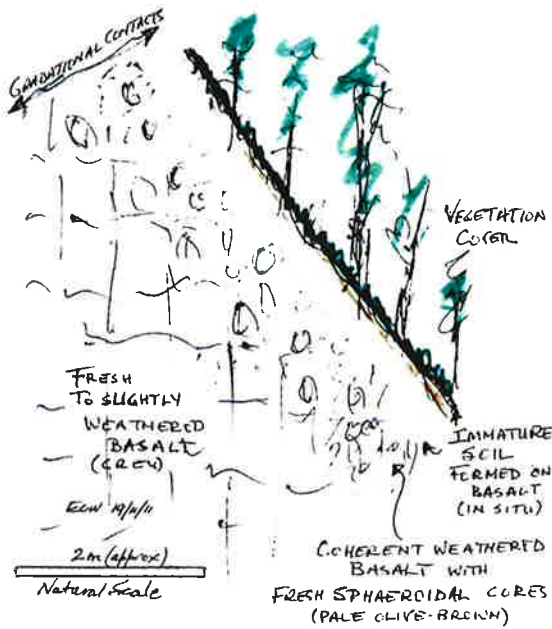
**Figure 4**

The solid geology along this track is uniform grey unweathered sometimes-vesicular basalt, grading into pale olive-brown weathered basalt (1 to 2 m thick), grading in turn to a thin (20-60 cm) immature mid-brown soil profile. These features are shown in Figure 4. The surface slopes steeply and is consistently mantled by weathered basalt and the thin soil. Colluvium is absent. The track has been cut into the soil and weathered basalt on the slope and often exposes the unweathered basalt beneath.

General representation of geological features along the Firetail Track

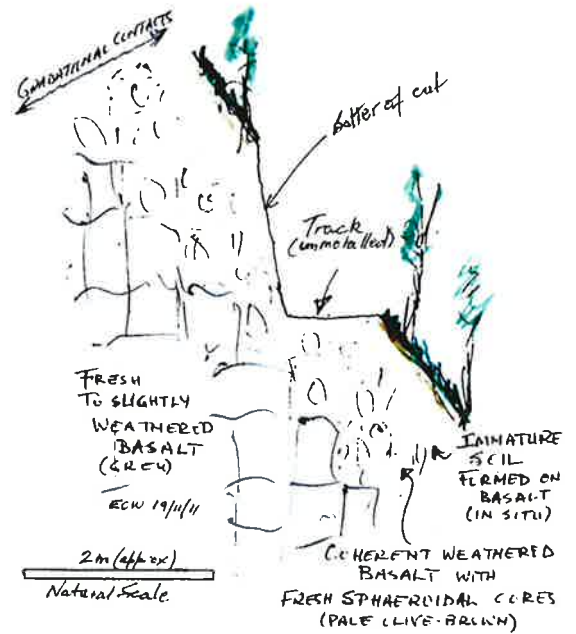
**Figure 5**

The underlying unweathered basalt and its cover of weathered basalt and of thin soil has provided a stable base for the track's construction. In the section inspected, no slips were seen either from above the track on to it or from the track edge. The track is not bitumened, but none-the-less the condition of the track in general is excellent. Figure 6 shows the intrusion of track construction on the geology and its effect on slope stability.

Effects of track construction on the geology on the Firetail Track

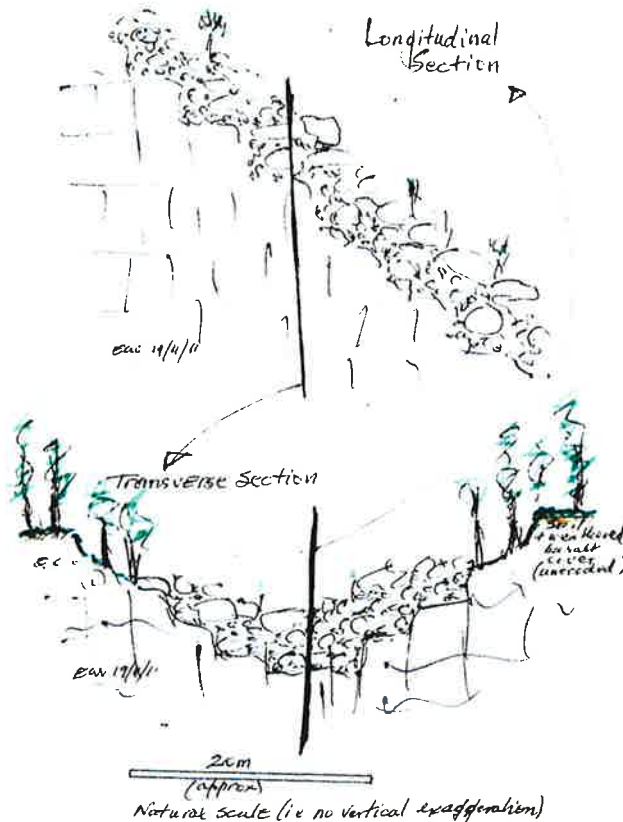
**Figure 6**

This slope is interrupted by torrential gullies. These narrow belts (10-30 m wide) are littered with boulders and cobbles of fresh basalt, with some exposures of the underlying solid basalt. These large fragments have been eroded from the underlying rock and then transported down slope during periods of torrential rain. Smaller pebbles and finer material settle between the larger fragments. The features of these gullies are illustrated in Figure 5. Heavy rainfall events (such as on 10/01/11) clear the central part of these belts of shrubs and trees to varying extents.

Where the track crosses the torrential gullies, the active erosion in the gullies themselves has possibly resulted in minor damage over very short sections of the track. This damage is expressed as steepening of the down-slope side of the embankment carrying the track over these gullies. The embankment is constructed from material derived from the track cutting and built over a pipe. The relatively minor damage to these embankments suggests that they may well have a stone core. The gullies have transported very little debris onto the track, suggesting that the 10/01/11 rain event did not significantly reshape these torrential gullies.

General representation of geological features of torrential gully cutting the Fantail Track

Retrieving the original construction specification (or more detailed inspection) of the gully crossing embankments may help establish whether the embankments have stone cores. If they do, then this track should be opened subject to existing difficulty grading and warnings. It might be considered to require minor cosmetic maintenance.

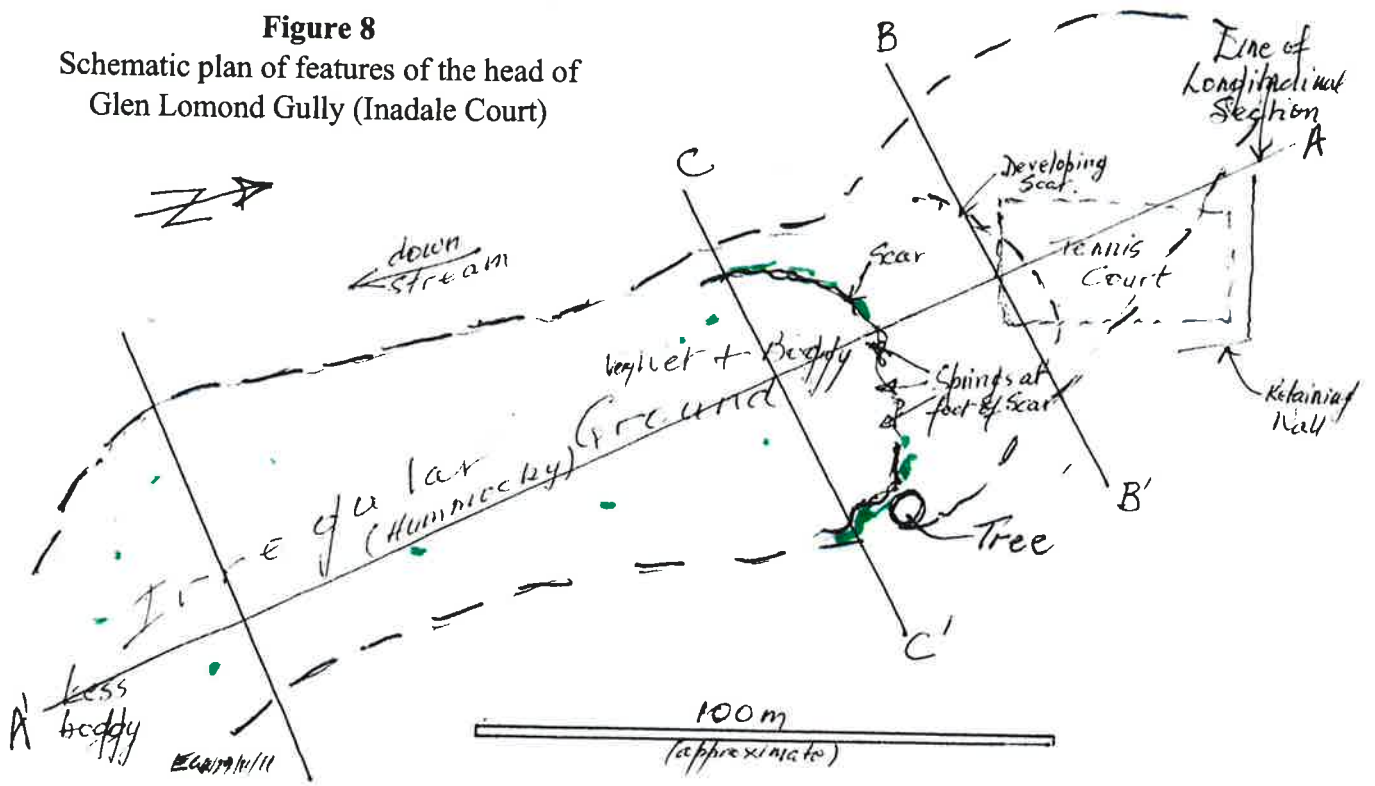
**Figure 8**  
Schematic plan of features of the head of  
Glen Lomond Gully (Inadale Court)

The reserve at the source of Glen Lomond Gully currently demonstrates active headward erosion in a colluvial-filled gully (of Holmes 1981) in the concave zone at the top of the eastern escarpment. The principal features are illustrated schematically in Figures 8 (plan), 9 (longitudinal section) and 10 (crosssections).

The most striking feature is the vertical scar - a vertical face exposing colluvium of the gully at the base overlain by made ground from soil, etc., derived presumably from the cut to construct the nearby tennis court; there is an active spring at the base. The scar separates:

- (a) on upstream side, smoother maintained ground of the upper reaches of the gully which includes a tennis court, and
- (b) on the downstream side, hummocky ground of the natural gully, which, at present, immediately below the scar is waterlogged and boggy passing downstream to still hummocky but drier ground.

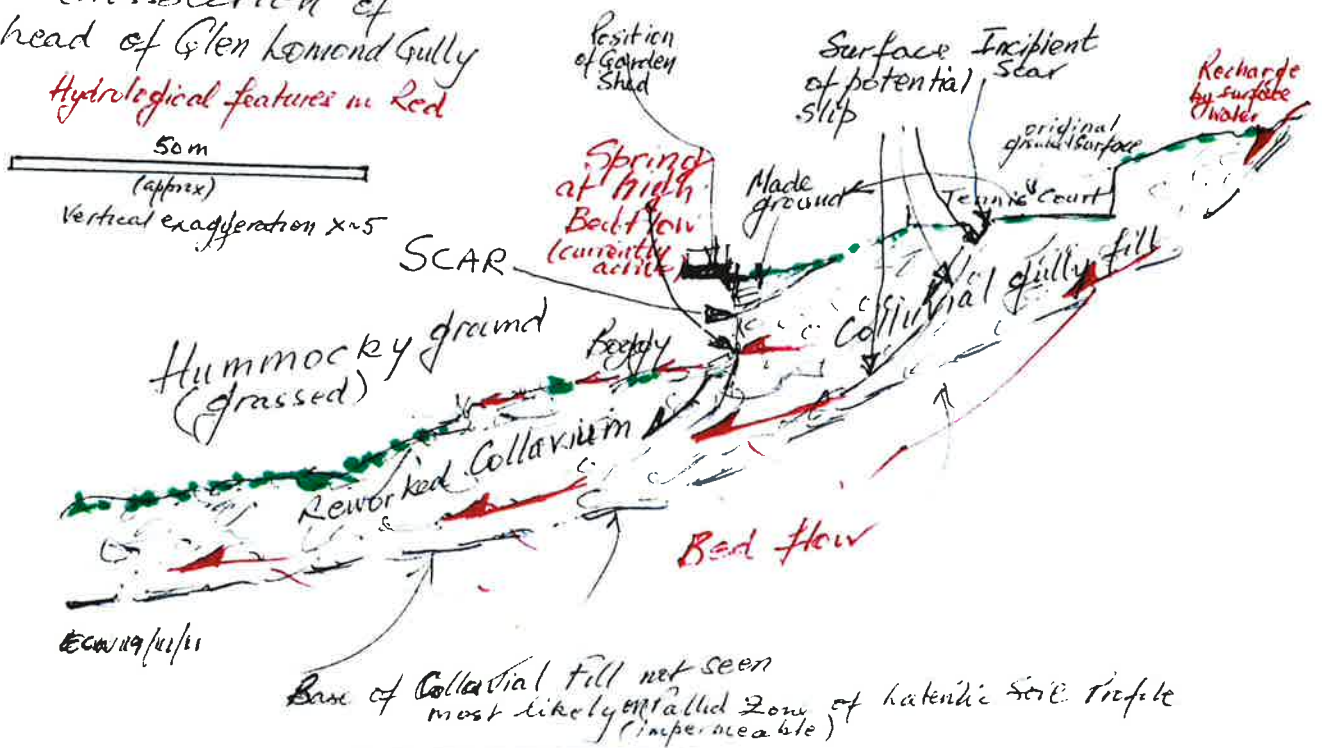
**Figure 9**  
Schematic longitudinal section along the head of  
Glen Lomond Gully (Inadale Court)

The observed hydrological activity (see Figure 9) is as follows. During periods of heavy rain, run-off water from higher ground has recharged the bed flow in the colluvial gully fill. Here it flows down stream within the colluvium. In wetter periods, this bed flow may emerge to the surface of the gully colluvium creating boggy ground; when in this boggy condition, the hydraulic pressure within the gully colluvium reduces the stabilizing effect grain-to-grain contacts and the wet colluvium will creep downslope in response to gravity. This movement generates the hummocky surface on the natural gully colluvium.

Schematic Longitudinal (A-A')  
Crosssection of  
head of Glen Lomond Gully  
Hydrological features in Red

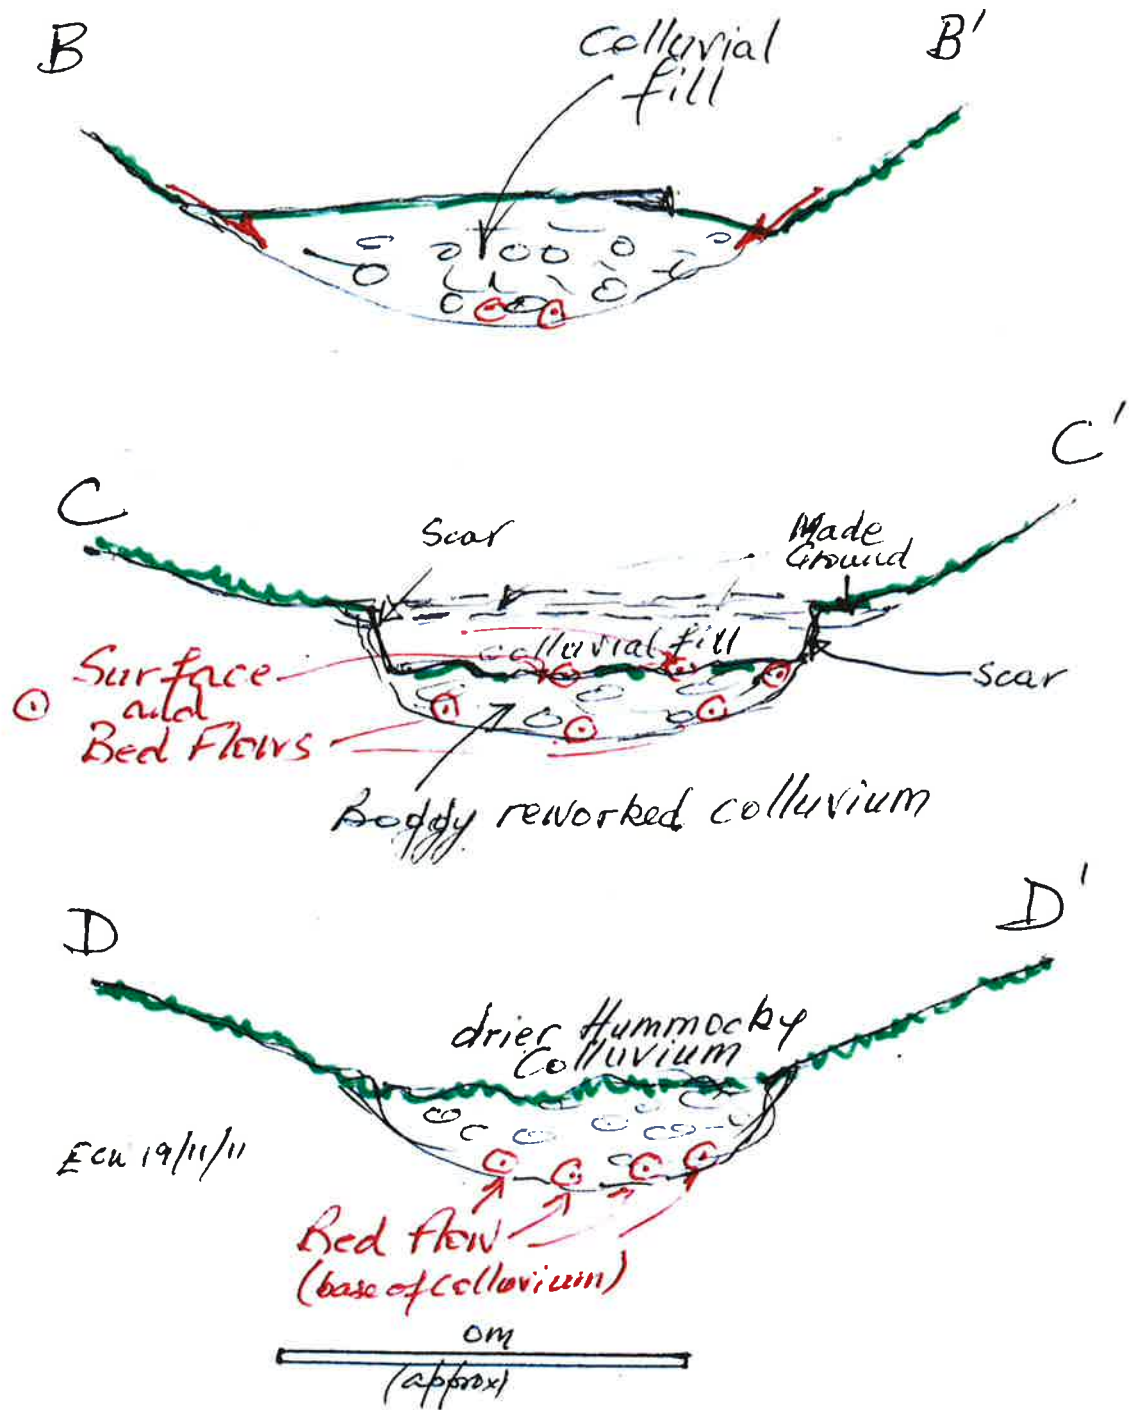
**Figure 10**  
Schematic crosssections across the head of  
Glen Lomond Gully (Inadale Court)

Larger masses of gully colluvium may move further in response to more extreme water intake conditions. Other factors may help trigger such movement. At this locality, made ground (probably from material removed to level ground for the tennis court) and a garden shed (its concrete foundations have been retrieved from the latest slump) have collectively added weight onto the underlying gully colluvium; recharge of water at the head of the gully (10/01/11) has saturated enough of the gully colluvial fill, which has yielded to gravity generating a major debris flow. This has left the vertical scar, which itself is unstable, and further incipient movement in response to gravity is reflected in the unevenness developed in the once level tennis court.
