## **Factors Influencing Failure of Bank Protection Embankment of Surma River**

### **Abstract**

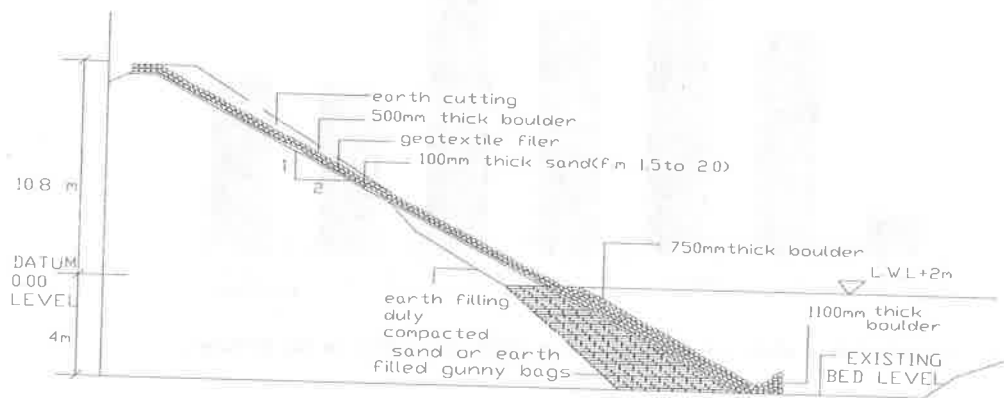
**Figure-3: Implemented design plan for "Kanishail to Ghashitula"**

The above comparison depicts that this design for the left bank of Kanishail to Ghashitula differs significantly from the estimated design of BWDB. As a consequence, the thickness of cover layer, grading size of stone, specifications of geotextile used in the bank protection works didn't satisfy the actual requirement. From the experimental results, it has been found that the soil carries significant amount of clay, fine silt and fine dust. This represents that the soil of such areas are subjected to be eroded, which poses a great risk to the safety of this city. In consequence of this the scour depth will more than the calculated one. The test results are shown in the Figure-4 and the Figure-5 represents photographic view of bank protection failure.

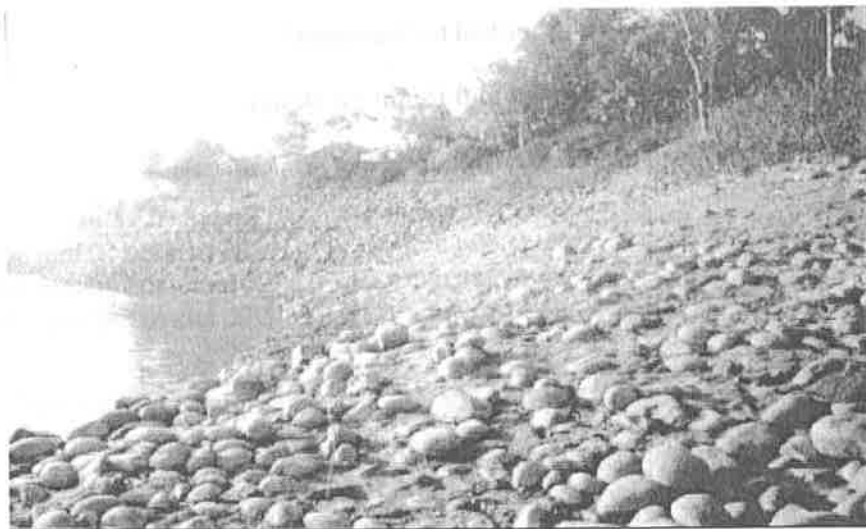
**Figure-5: Bank Protection Embankment, location Kanishail to Ghashitula**
