# Failure mechanisms of bridge infrastructure in an extreme flood event

Mohamed Farook Kalendher Lebbe<sup>1</sup>, Weena Lokuge<sup>2,5</sup>, Sujeeva Setunge<sup>3,5</sup>, Kevin Zhang<sup>4,5</sup>

Lebbe, Mohamed Farook Kalendher and Lokuge, Weena and Setunge, Sujeeva and Zhang, Kevin (2014) *Failure mechanisms of bridge infrastructure in an extreme flood event*. In: Proceedings of the First International Conference on Infrastructure Failures and Consequences, 16-20 July 2014, Melbourne, pp124-132. ISBN: 978-0-9925570-1-0

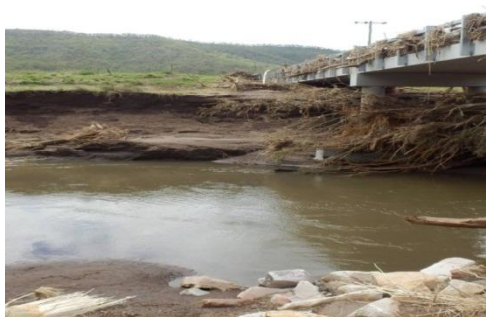
Bridge No. 2 abutment headstock damaged

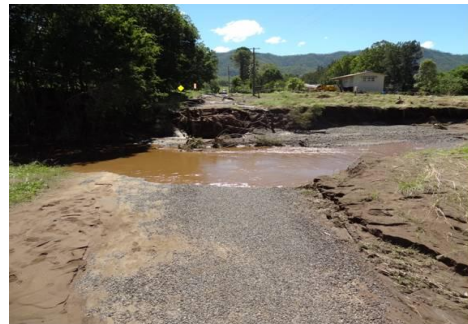
Bridge No. 16 completely washed away

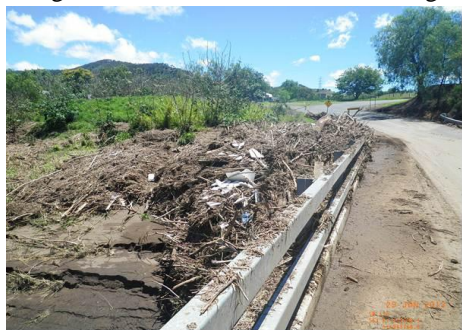
Damaged due to debris

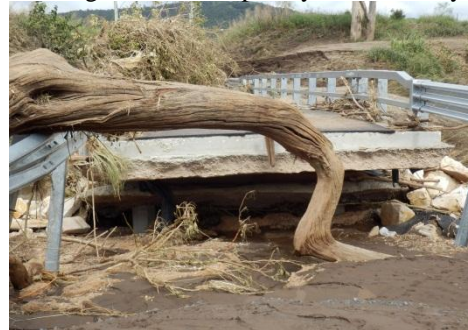
Damaged relieving slab
