**Micrographs of the Fracture of Vinyl Ester Composites Cured by Microwaves:
Pilot Study**

C S Chew, H Ku, D Baddeley and C Snook

Faculty of Engineering and Surveying,
University of Southern Queensland, Australia.

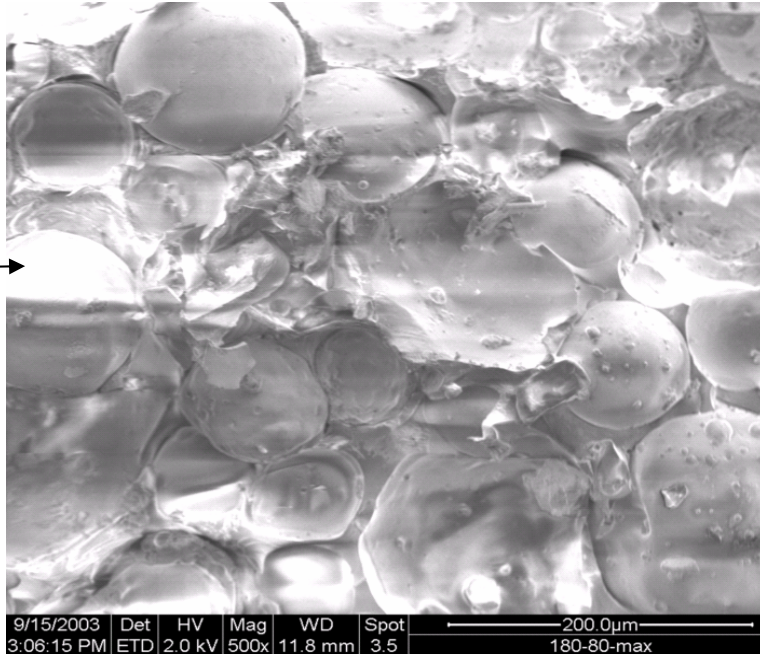
The first specimen chosen was the 180-watt microwave power with an exposure of 60 seconds. The five critical points (Figure 4) were analyzed by magnification of up to 500 times as illustrated in Figures 5 through 9. Figure 5 is the micrograph of area 1; it shows the cleavage fracture at the tip of the chevron cut and there is some electrical discharge in the image (transparent part). Figure 6 illustrates the micrograph of area 2, the stretch-zone. Figure 7 is the micrograph of area 3; it depicts that some matrix is elongated. Figure 8 is the micrograph of area 4; it illustrates some micro voids and some scratches on the fractured surface. Figure 9 is the micrograph of area 5; it shows the matrix failed in brittle manner but there is some dirt in the image.

Figure 5: Micrograph of area 1 showing the cleavage fracture at the tip of the chevron cut and there is some electrical discharge in the image.

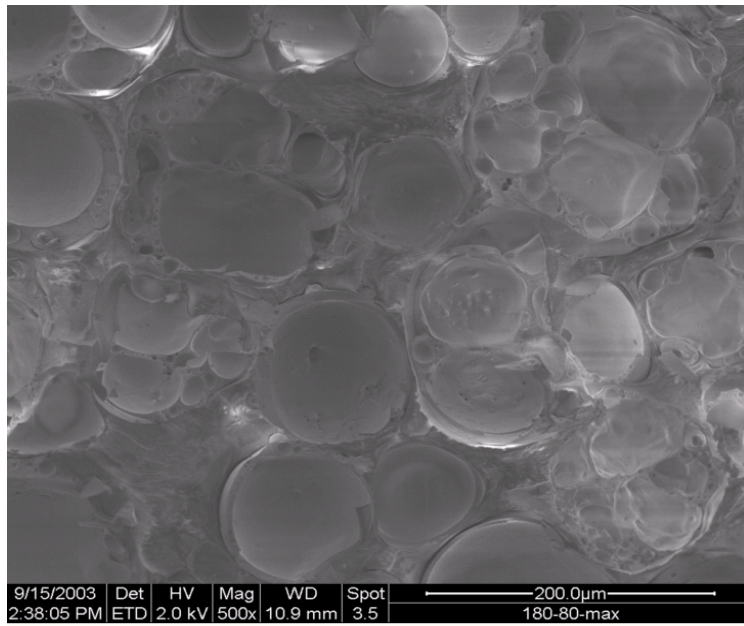
Figure 6 (area 2, 180 W power and 60 seconds) shows that the sample was stretched; the elongation at peak, the elongation at break, and the fracture toughness of the sample are 1.214 mm, 1.557 mm and $52.72 \text{ MPa}\sqrt{m}$ respectively. Figure 11 (area 2, 360 W power and 80 seconds) illustrates that micro voids existed in the matrixes; the elongation at peak, the elongation at break, and the fracture toughness of the sample are 1.121 mm, 1.445 mm and $48.49 \text{ MPa}\sqrt{m}$ respectively. From the elongations and fracture toughness values of the two samples, it can be found that the micrographs give reasonable explanations to the mechanical behavior of the samples. The stretched sample (Figure 6) had higher elongations and fracture toughness values than its counterparts (Figure 11). Figure 7 (area 3, 180 W power and 60 seconds) also illustrates that the matrixes were elongated and stretched. Figure 12 (area 3, 360 W power and 80 seconds) shows that the fractured surface was damaged. This phenomenon can also be explained by the differences in elongation and fracture toughness values as explained for area 2 (Figures 6 and 11). From the two areas investigated, they show that specimen microwaved at 180 W for 60 seconds is tougher than its counterparts.

Figure 6: Micrograph of area 2 is the stretch-zone.

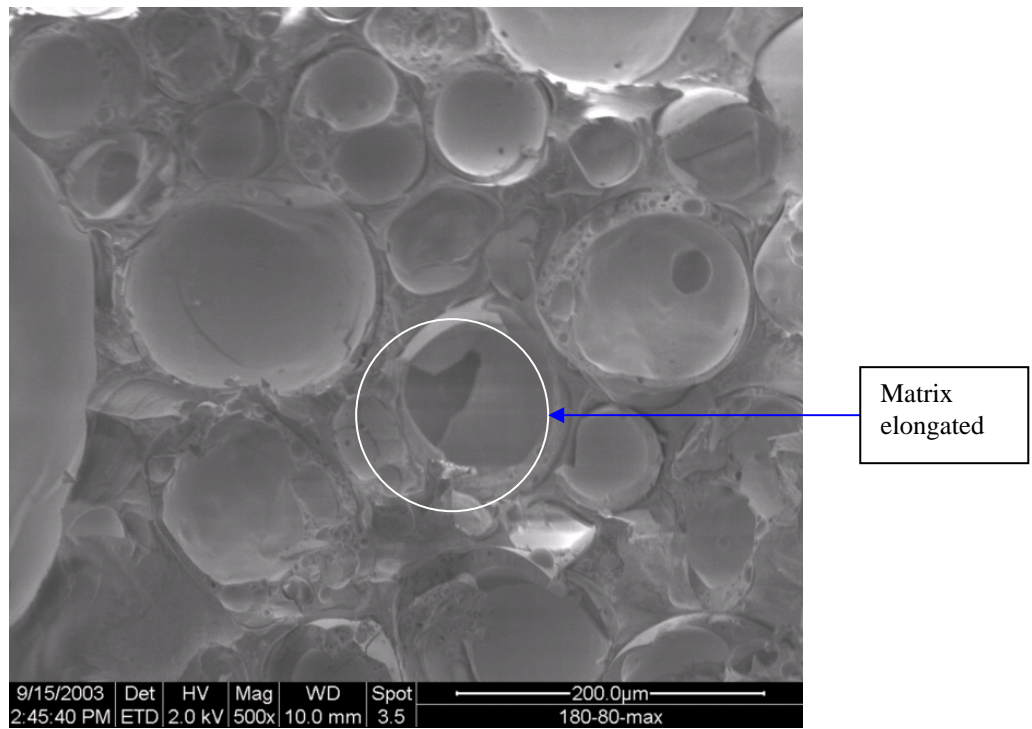
Figure 7: Micrograph of area 3 shows some matrices are elongated.

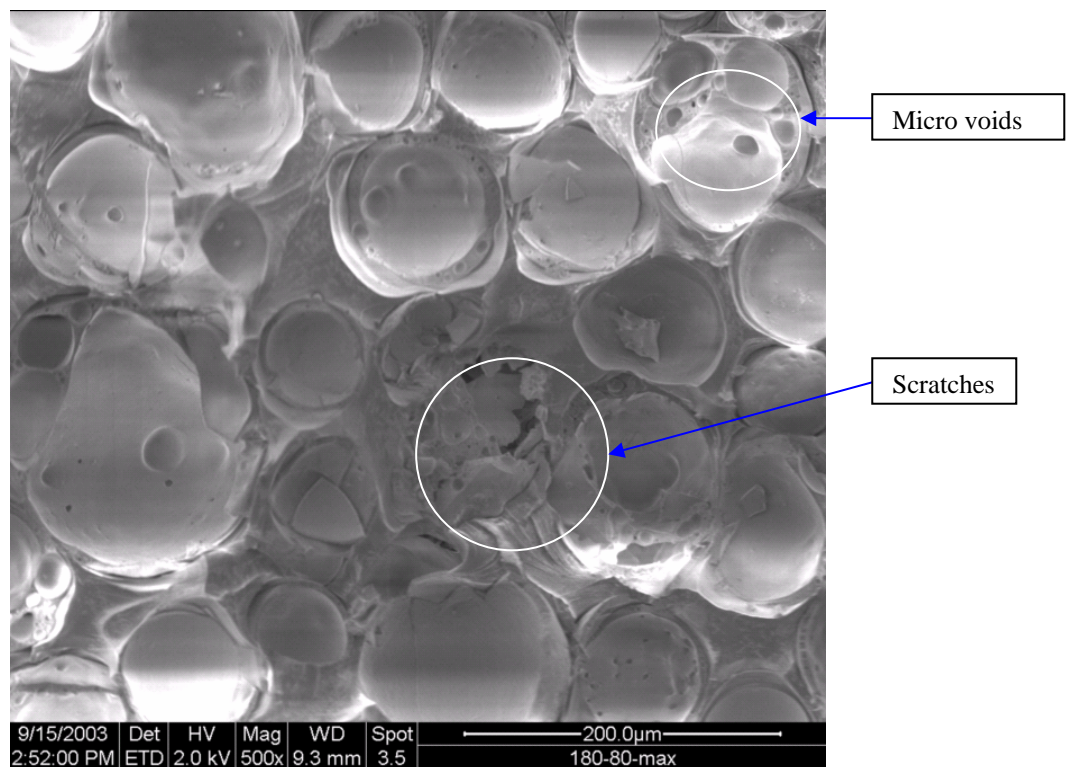
Figure 8: Micrograph of area 4 shows some micro voids and some scratches on the fractured surface

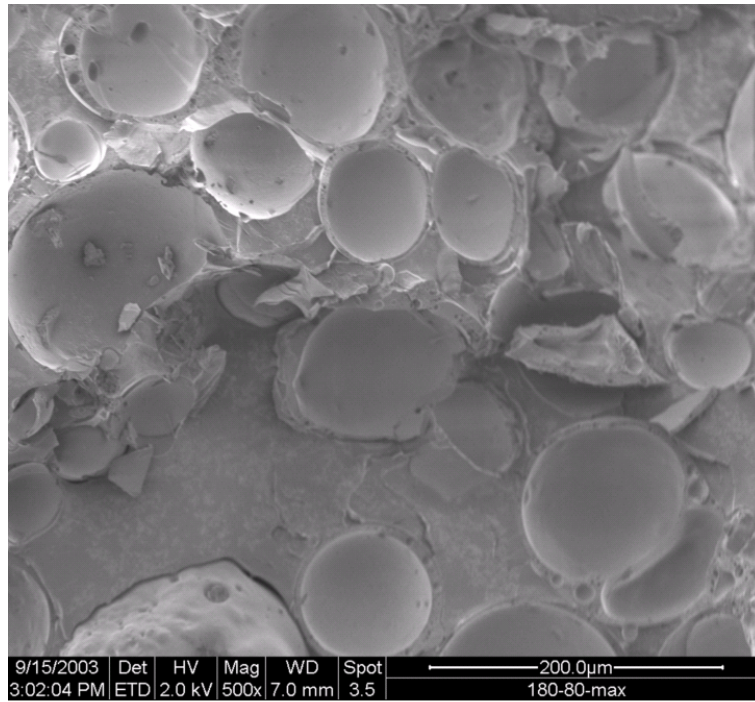
Figure 9: Micrograph of area 5 shows the brittle failure of the matrix.

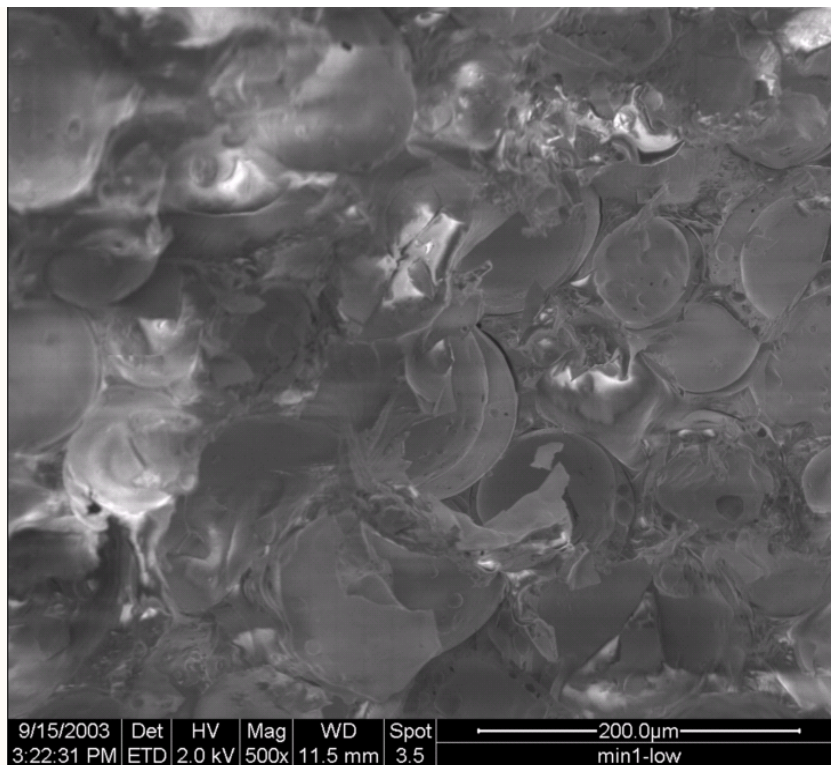
The second specimen chosen was the 360-watt power level with an 80 exposure of seconds. Similarly, five critical points were analyzed by magnification of up to 500 times as depicted in Figures 10 through 14. Figure 10 is the micrograph of area 1; it shows that matrixes are averagely elongated to initiate crack. Figure 11 is the micrograph of area 2; it depicts that some micro voids exist in the matrix. Figure 12 is the micrograph of area 3; it illustrates that most of the fracture surface has been damaged. Figure 13 is the micrograph of area 4; it shows that the material has failed in brittle manner and some micro voids exist. Figure 14 is the micrograph of area 5; it illustrates that the matrix has failed in brittle manner and electrical discharge exists in the image.

Figure 10: The micrograph of area 1 showing the matrixes are averagely elongated to initiate crack.

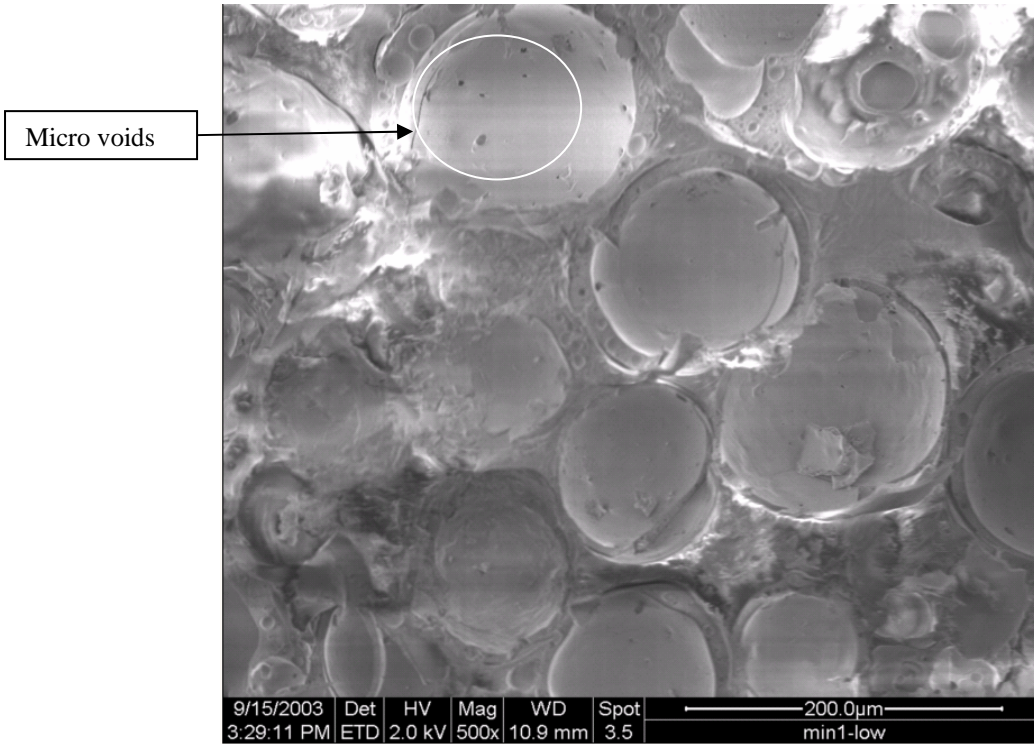
Figure 11: The micrograph of area 2 shows that some micro voids exist in the matrix.

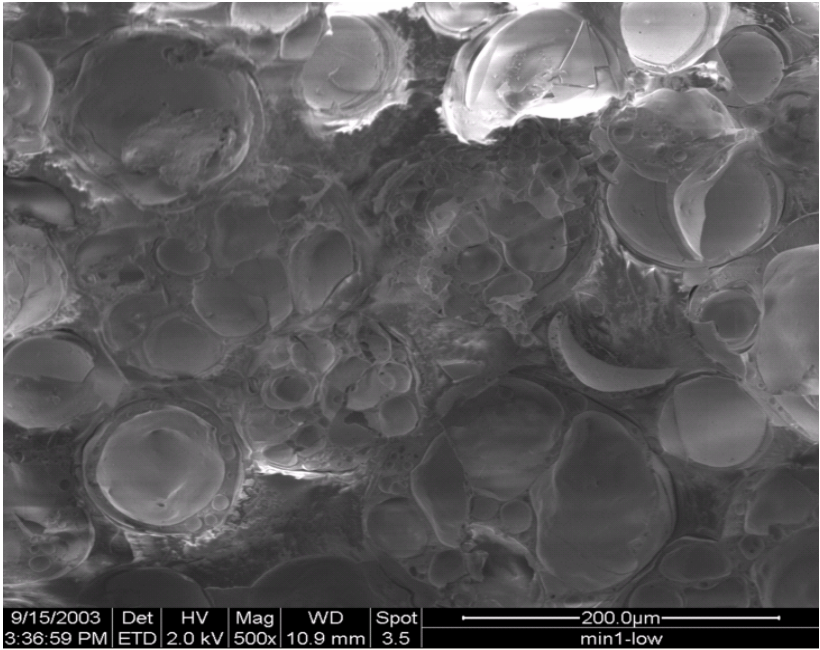
Figure 12: The micrograph of area 3 shows that most of the fractured surface has been damaged.

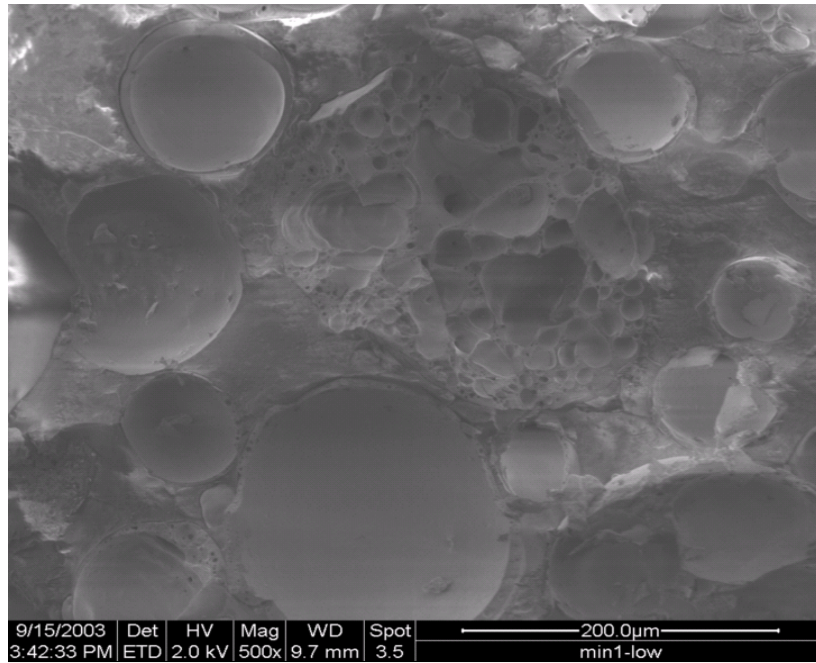
Figure 13: The micrograph of area 4 shows the brittle failure of material and some micro voids exist.

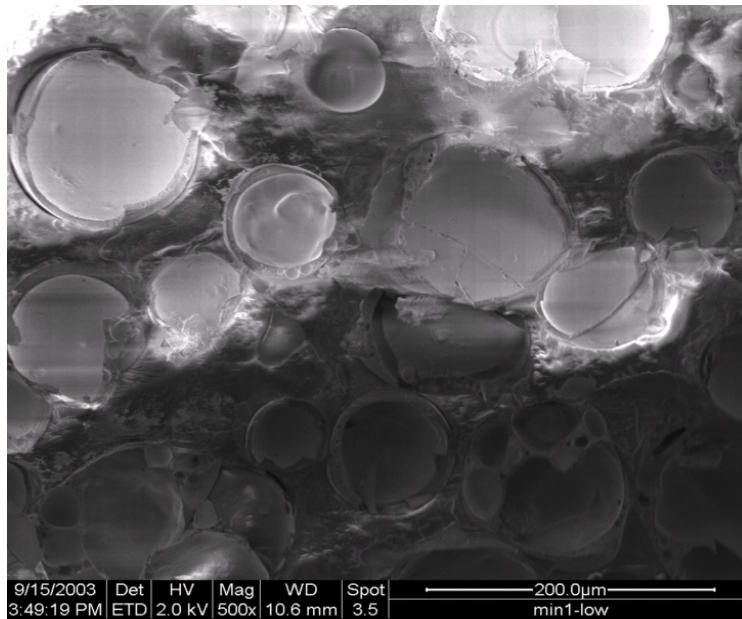
Figure 14: The micrograph of area 5 shows the brittle failure of the matrix and electrical discharge exists in the image.
