# Investigation into the Strength of Lego Technic Liftarms and Brick Beams, and of Liftarm Pin Connections

*Tristan Lostroh*

*January 2012*

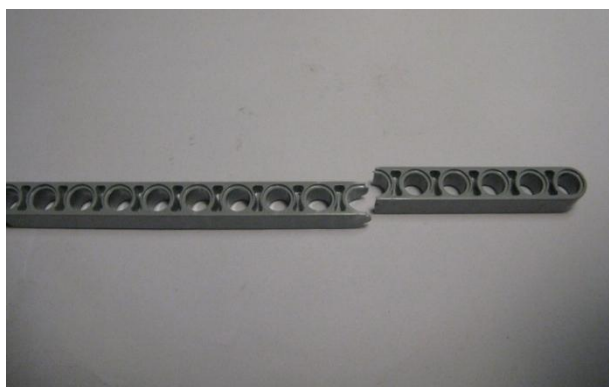
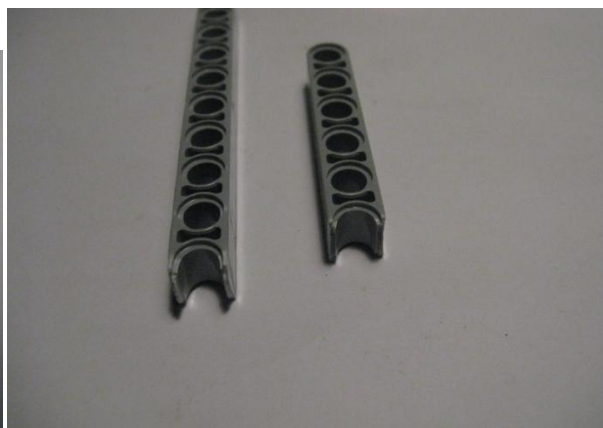
This first specimen was misaligned when tested. As such, the force required before it broke is much less than those of the next tests. Because of this misalignment, it was concered best to remove the test from the results.

All Beams were supported from the endmost 6 pin holes (Only 4 simple supports on each end was used though). The image above clearly shows that the greatest force is on the last supportive pin hole. This is also what I hypothesised in July 2011. It is good that even though the values are wrong, the principle was not.

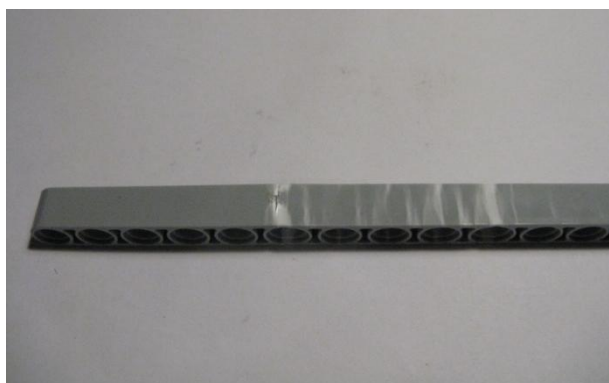
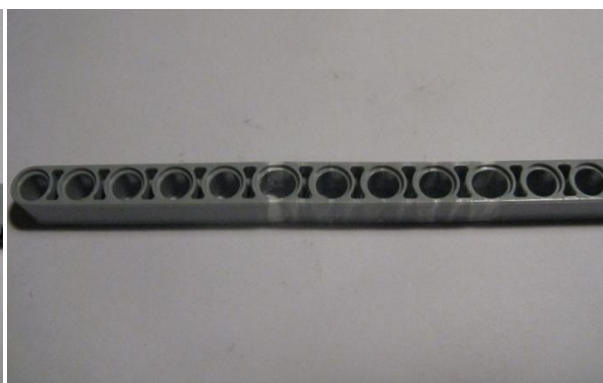
This is the first respectable result from the Liftarms. As you can see, there is no stress or fractures except from the middle 5 pin holes. The greatest fracture is at the first support pin hole. Unlike the first Liftarm, this one did not fracture. This highlights the importance of maintaining the alignment of the force. The other two specimens are all similar in appearance.

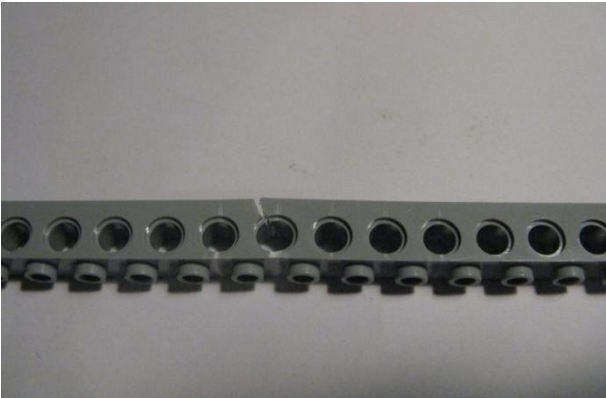
The Brick Beams behaved in a similar way to the Liftarms. There was no damage observed on the support pin holes, but the centre span had creases and stress points located throughout. This is much the same as the Liftarms so although the Brick Beam is stronger, the damage sustained is the same.

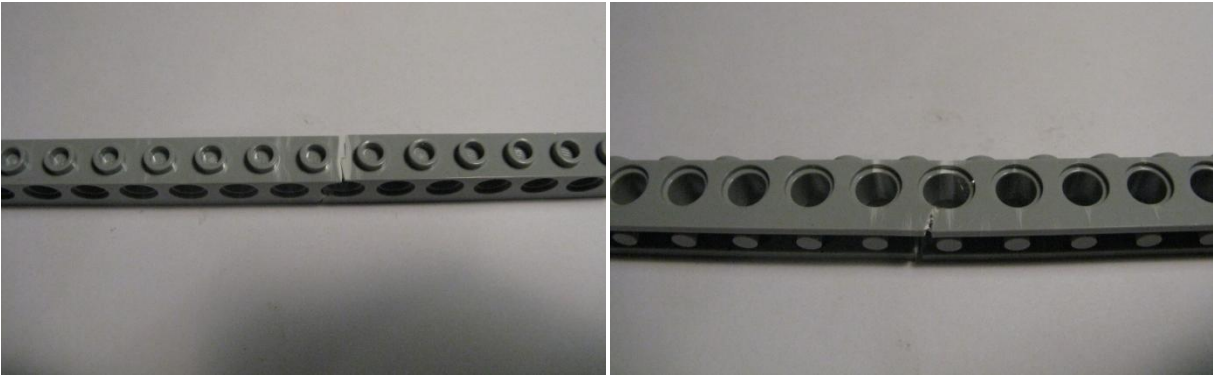
These are from two different tests however both show signs of fracture. The left image was the closest Brick Beam to complete separation, while the right image only has the bottom of the Beam fractured. It is interesting to note that there is some damage beyond the first (6<sup>th</sup>) support pin hole. This is unusual as no other Beams had such damage.

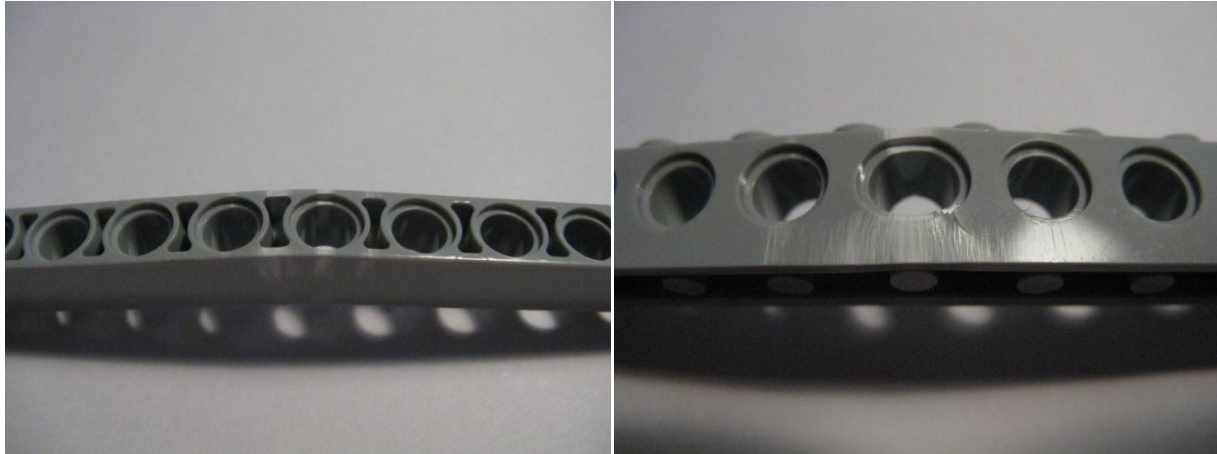
These pictures show a comparison in damage to the Beams. It is quite clear that the Brick Beam has sustained more damage than the Liftarm. It is unclear if the plastics used are different. It would appear that the Brick Beam is more brittle. More likely however, the structure of the Brick Beam makes the whole thing more rigid and more brittle. This is quite a big difference, especially if bending is expected in the MOC. If the Brick Beam is bent too far, while it may take more force, the Beam is more likely to fracture. This is in direct contrast to the Liftarm which will bend a lot more before it starts fracturing.

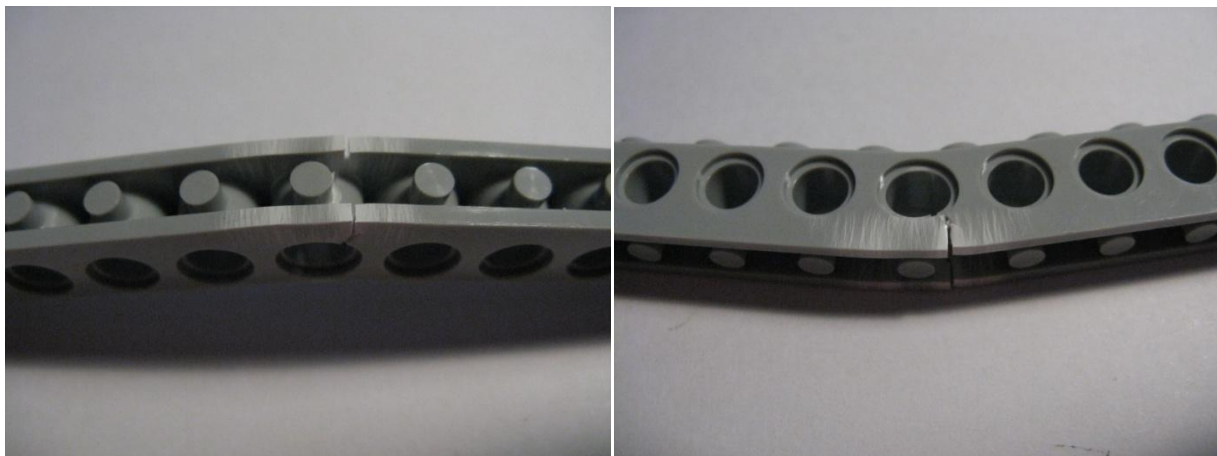
These images show the propagation of the fractures. It is off to the side of the application of the force. This possibly could be from the clutch pin. This then highlights a key weak point in the Brick Beam. It is also interesting to see that the crack went through the edge of the pin hole. The fracturing here is very much like the fracturing seen in the pin connection tension tests. Therefore it is not too bold to predict that there will be more problems with pin holes fracturing rather than the rest of the Beam.

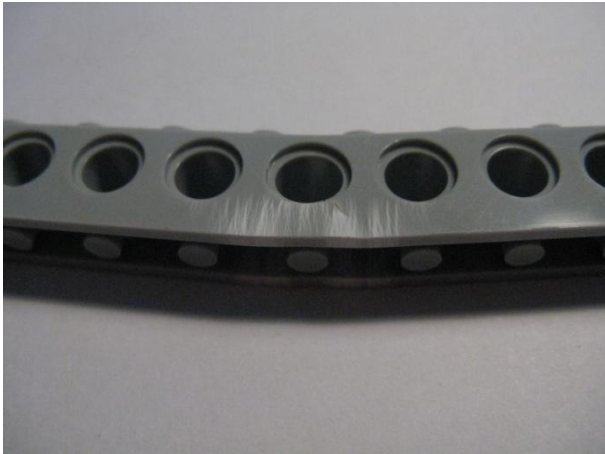
This final image shows the formation of the above fracture. This was however from a different test. This reinforces my last point. It is quite interesting to see that the base of the Beam is flat. Even though the force was applied to the center, the force is manipulated outwards to beside the pin holes. This then implies that the support for such a Beam should probably be centered on the clutch pin rather than the stud gap (i.e. Support Beams should be aligned with the Technic pin holes rather than the 'traditional' studs). Hopefully with this information MOC builders can build stronger bases.

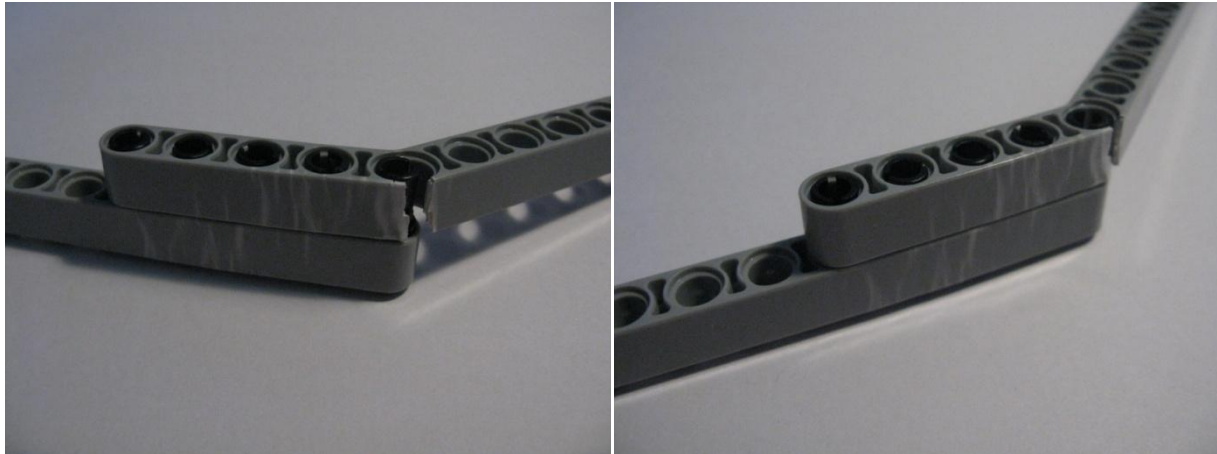
These images clearly show the failure of the Liftarm. The location of the break is most interesting. Unlike most of the other breaks, it is in the centre of the pin hole. It is also clear that the other Liftarm did not break nor bend as much. No other Liftarm fractured at that location so there may have been a defect on the Liftarm. Ultimately it did not have an effect on the strength and not much can really be learned as it was unusual.

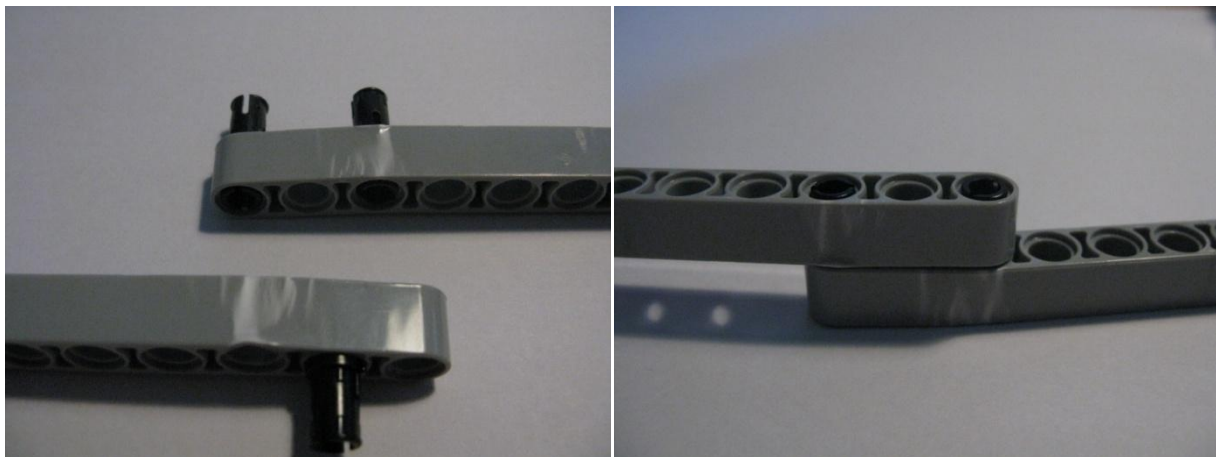
Both these specimens were similar (as they had a 3 pin overlap) but the results are quite different. One we see has only severe bending at the edges. However, the other (with only 2 pins) has the start of a fracture forming. All 3 pin overlap, 2 pins used have this same phenomenon. The combination of the gap and only 2 pins seems to magnify the force and fracture the Liftarms. This is a particularly important result. Many MOCs would use the 3/2 connection but although it can withstand more force, the chance of a catastrophic failure is much higher.

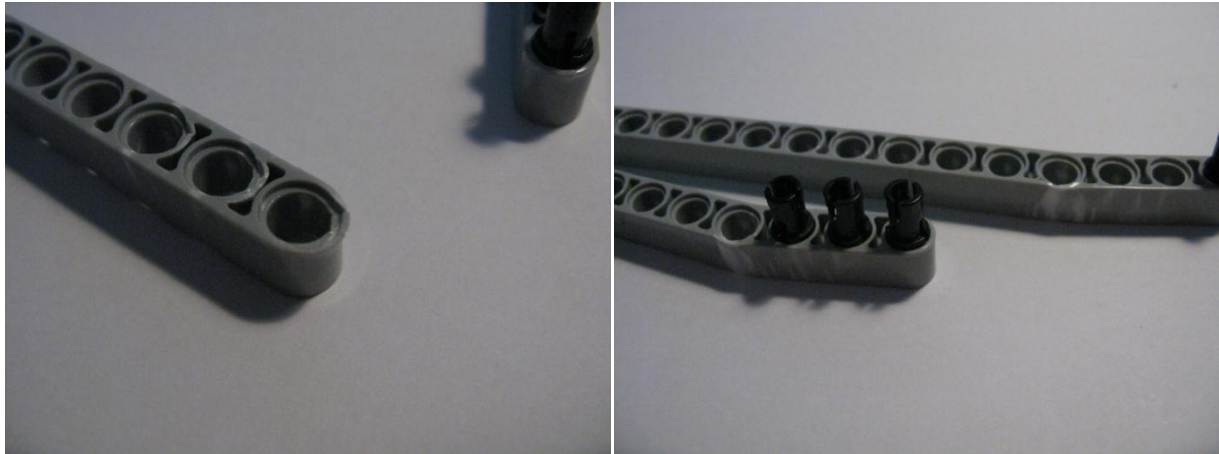
These images show the most common result of the transverse tests. There is substantial damage to the edge of the pin holes. This would basically render them useless. The other image shows both Liftarms with bends in them. Most Liftarms bent but some didn't. The results in this experiment are much closer to the 5 pin transverse test in the July experiment.

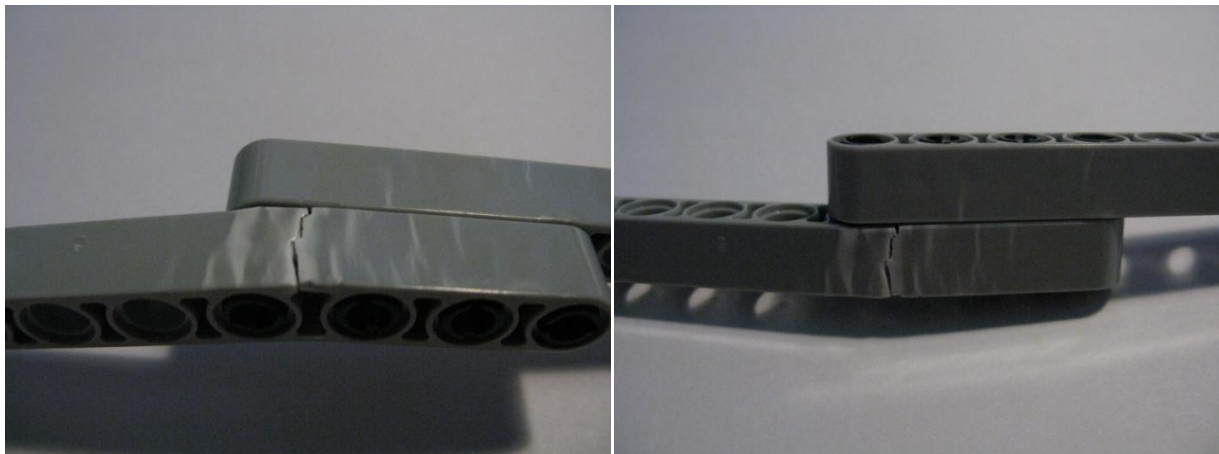
This specimen behaved quite unusually. Most of the transverse specimens did not fracture. It is quite clear that this one did. The location of the fracture is quite similar to the location of the fractures from the transverse Brick Beams. This is clearly highlighting a trend. It is also important to see that the bend is very asymmetric. Only one Beam is fractured. I am not able to explain this but it does show that even in controlled testing, inconsistent results are still possible.

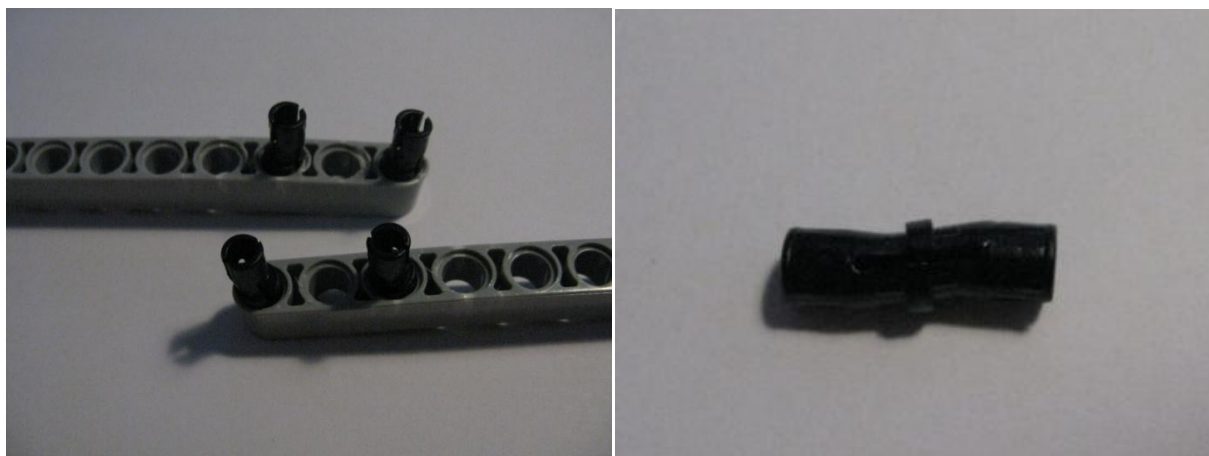
One observation is that even with zip ties it was not possible to actually break a pin. The closest was some doubly bent pins from a 4 pin test. There were two bends halfway on each side. No visible fractures were seen although the clutch action was severely compromised. The Liftarm itself sustained the most damage.

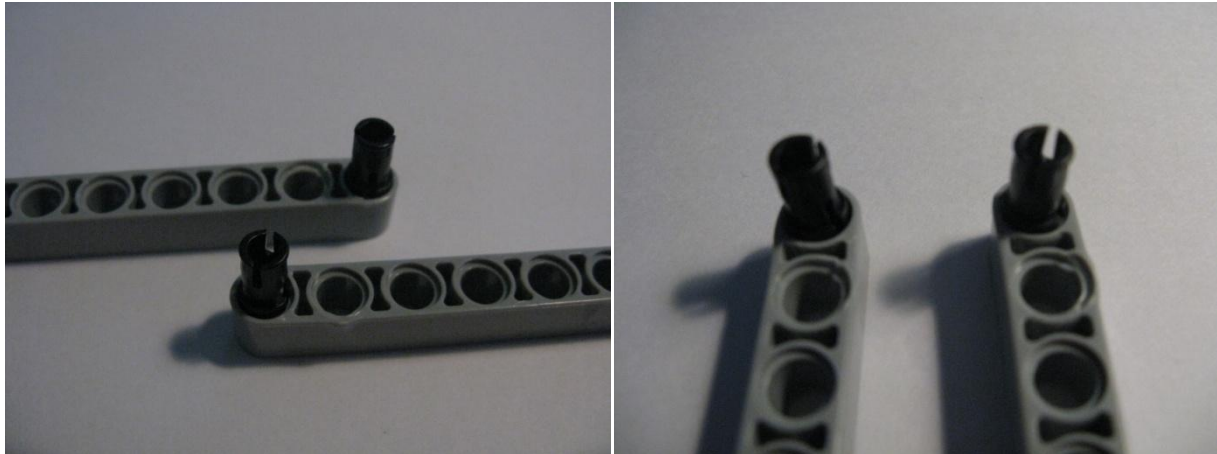
All the Liftarms used in the tension pin tests were all ruined after one test. This was quite surprising. In every case the holes were deformed around the edges. The two images above clearly show this problem. Also observed, the angles that the Liftarms and pins were at were quite substantial. Certainly the perceived limits of the pin connections are quite a lot higher than any normal builder would consider 'safe' (i.e. no damage to the Liftarms). This is almost certainly in the design of the Liftarms and pins. The Lego Group would much prefer a deformed Liftarm than the chance of the flying projectile. It is a good learning experience to see the absolute limits of the material.

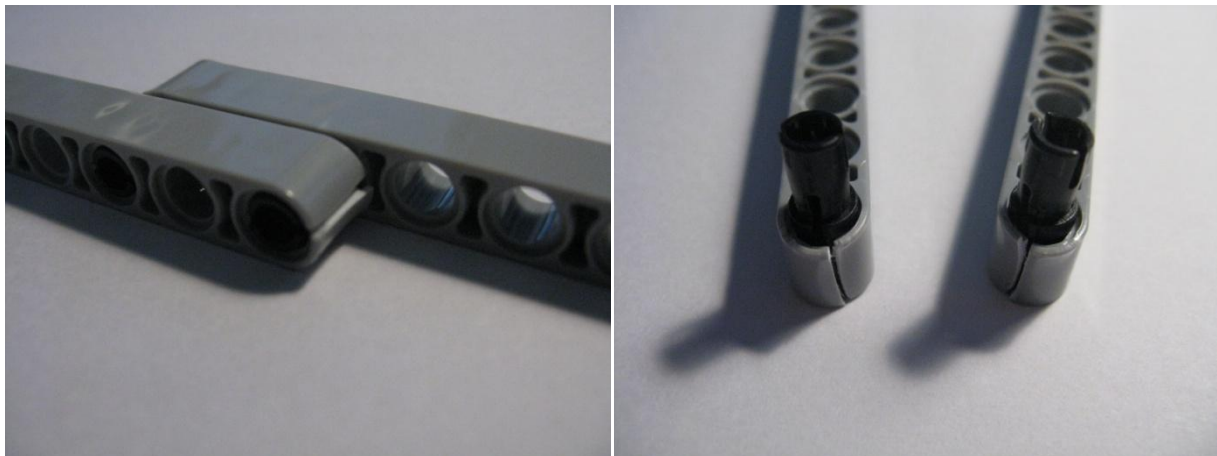
One of the more unusual results and really un-expected is the Liftarms failing. As the image shows, both Liftarms have failed at the pins. Again the pins themselves are not deformed however the clutch mechanism has weakened. This is surprising because on two of the three tests (that being the 3 pin space with 2 pins used) the Liftarms failed. The third was starting to fracture. No other connection failed like this. It does however partially confirm the hypothesis I made in June 2011. The end of each Liftarm seems to have concentrated the force to a small area. As there is no middle pin to share some of the force, the force on the end of each Liftarm may have breached the limit of the material.

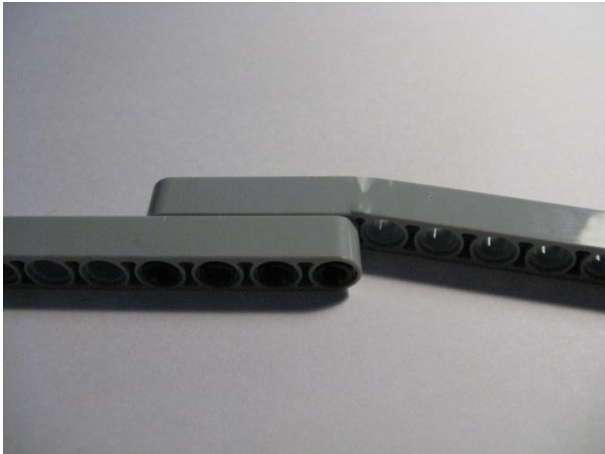
This final image is a specimen from a failed test. While adjusting the vertical position, the jaws moved too far. The result is the bent Liftarm. This is quite different to the other tests as it was the only compressive force applied to the connection. As this was not a controlled test, there was no force reading available. However, it still shows what should happen when a large compressive load is applied.

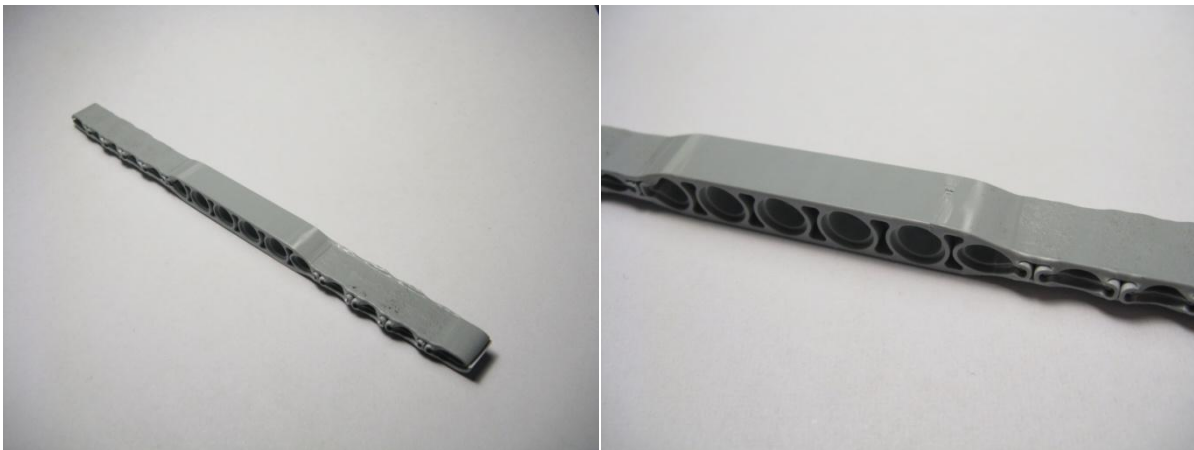
The first tension test is unusual in that there is no detectable fracture present, which is the case. The fracture is actually the stress line shown below.

The location of the fracture is quite interesting. In both cases, the failure point is on the boundary between the hole and the outer covering. The acute angle between the hole and the flat outer covering probably has made a big difference to the strength of the Liftarm. It also highlights the major weak point of the Liftarm. If this was in a real life situation, it is likely that the Liftarm will fail not in the middle and not at the joints to other Liftarms but in between the joints and the middle of the Liftarm.

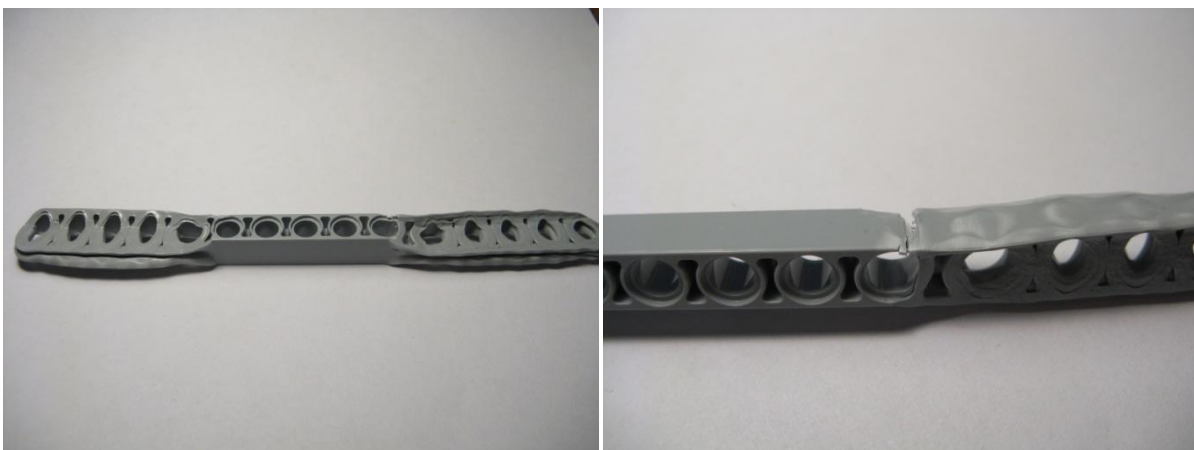
The fracture is more visible in the second test of the Liftarm here.

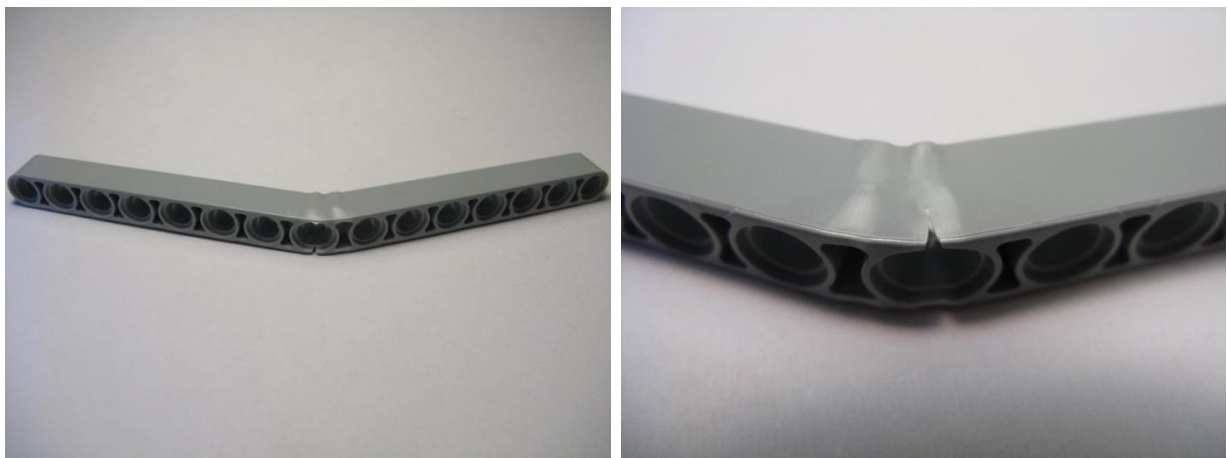
The third test involved a transverse force on the Liftarm with the pins facing to the top. It makes logical sense that this would be the strongest direction as there is more structure for the stresses to pass.

The numerical results show it is the weaker of the 2 directions with it only able to support 97N before failure. It appears in the expected location and there are clear and visible signs of buckling.

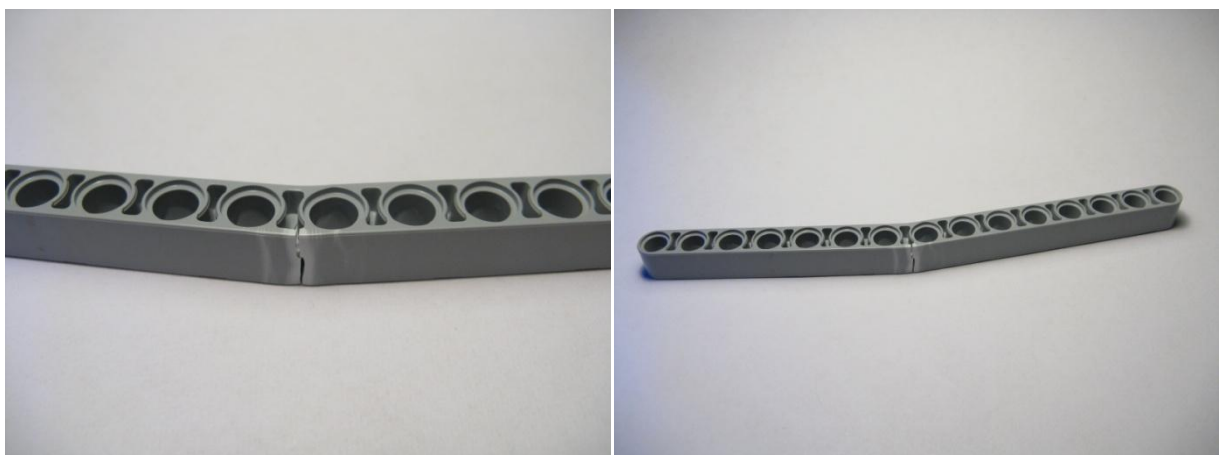
This fourth set of images show the first test which involved a pause during the application of the force.

As we can see, the fracture is quite large and occurs on the joint between the hole and the outer covering. This is quite similar to the tensions tests in the location. It highlights the weak point of the Liftarm.

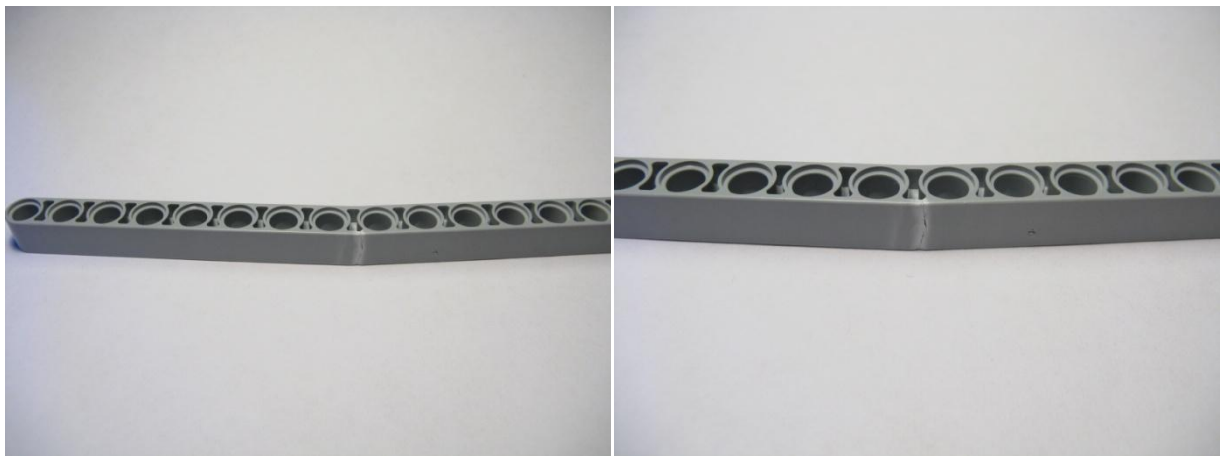
The fifth set of pictures show the same test above except that there was no pause.

It is clear that the pause had a small effect on the maximum force. The fracture is also a lot smaller. Again the fracture is in the same place further highlighting the weakpoint.

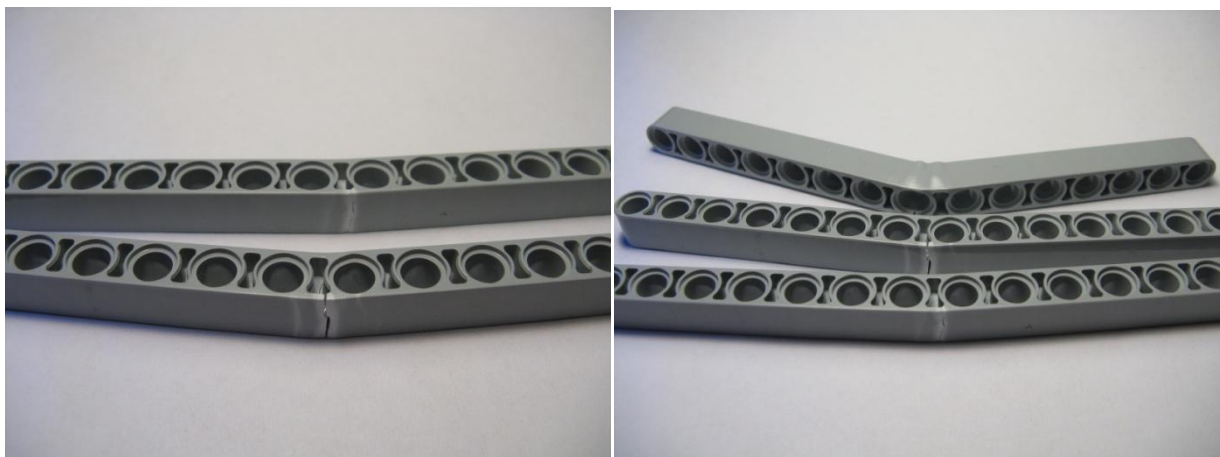
These next images show the Liftarms in the same image to compare displacement.

By comparing the displacement of the Liftarms to the force required, we come to the conclusion that the more force required to break the Liftarm, the less displacement required. It logically makes no sense at all. Overall it can also be said that the Liftarm is strongest in transverse when the pins are on the side when the force is applied on top.

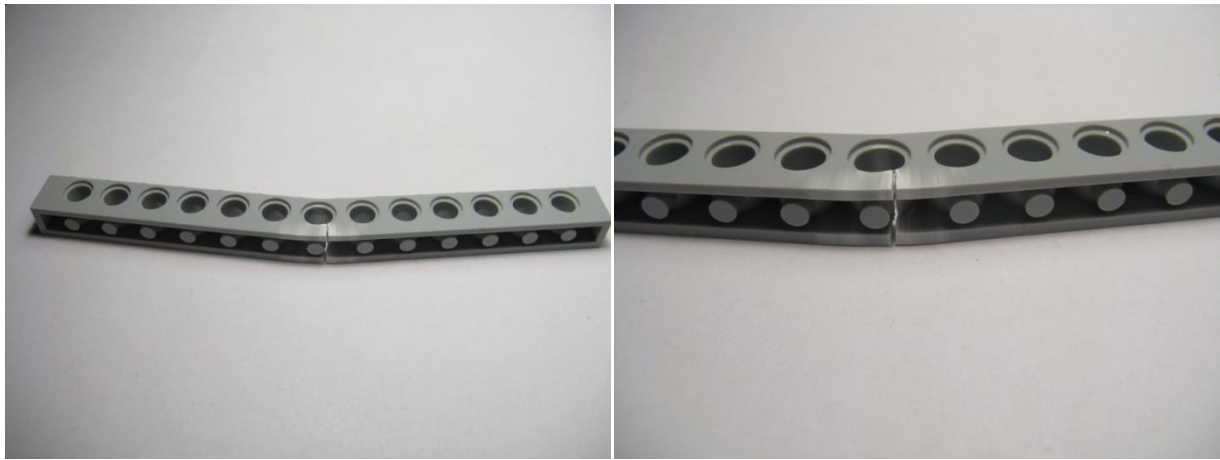
The seventh test was a Brick Beam in transverse.

As the raw numbers show, the Brick Beam is much stronger in transverse. The failure is also in the expected location, where there is little material in the cross section. The displacement is similar to the fourth test.

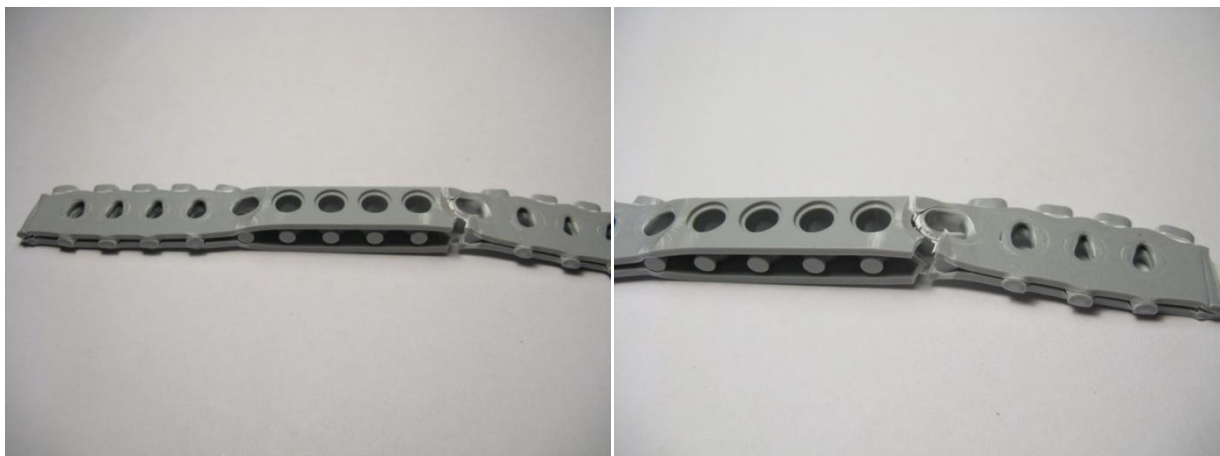
The eighth test was the Brick Beam in a tension environment.

The point of failure is again similar to the transverse test, and most interesting, similar to the point of failure of the Liftarms. It is quite clear to see the pin hole pulling away from the rest of Brick Beam. This reinforces the fact that the edge of the connection area will fail before the middle of the Brick Beam. We can also see that the strength is about 20% less than the Liftarm. This quite significant as the Brick Beam is much stronger than the Liftarm in the transverse test.

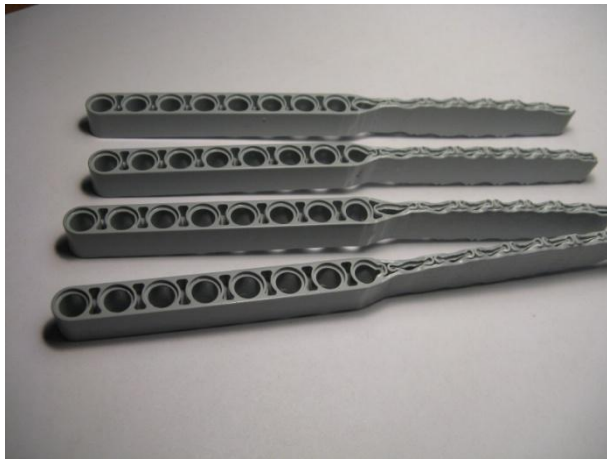
These Liftarms were used in multiple tests as it was observed that it would be a waste as the crushing had no visible effect on the strength. The transverse tests were performed with different Liftarms, but they were unaffected apart from some marks from the plunger.

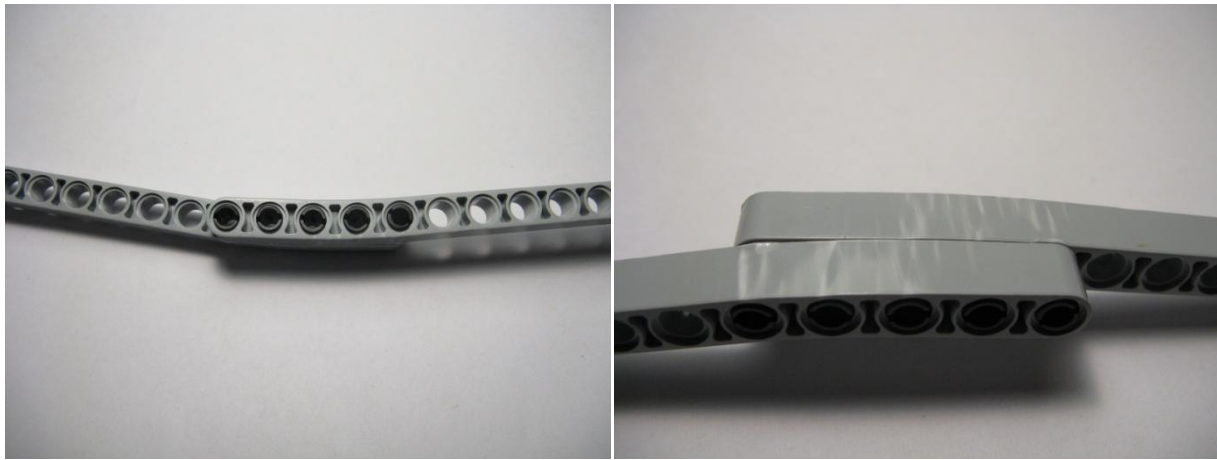
The last test performed was the 5 pin transverse test. It was definitely the most interesting.

It is quite clear that the whole Liftarm has been bent. The pins did not pop out. It appears that the Liftarm and pins holes have bent at the same time. It is also interesting as it is a permanent bend. The only other times this happened was when the Liftarm fractured. In this case, no fracture is visible and the Liftarm appears to have maintained its strength. As the transverse tests did not exert a large sideways force, this result leads to the conclusion that it is possible to have the Liftarm 'fail' before the join does though it should be noted that it didn't happen in any other tested and might just be a fluke.
