University of
**Southern
Queensland**

**THE DETECTION AND ANALYSIS OF
IRRIGATION CHANNEL LEAKAGE
USING IMAGING FROM
AN UNMANNED AERIAL VEHICLE.**

Master of Science

2022

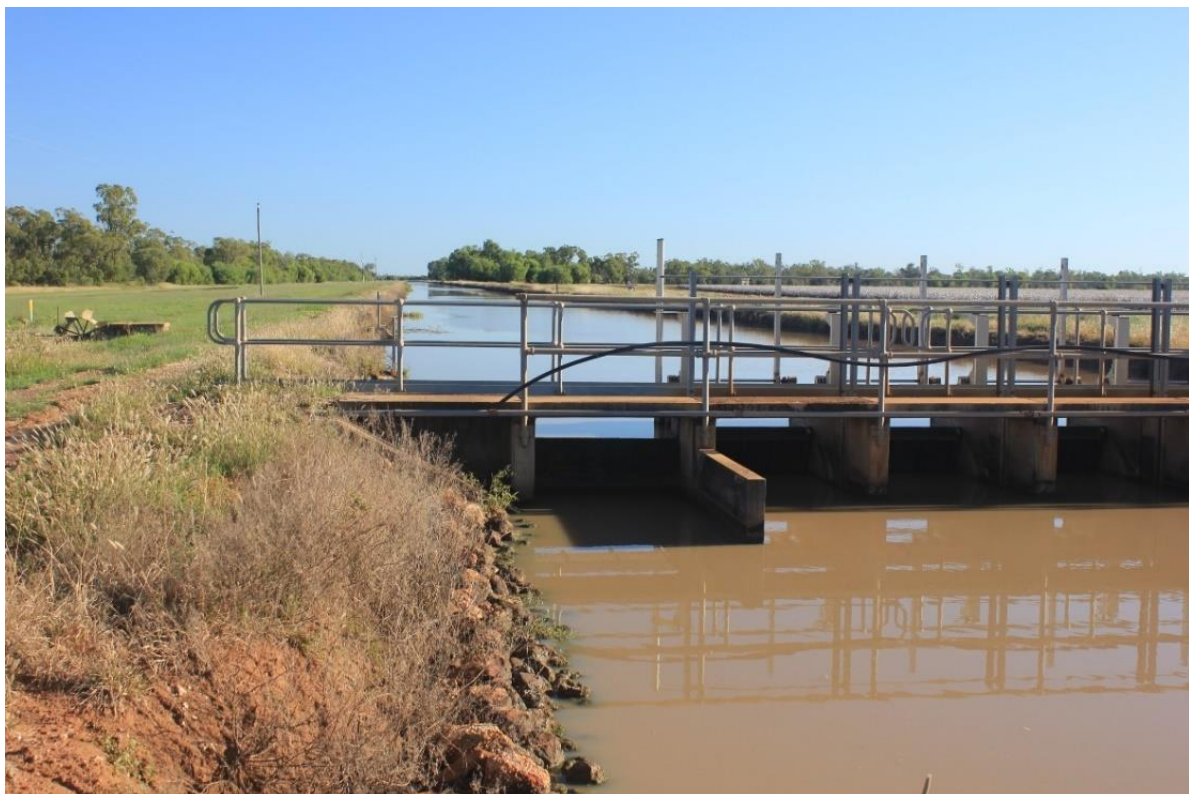
Figure 2

Bundoran Road Channel (Channel B2)

Note: Irrigation channel at register point, Dethridge Wheel for water delivery measurements at left and cotton ready for harvest at right. Own photo 13 Apr 2022.

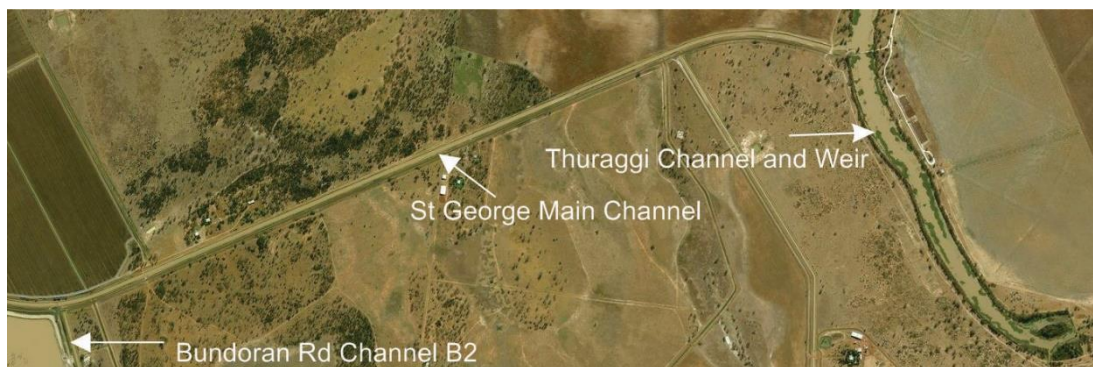
Figure 5

Buckinbah Weir. Thuraggi Channel and main channels are shown below as Figure 5. All of the channels are open earth construction, without any lining and are fully gravity operated. The majority of the irrigation channels have been constructed above ground level. There are manually operated flow control systems to meet irrigator's crop demands (SunWater, 2021).

Thuraggi Channel at 100% capacity.

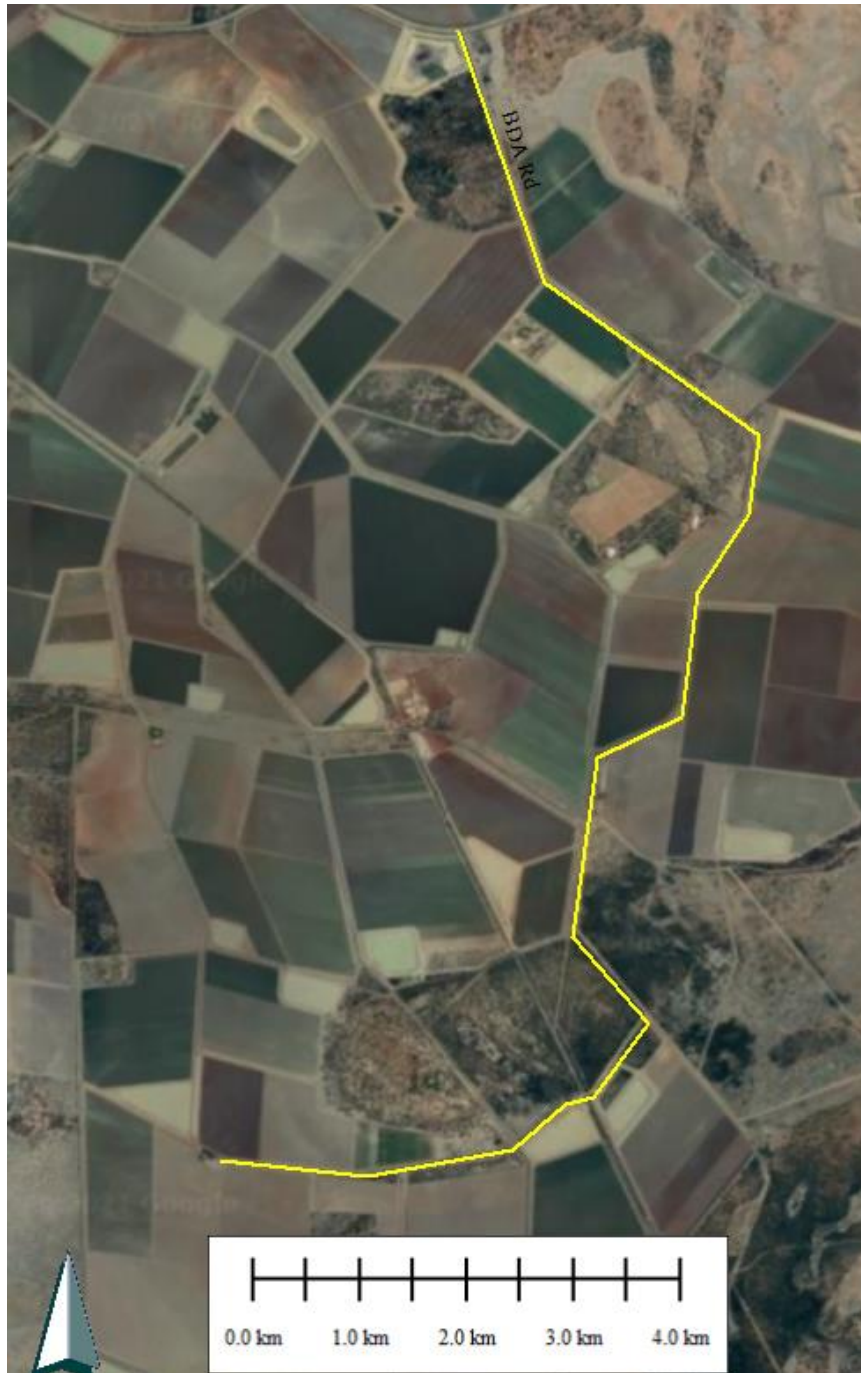
Irrigation channel flights April 2021

The flight path used in April 2021 is shown in Figure 8. All of Bundoran Road channel (Channel B2) was flown. In April 2022 the flights were flown over sections BDA Flt Paths 1,4,5,6,7and 8 as shown in Figure 9. BDA Flt Paths 2 and 3 were eliminated following a visual safety inspection that included, trees, power-lines and residences prior to commencement of flights. The areas eliminated had been recently mown and Mallawa Irrigation Ltd., management reported that no leaks were identified during this mowing process.

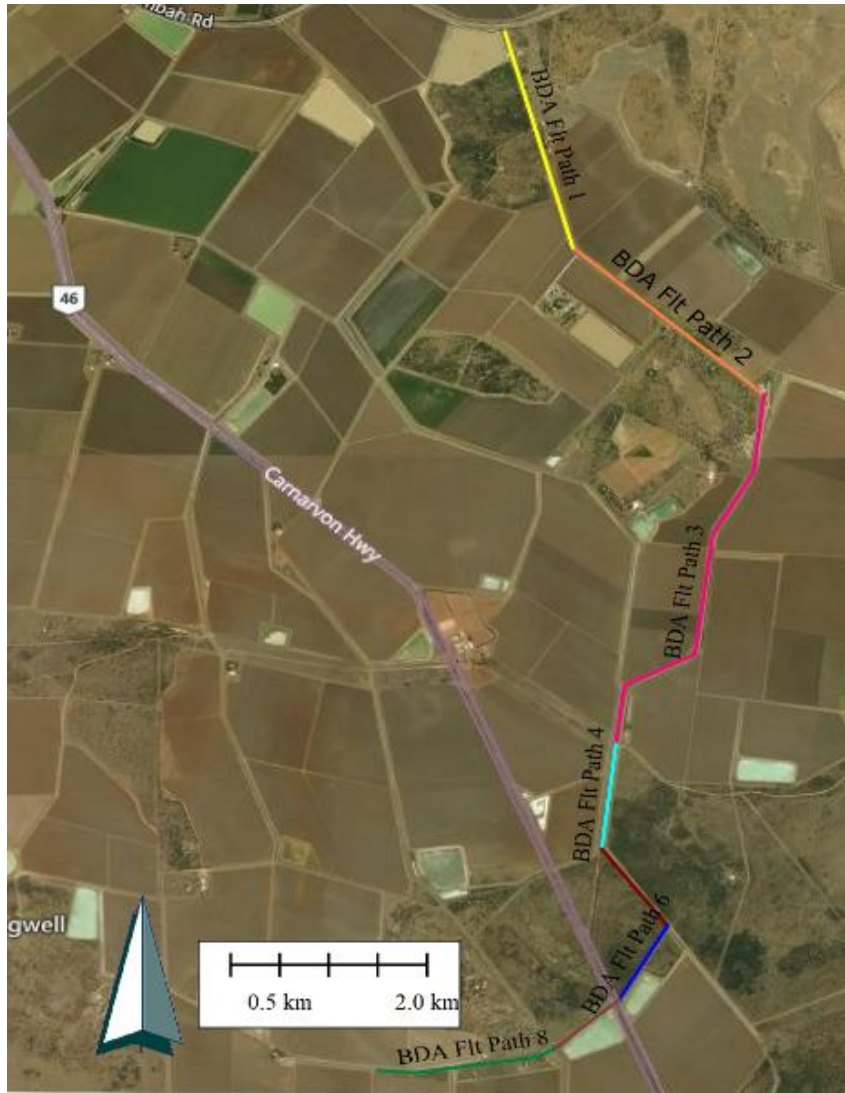
Figure 9

Flight paths flown in April 2022

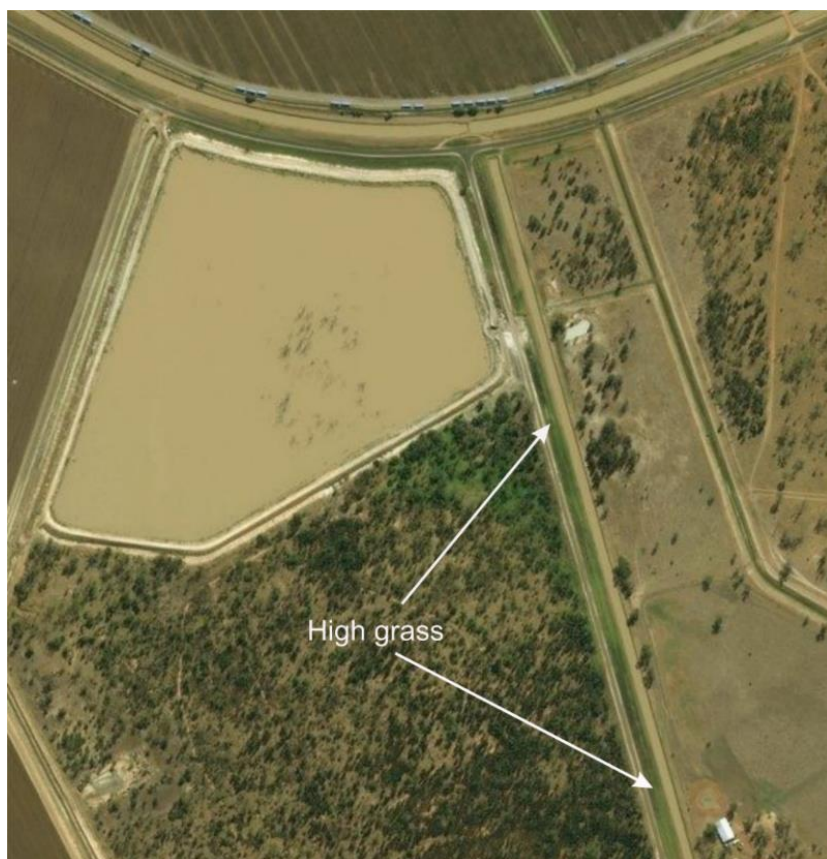
Beginning of Channel B2, with high grass.

Financial and time constraints for this project meant that these irrigation channels were chosen by Mallowa Irrigation Limited who advised that this irrigation channel, B2, had the greatest potential for leakage. Vehicle access along the total length of this channel is good and visible high green grass and weeds are visible on the satellite images shown in Figure 10 below.

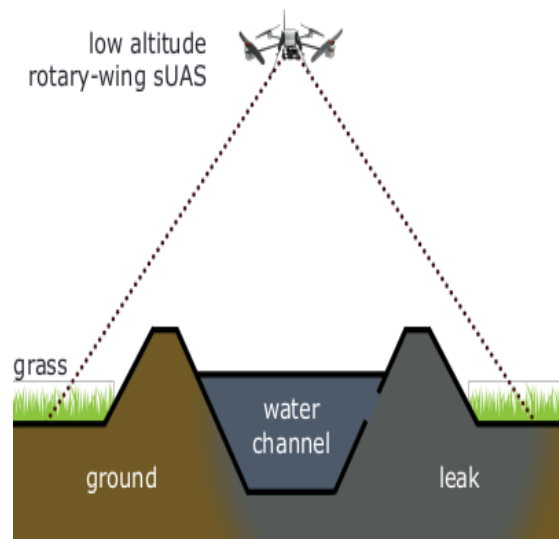
Texas A & M University's UAV program.

Unfortunately, the trials are subject to ‘Patent Pending’ and no further information is available (Dufek et al., 2017). The paper concludes that this method was considered successful but a search of the US Patent Office for the terms “Irrigation channel leak detection” and “Irrigation canal leak detection” did not produce any positive results (US Government, 2021). The flight concept used by Texas A &M University is shown in Figure 11 below.

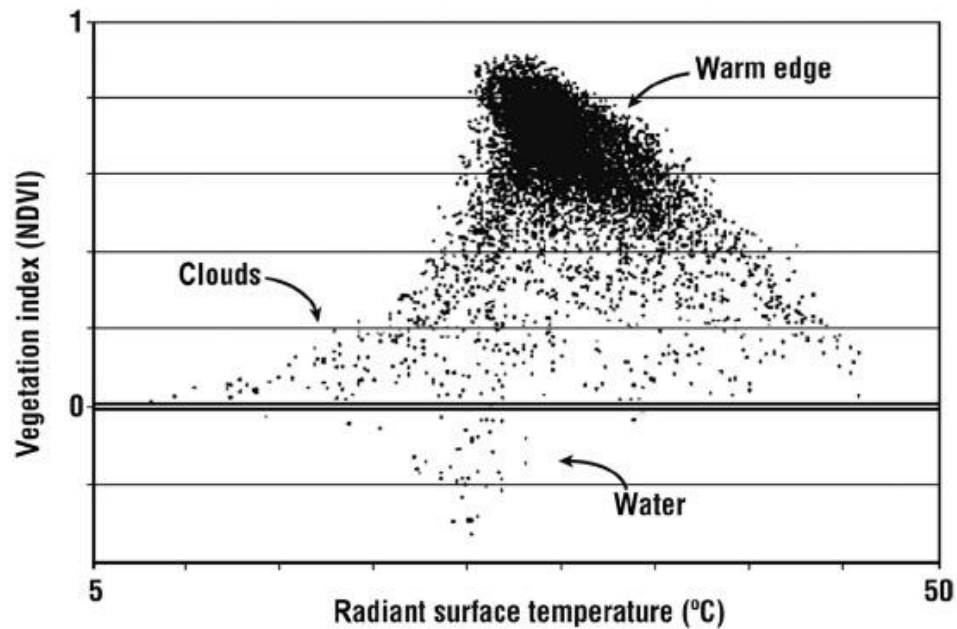
Two-dimensional tri-angle plot.

The values of F_r and T^* are then plotted on a two-dimensional triangle to determine if soil moisture is present. Figure 13 below is an example of this type of plot.

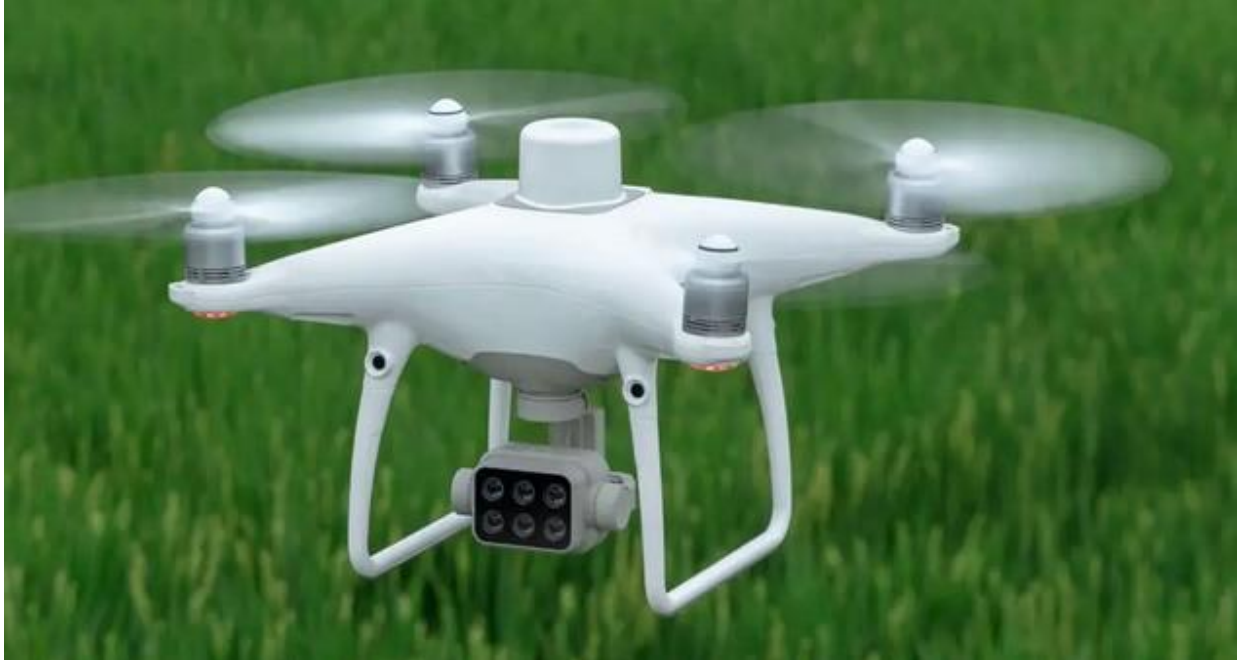
DJI P4 UAV with multi-spectral camera.

The camera is fitted with the following complementary metal oxide semiconductor (CMOS) sensors as per Table 2 below. This data is from DJI Multi-spectral camera specifications (DJI, 2021).

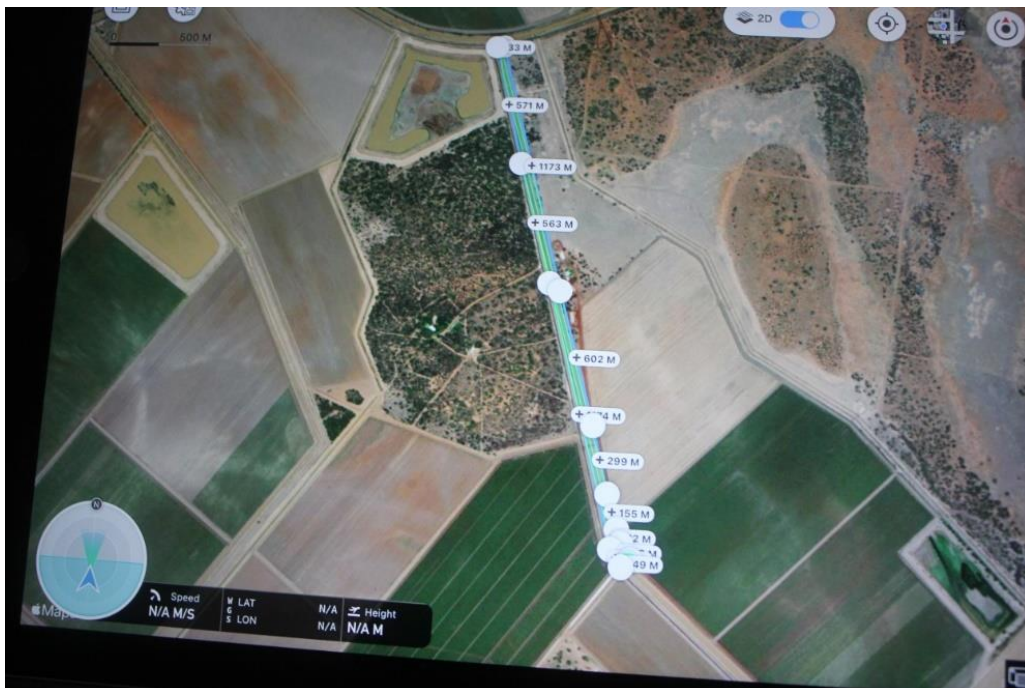
Screen capture of DJI GS Pro Flight Plan # 1.

Flight planning for the DJI P4 UAV is done with the use of DJI GS Pro (Ground Station Pro) Flight Management software (DJI Technology Co., Limited, 2022). This software is commercial and is sold on a month-by-month fee payment basis. Table 3 below shows the properties that can be used in this software. The data in this table comes the meta-data of images from Flight Path #1 at St George on 12 April 2022.

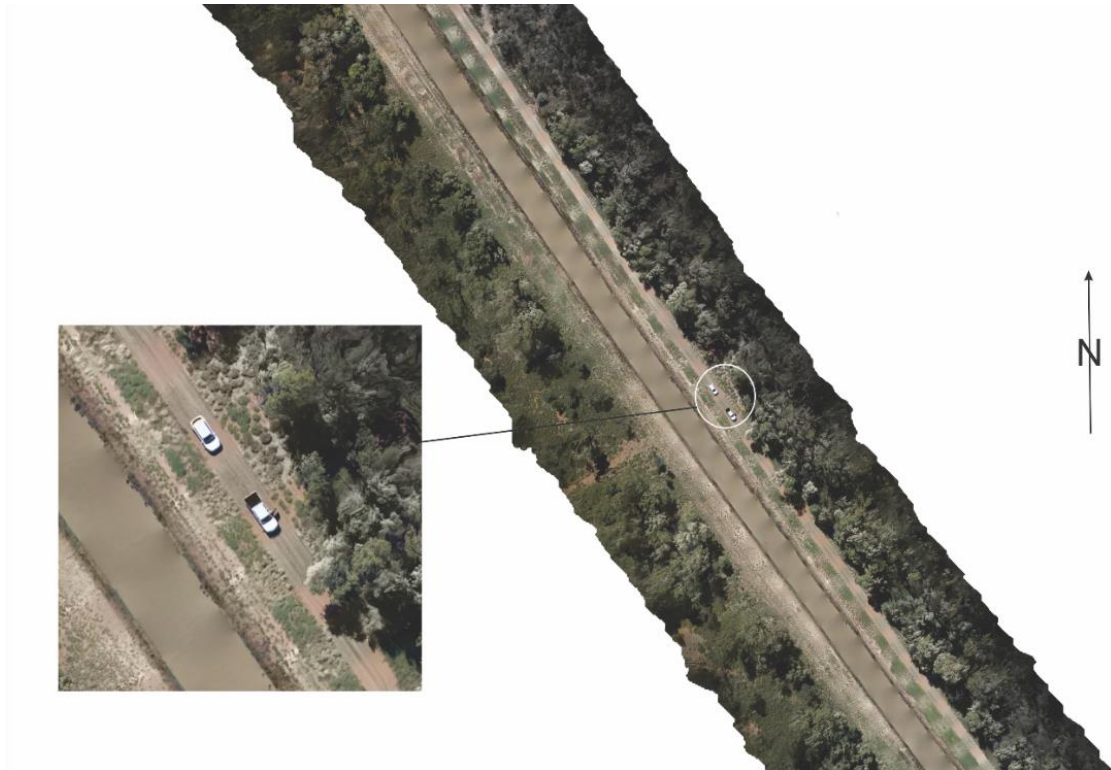
Ortho-photo-mosaic of UAV Flight with enlarged vehicles.

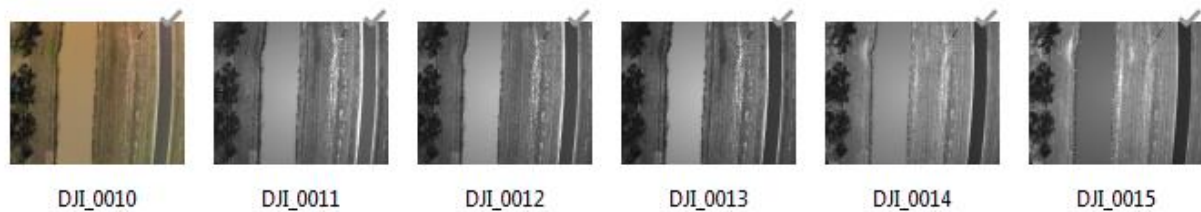
Image set from DJI P4 multi-spectral camera.

Note: From left RGB, red, green, blue, red edge and near Infra-red image bands.

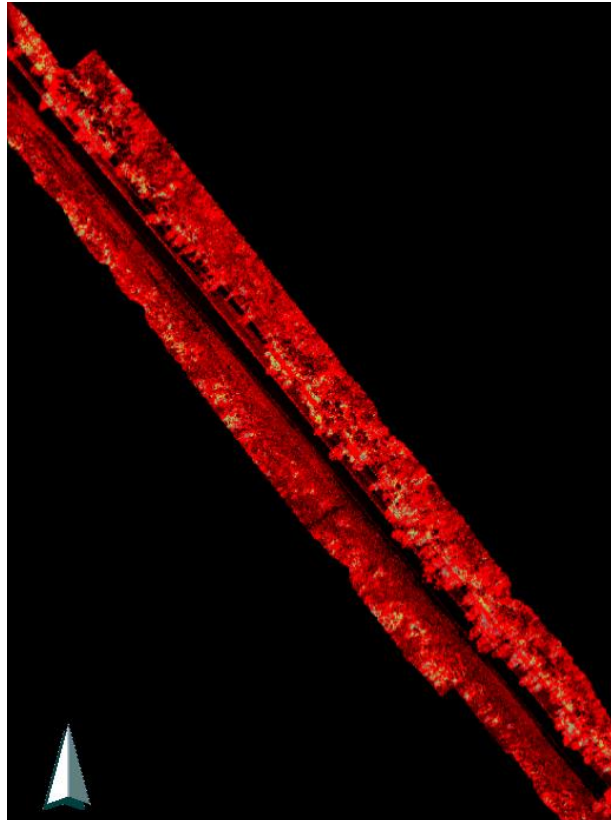
Mask Manager set for between 0.8 and 1.0 GNDVI and resulting hotspot map

Note: Hotspot Transparency set $0.8 < 1.0$. From European Space Agency SNAP Toolkit (European Space Agency, 2021).

Only locations identified as hotspots near the banks of the irrigation channel are considered to be potential irrigation channel leaks. This is seen in the above image where yellow hotspots appear on the left and right edges of the image and may not be irrigation channel leak but vegetation with high Chl-a values.

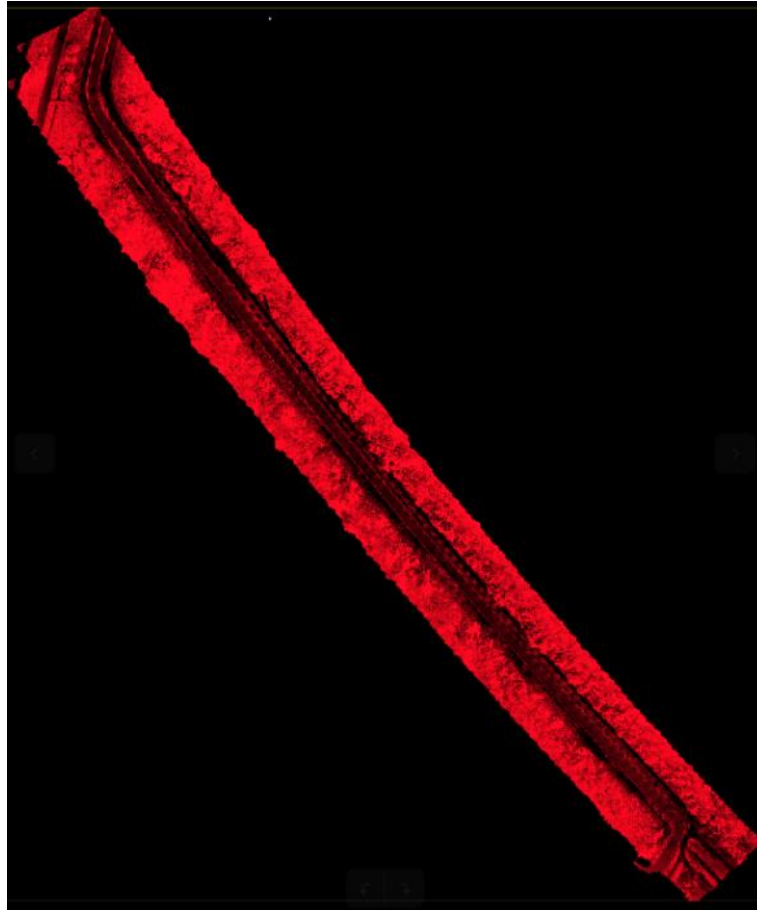
GNDVI image derived from ortho-photo-mosaic.

The red values in Figure 20 above are graded colour depending on the calculated GNDVI results (from -1 to +1) from the SNAP Toolbox Vegetation Radiometric Index calculation. The histogram of the colour strength, which relates to the value of the GNDVI is shown below as Figure 19. Using colour manipulation properties of this histogram the values of the GNDVI and consequently its represented colour, can be increased or decreased. If increased, it will show a deeper red colour for the higher GNDVI value. The red value is set to 0.62 which is the value used in Figure 17 above.

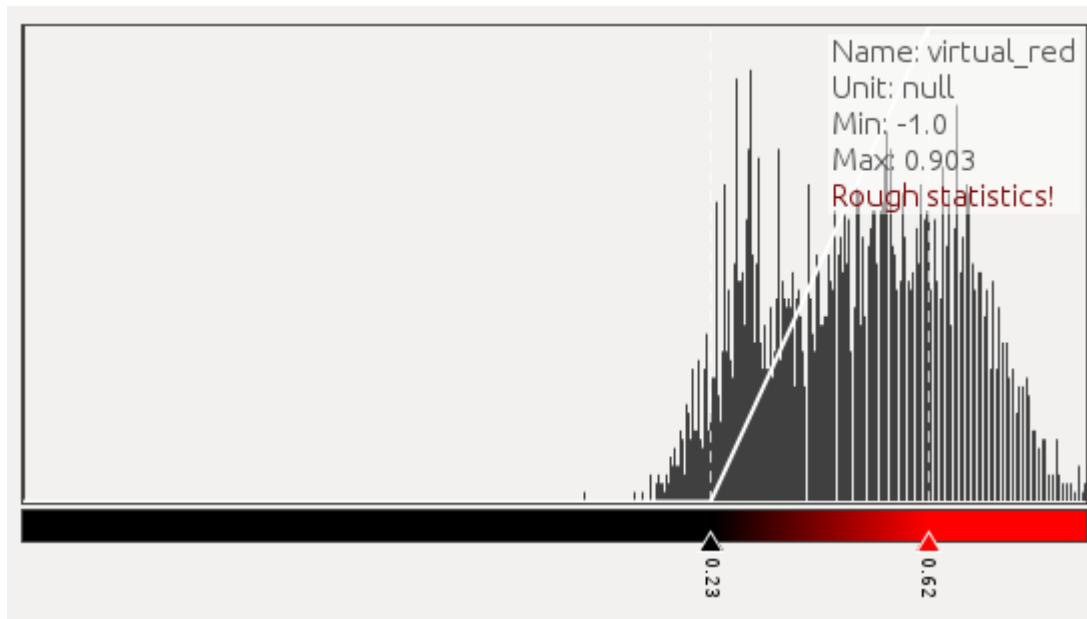
Colour manipulation histogram

Figure 22 shows the same image as Figure 20, above, but with the black value decreased to 0.41 and the red value increased to 0.84. By doing these alterations the potential hotspots are visible.

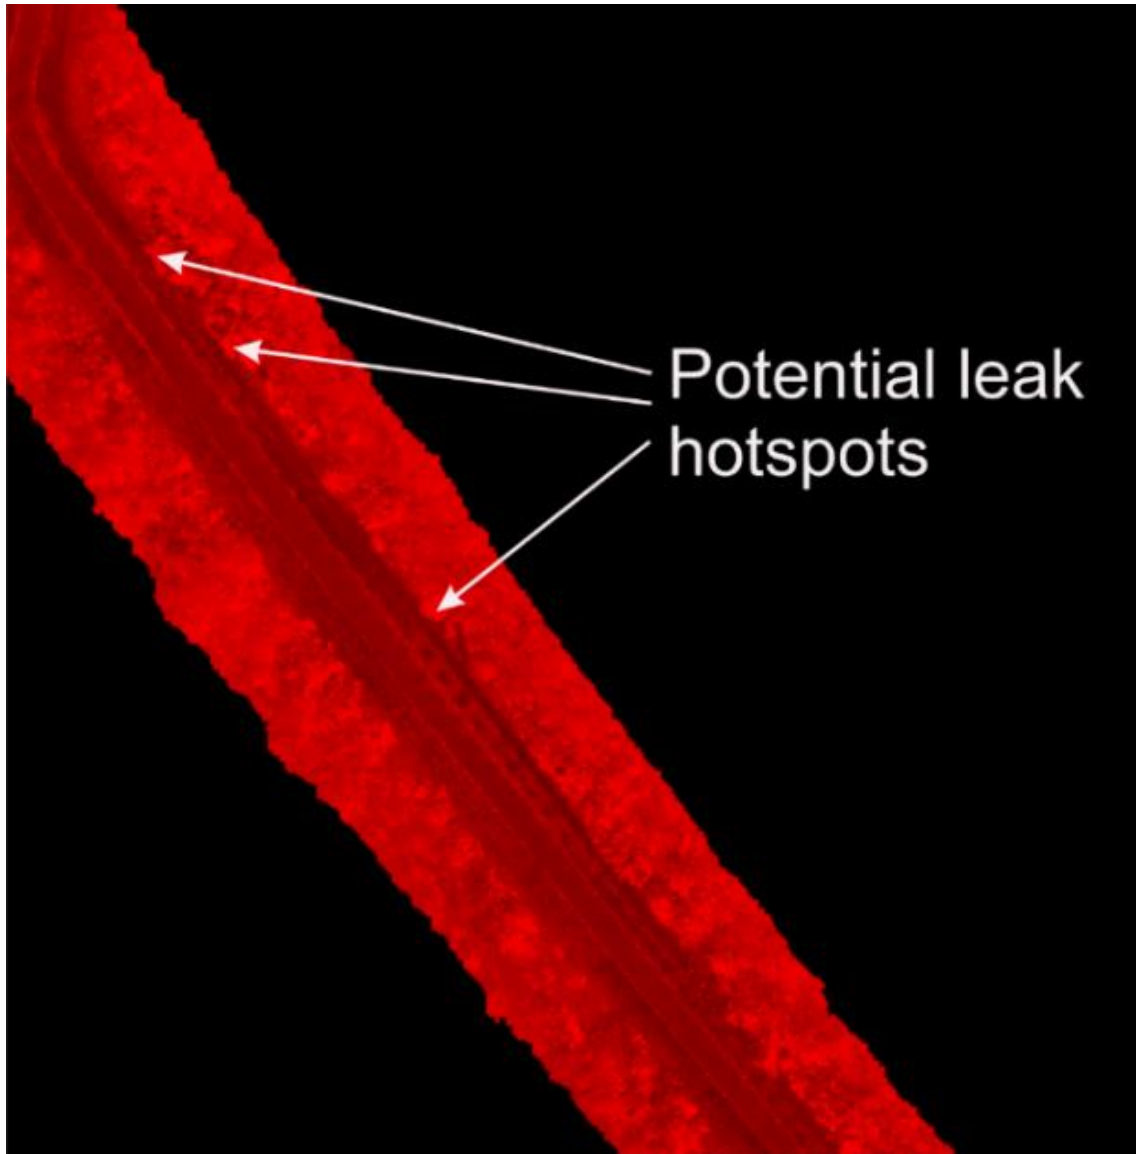
Manipulated colours of GNDVI overlay

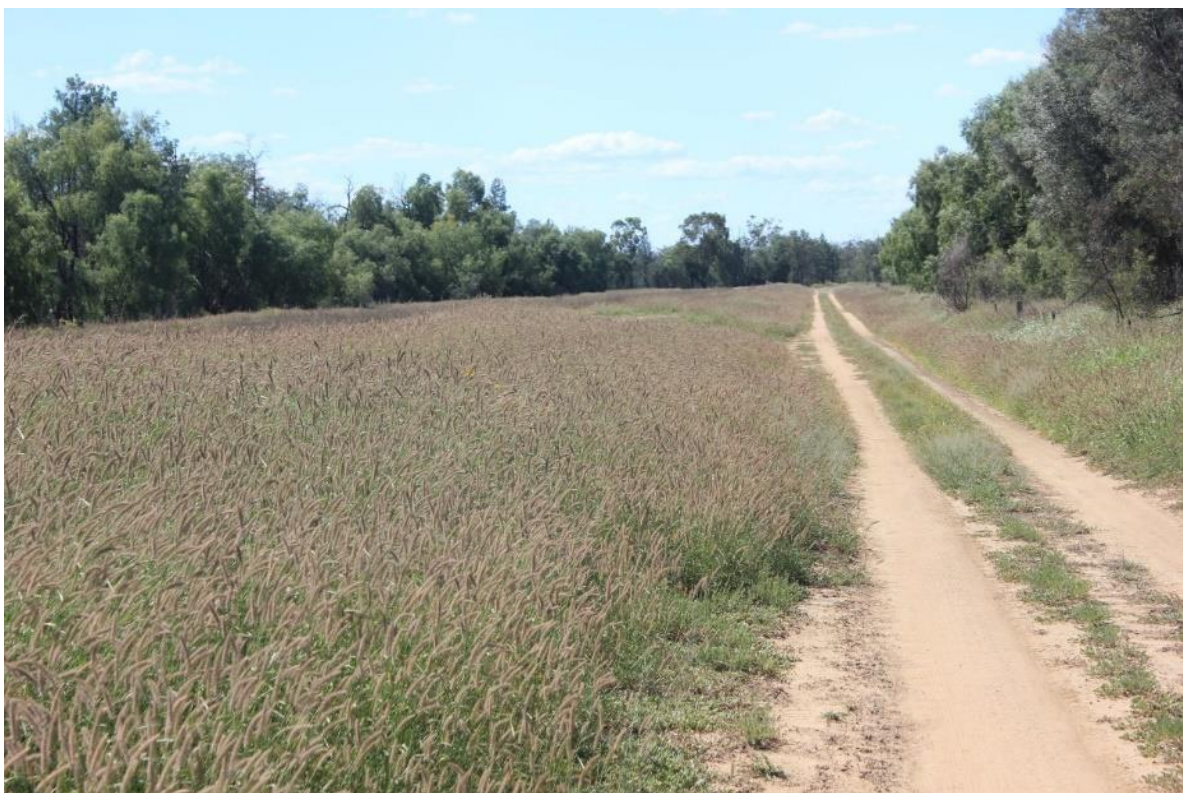
Hotspot location 4.2 showing Buffell Grass on bank

Note: 9 Apr 2021. Irrigation channel is to the left of this image. Own photo.

Between 1 Mar 2021 and 9 Apr 2021, 139.2mm of rain had fallen in the St George area (FarmOnLine Inc, 2021). This rainfall promoted a rapid growth of grasses such as Buffell Grass and Rhodes Grass (Qld Department of Agriculture, Forests and Fisheries, 2013). This growth is visible along the banks of irrigation channel B2, as shown in Figure 24 and Figure 25. It should be noted that Buffell Grass is not tolerant to high water levels in the soil (Cook, 2007).

The SMC values along Flight Path #4, where the photos in Figures 24 and 25 were taken were all below 1.16%. This indicates that high SMC values were not present. The Buffell Grass in Figure 24 is over 1m high confirms that high SMC values are not present along this part of the irrigation channel system.

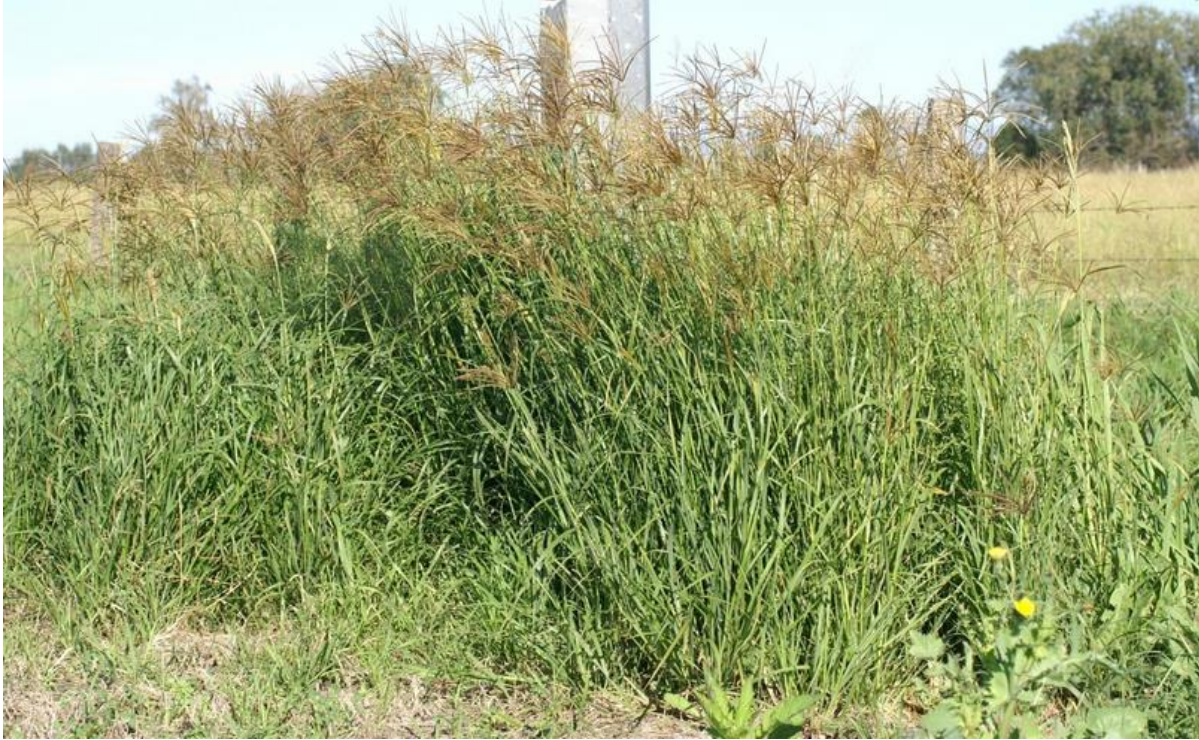
Figure 25

Rhodes Grass near irrigation channel bank

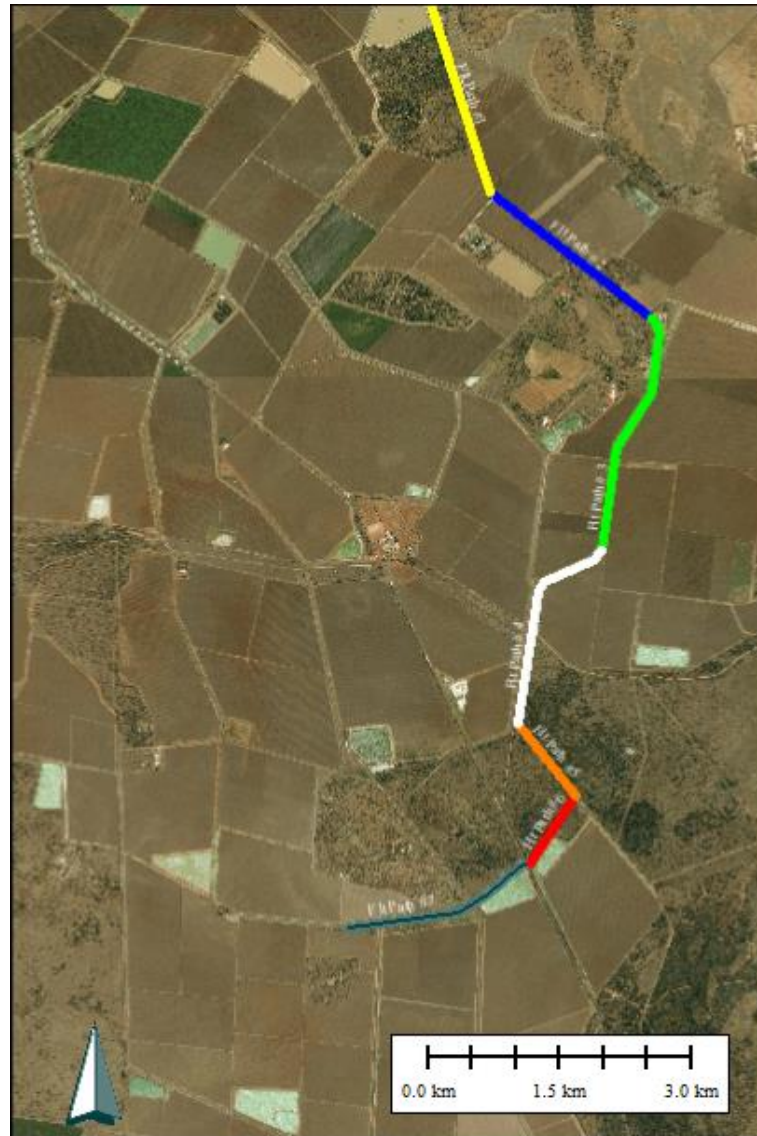
Figure 27

Five flight paths were flown from the seven originally selected. These flight paths are shown in Figure 27. There are sections of the irrigation channel system that were not flown due to time constraints. These are the Flight Path #2 and Flight Path # 3 together with the section of irrigation channel B2 that continues after the western end of Flight Path #5. All of the sections that were not flown during this project were checked during the Risk Assessment stage and visual inspections showed there was not any location that had the potential to be an irrigation channel leak site. Lack of lush vegetation was the prime factor in eliminating these locations. Channel B2 extension from Flight Path #5 was not flown as there had not been water in this irrigation channel.

Flight paths flown by UAV during Phase 1.

All heights were flown at 80m above ground level. This height was consistent over the whole project as the longitudinal slope of the irrigation channels was minimal. The duration of each flight was less than 20 minutes. The time for each flight depended on the geographical features

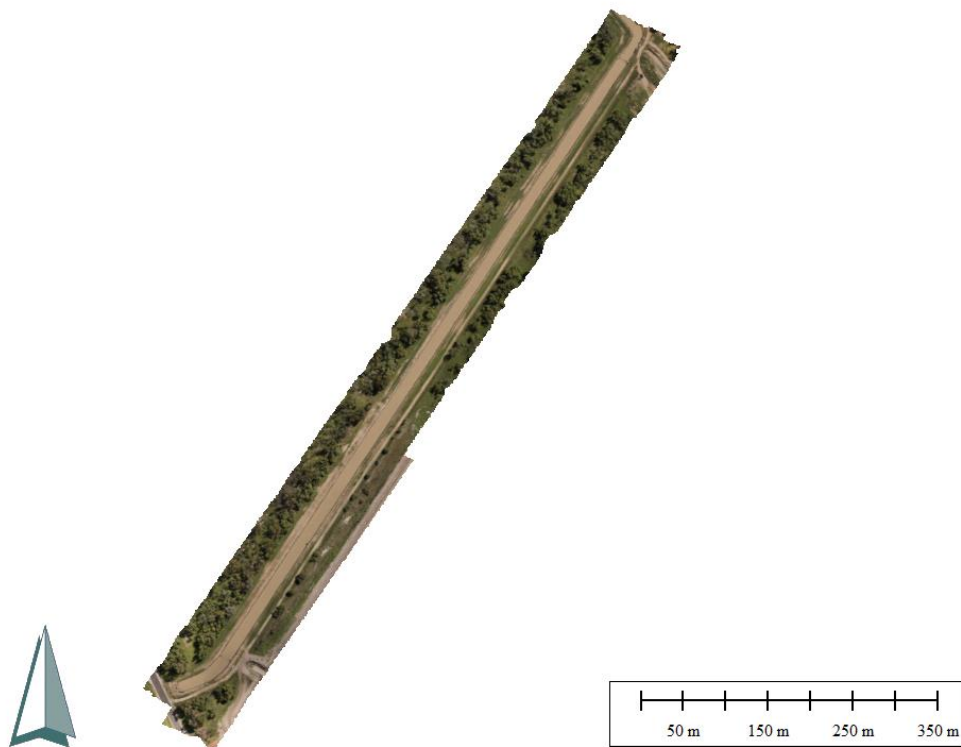
Figure 28

Agisoft® Metashape V1.7.4 (Agisoft LLC, 2021) software was used to convert the individual images from the UAV into an ortho-photo-mosaic. An example of an ortho-photo-mosaic is shown as Figure 28.

Ortho-photo mosaic of flight path #6

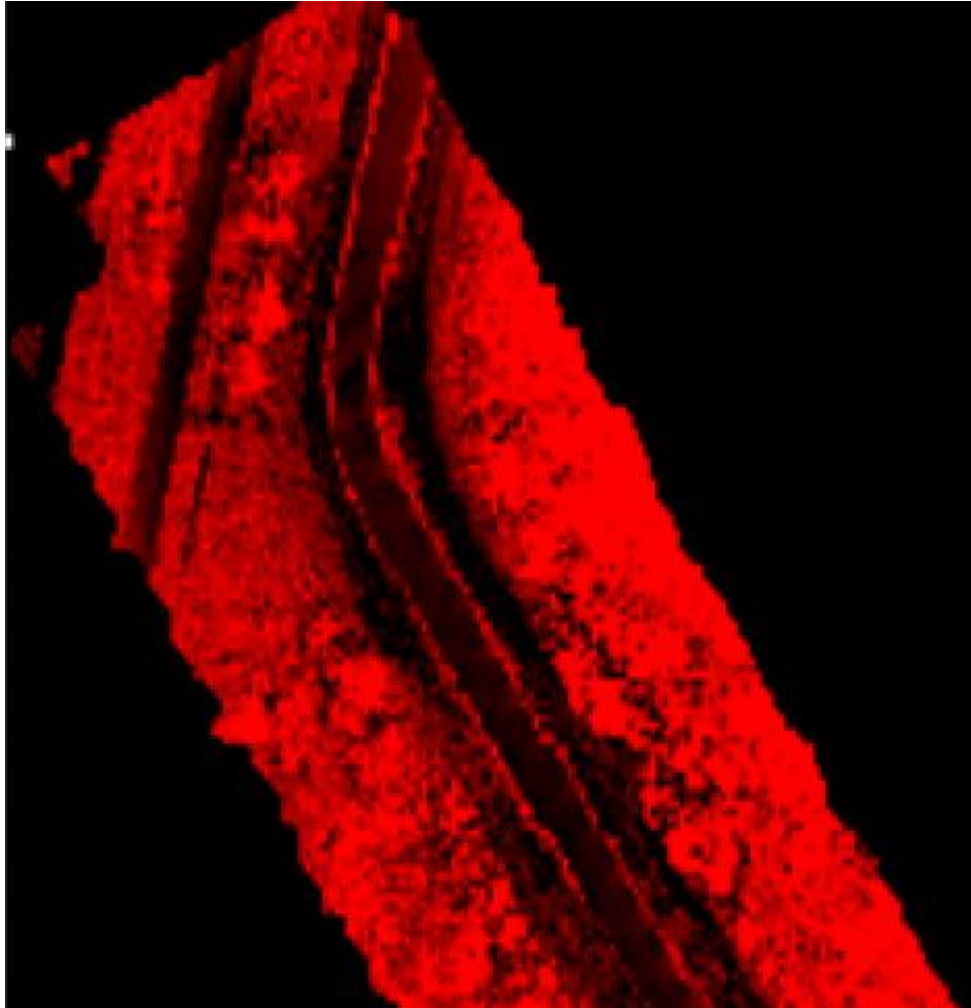
GNDVI overlay of ortho-photo-mosaic for Flight Path # 4

After the GNDVI overlay is generated the Mask Manager component of the software can now be opened. The Mask Manager allows for the determination of pixels with a high GNDVI value, using values from -1 to +1. In this project the value range set for the mask was for a GNDVI value between a minimum of 0.6 and a maximum of 0.85. Mask values are determined by adjusting the values until hotspots are clearly identified. For Flight path #4 the ideal value to identify the hotspots

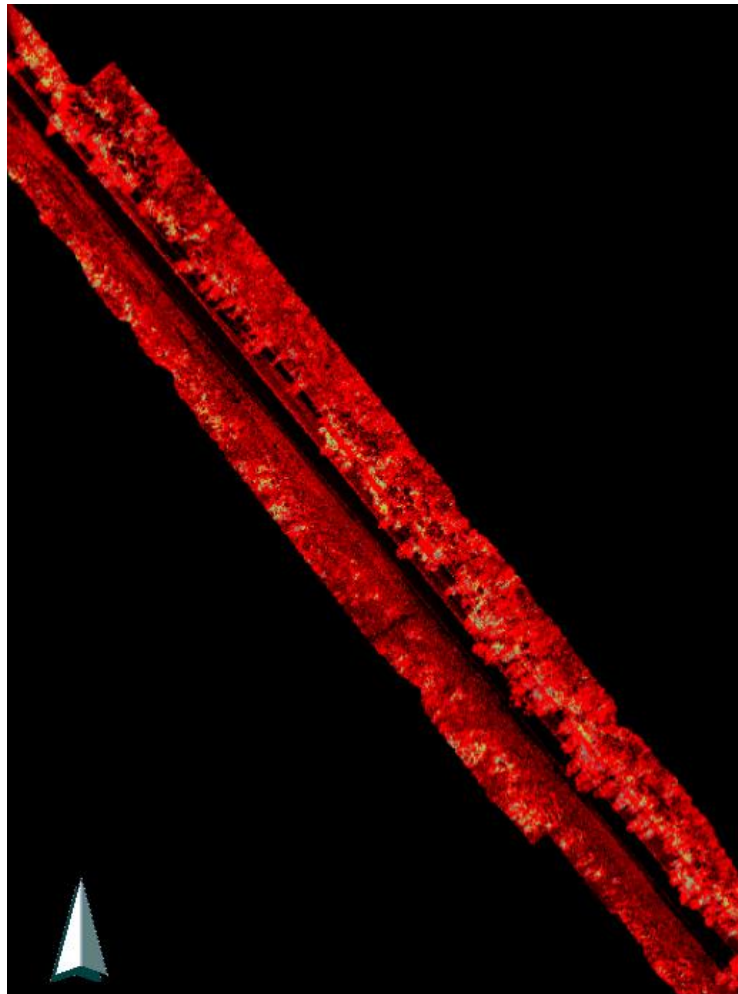
GNDVI overlay with arithmetic mask overlays

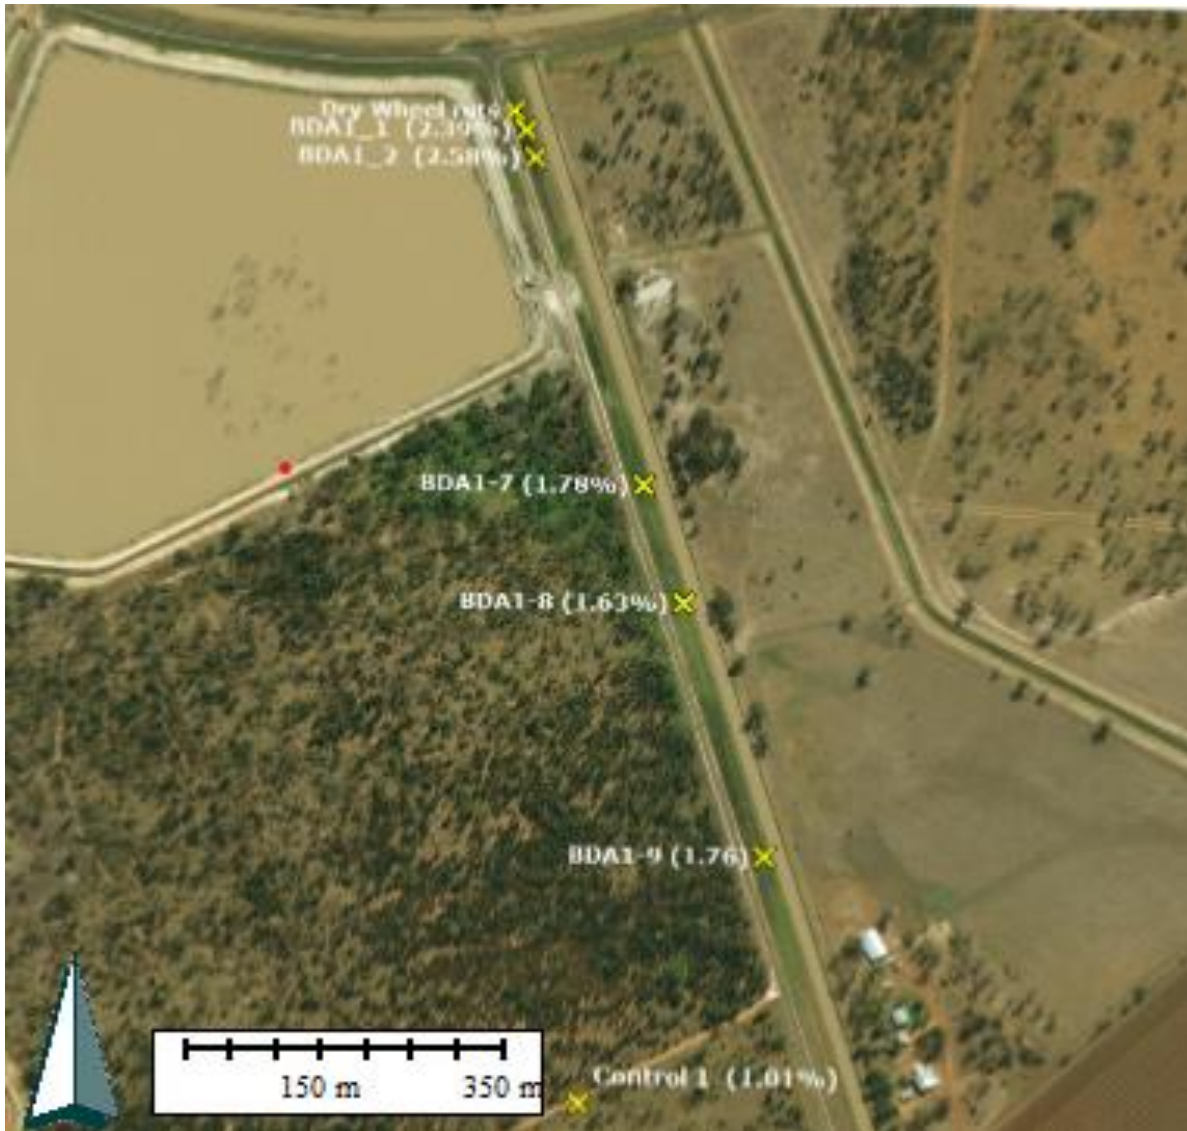
Channel B2 top section - hotspots and Soil Moisture Content values

There were 12 hotspots identified. In addition, two wheel ruts were identified which were probably created when a vehicle drove over an area with a high SMC at one time; possibly during earlier periods of high rainfall as there was no evidence of high SMC values found at these locations. The second wheel rut location did not show a high SMC value so it may be that during wetter seasons, water from the large nearby dam or the lateral roadside drainage channel along the Castlereagh Highway may be the source of water for this wet spot. The high moisture contents in Figure 31, the top section, identified as BDA1-1 and BDA1-2 may be caused by these points being in the vicinity of the large dam across the road.

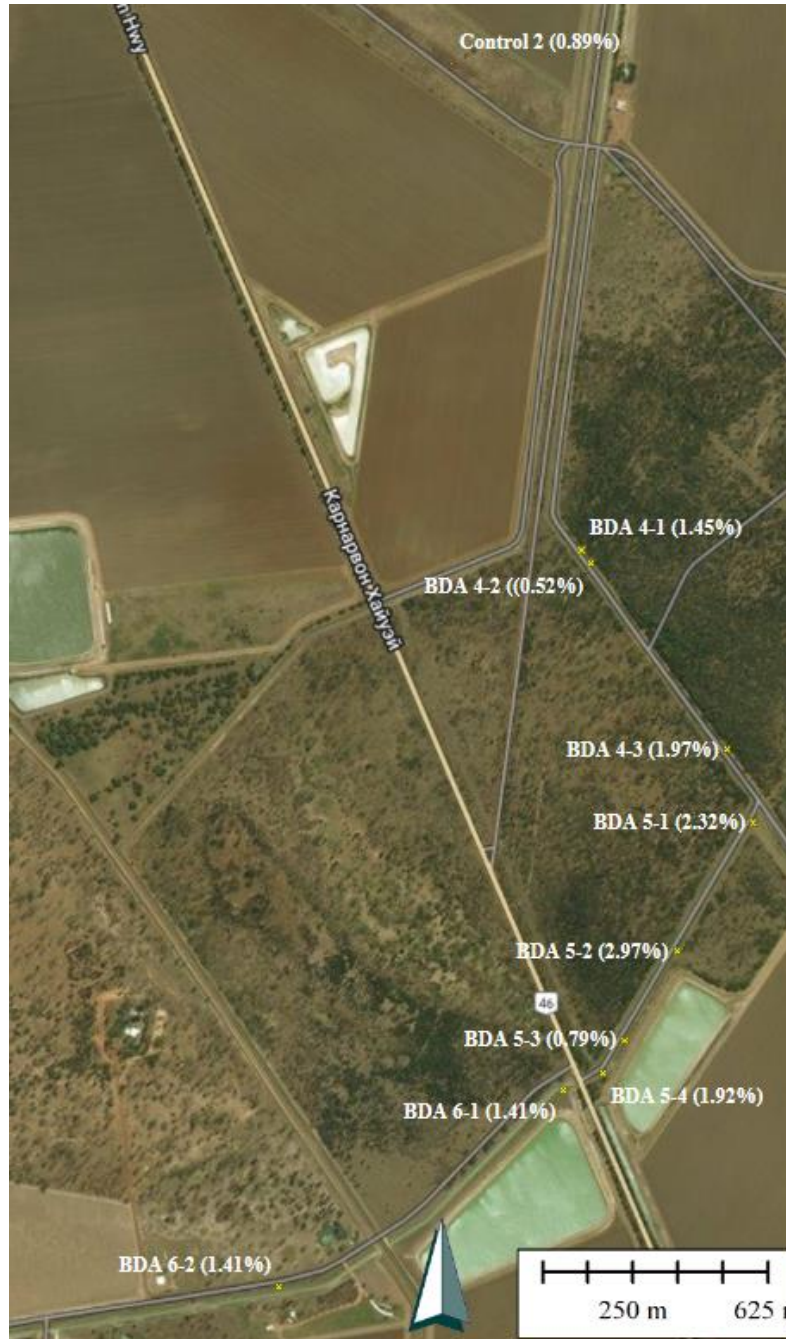
Figure 32

Channel B2 bottom section hotspots and Soil Moisture Content

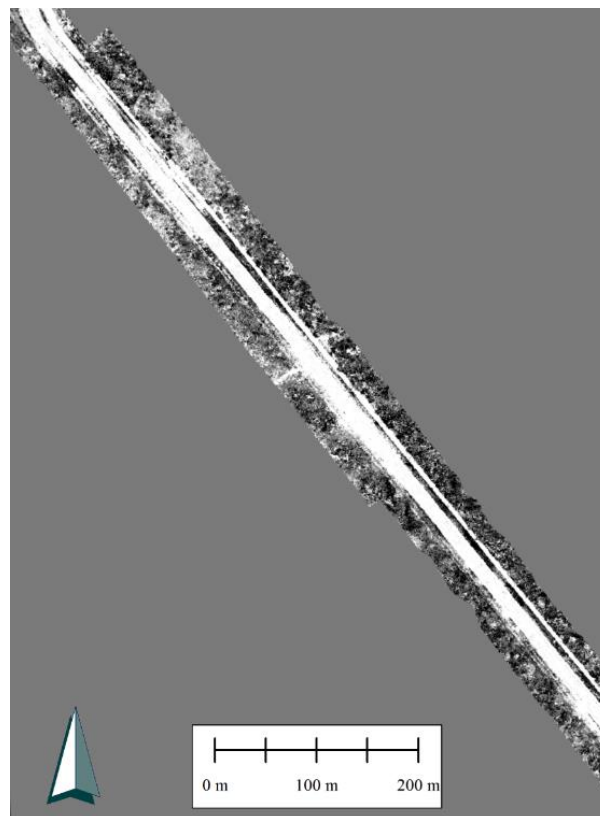
GNDVI Map of Flight Path # 5

Note: Source: DJI P4 UAV and Agisoft ® Metashape V1.82 (Agisoft LLC, 2022). This is the second flight along Flight Path #5; re-flown to eliminate tree shadows.

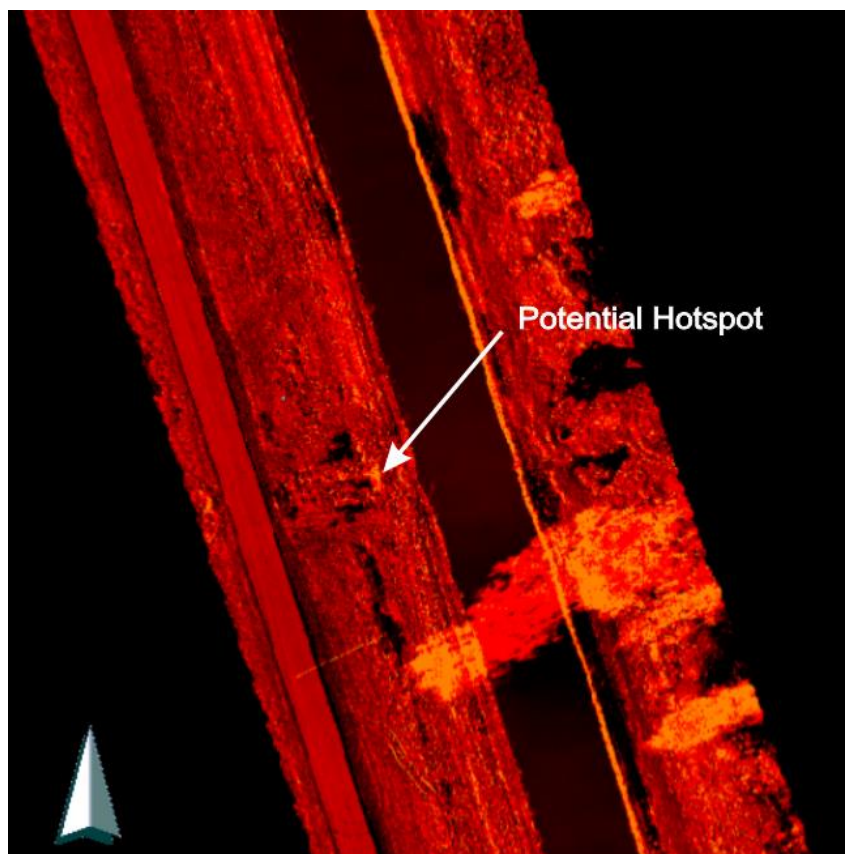
GNDVI overlay with arithmetic mask value of between 0.58 and 0.8

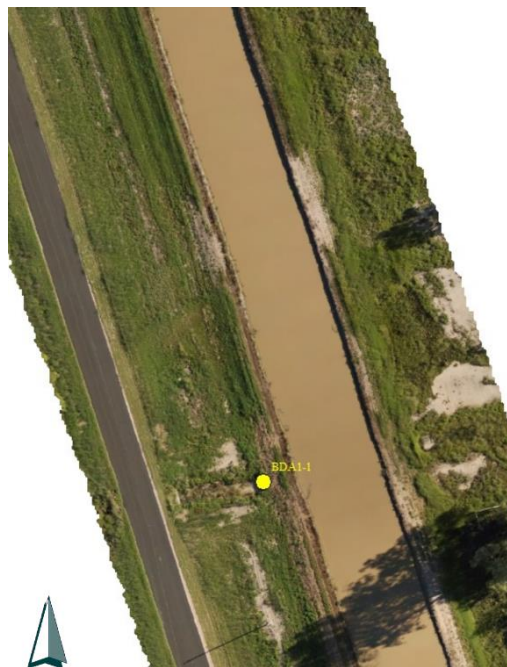
Identified hotspot at Flight Path #1
