University of
**Southern
Queensland**

**THE DETECTION AND ANALYSIS OF
IRRIGATION CHANNEL LEAKAGE
USING IMAGING FROM
AN UNMANNED AERIAL VEHICLE.**

Master of Science

2022

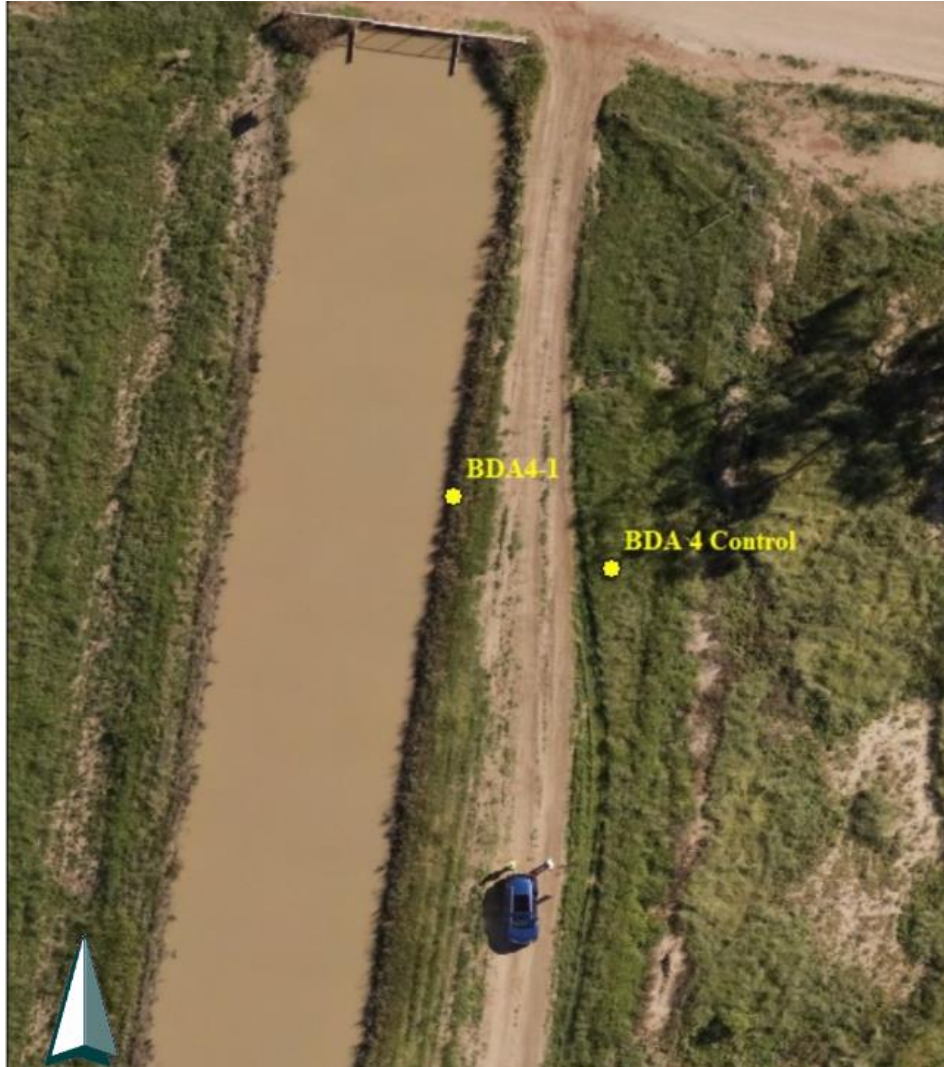
Figure 37

Identified hotspot at Flight Path # 4

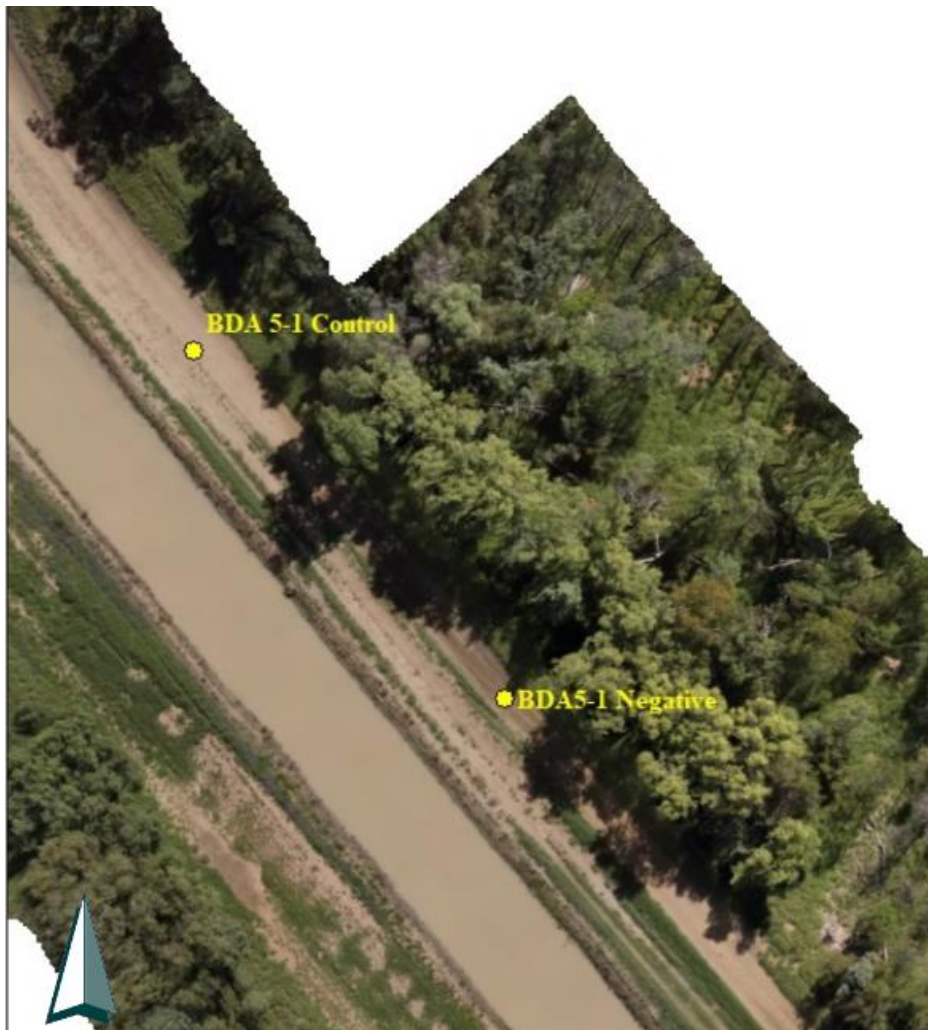
Figure 38

Identified hotspot at Flight Path # 5

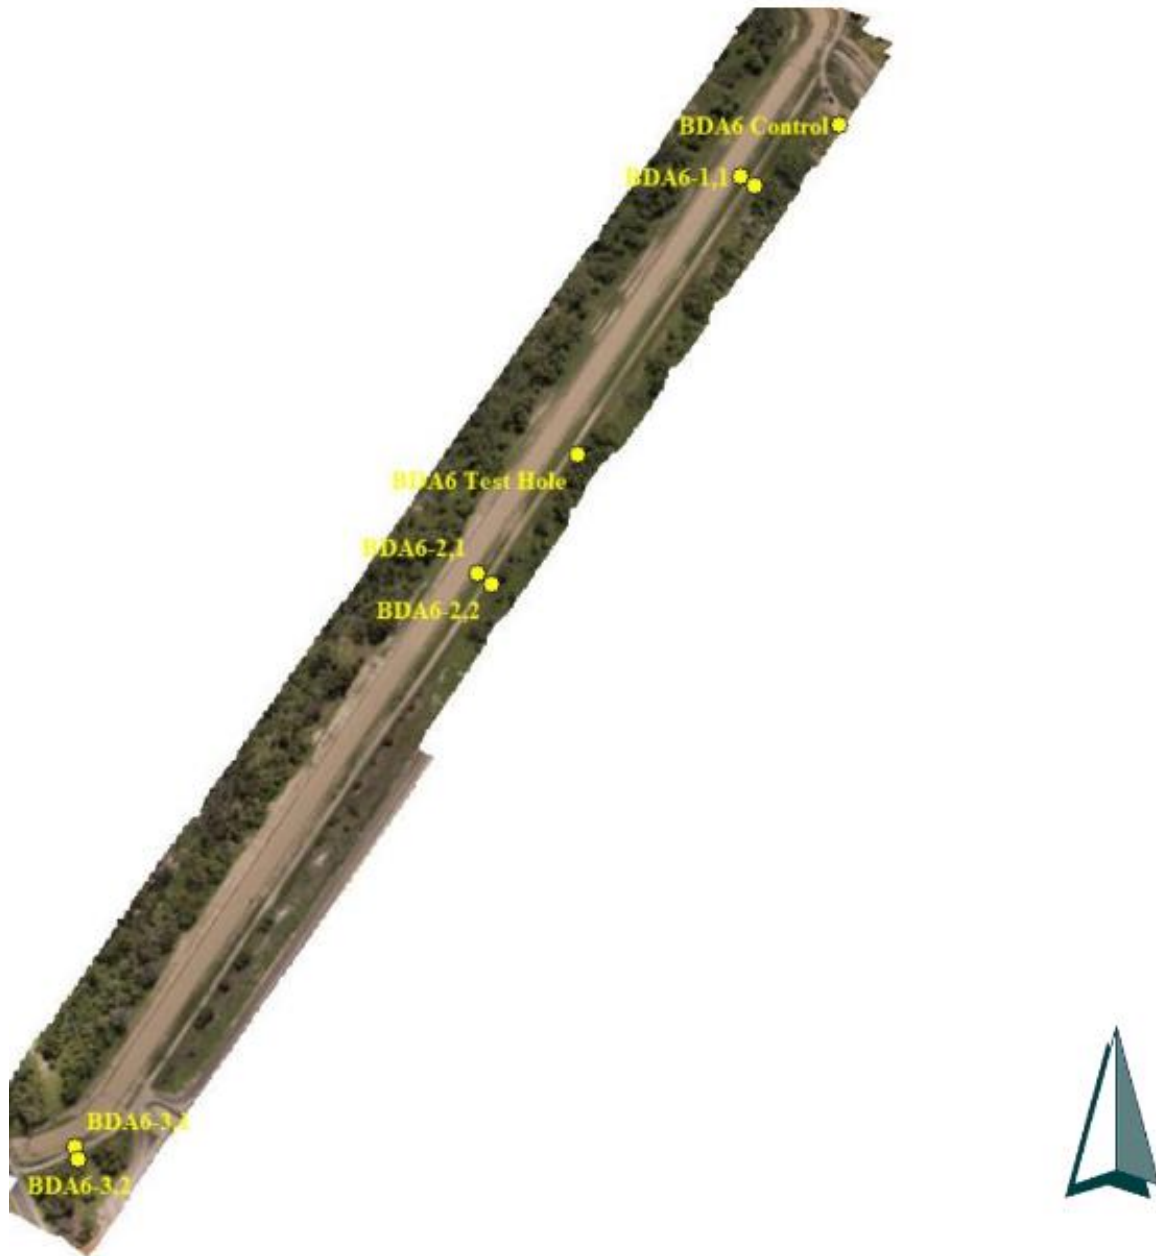
Figure 39

Identified hotspots at Flight Path # 6

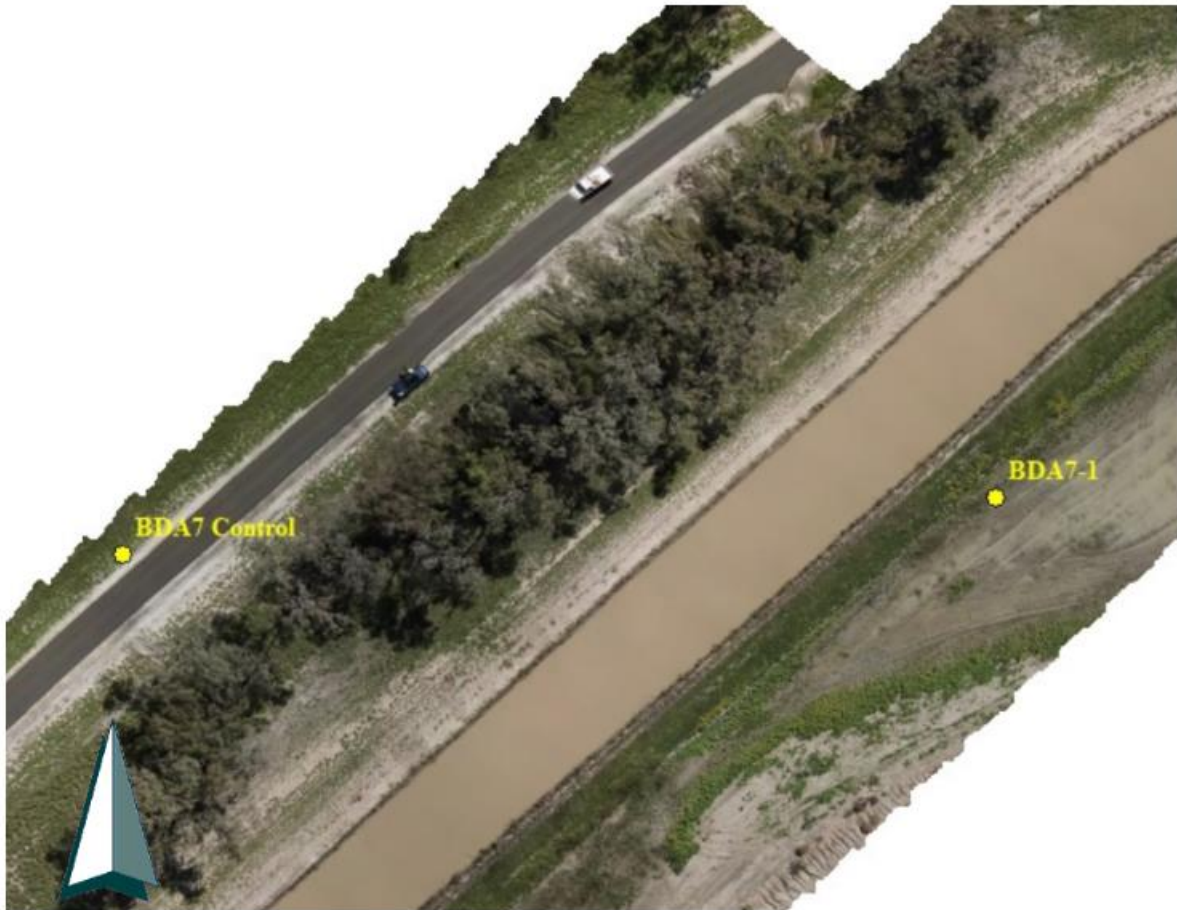
Figure 40

Identified hotspots at Flight Path #7

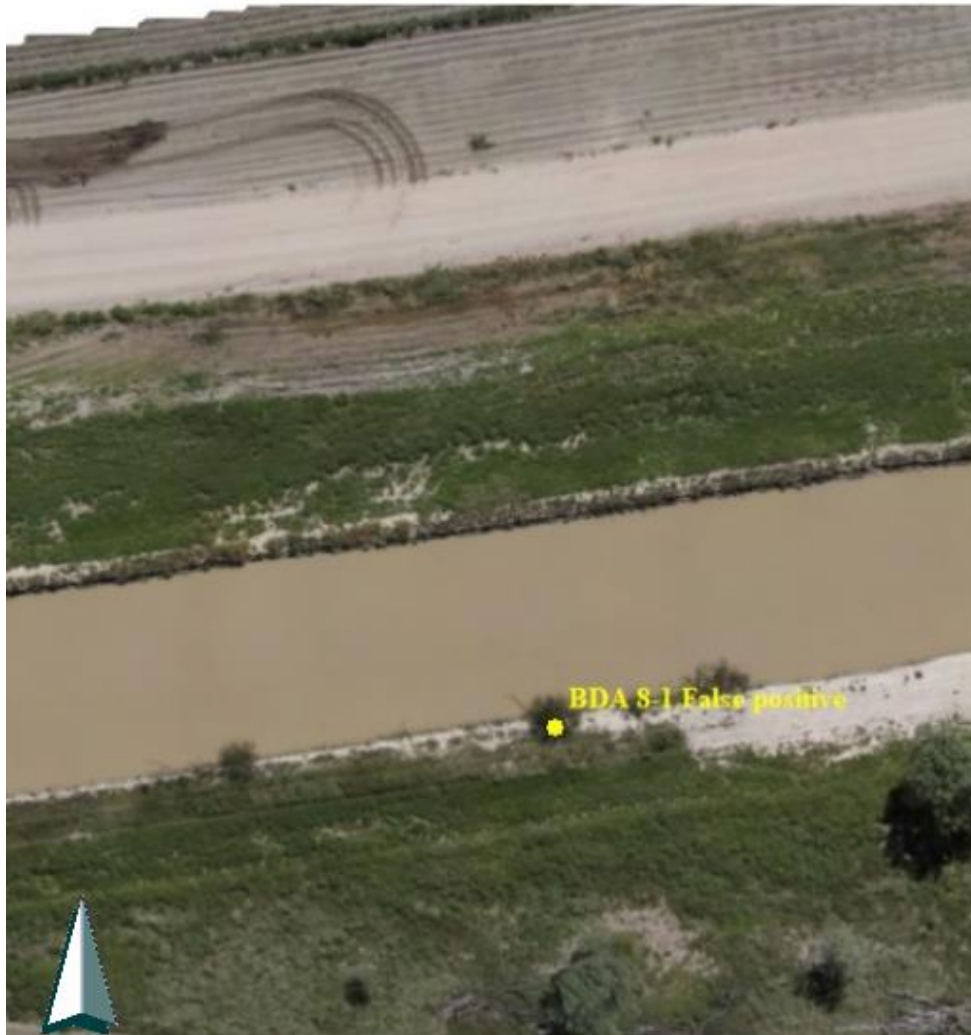
Figure 41

Identified hotspots at Flight Path #8

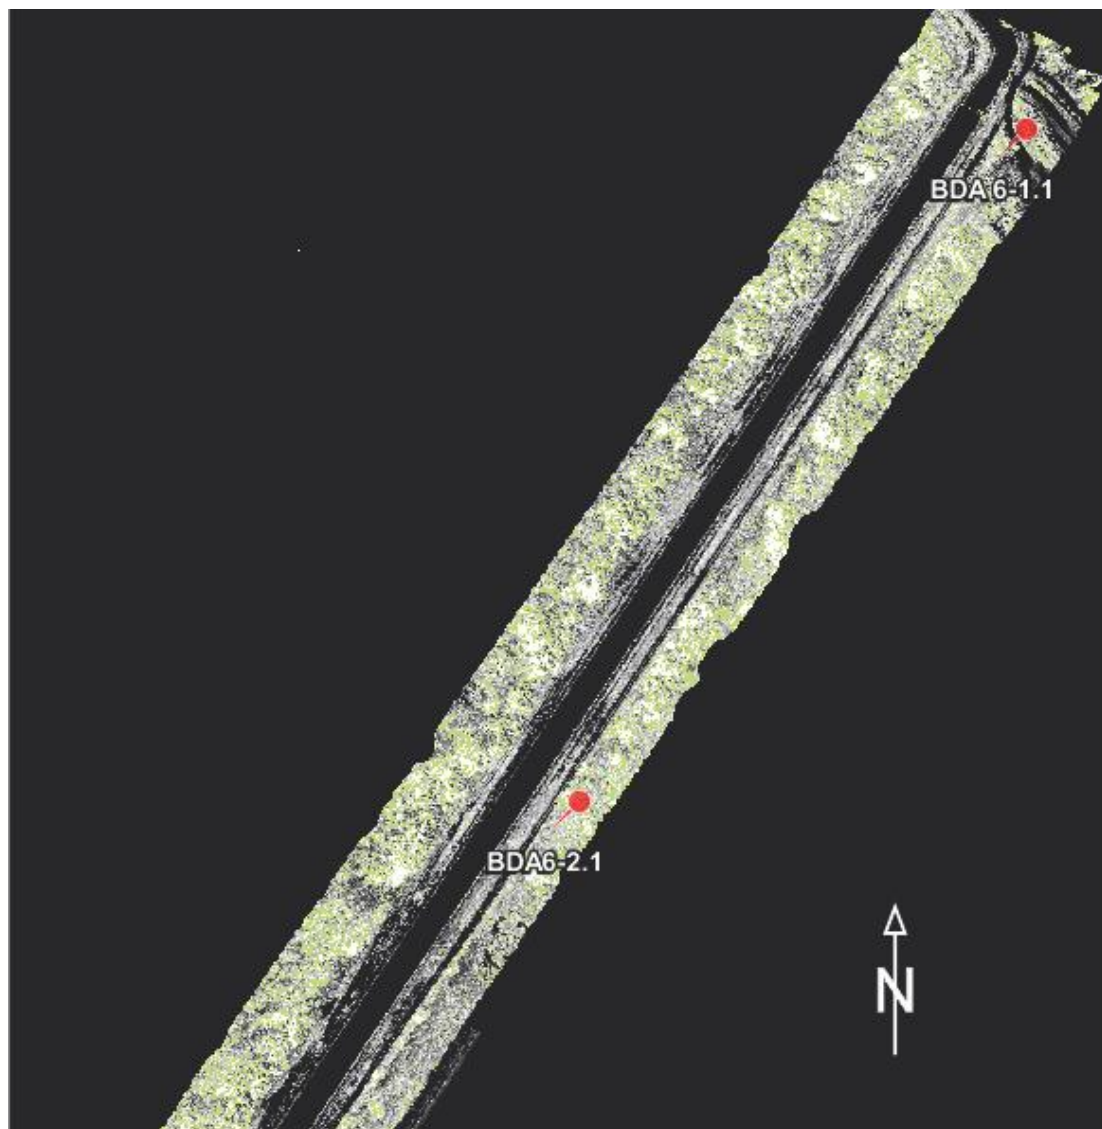
NDVI Mask for Flight Path #6

**Legend**
Hotspot identified by
GNDVI process but not by
NDVI process.
NDVI mask shown in light
green.

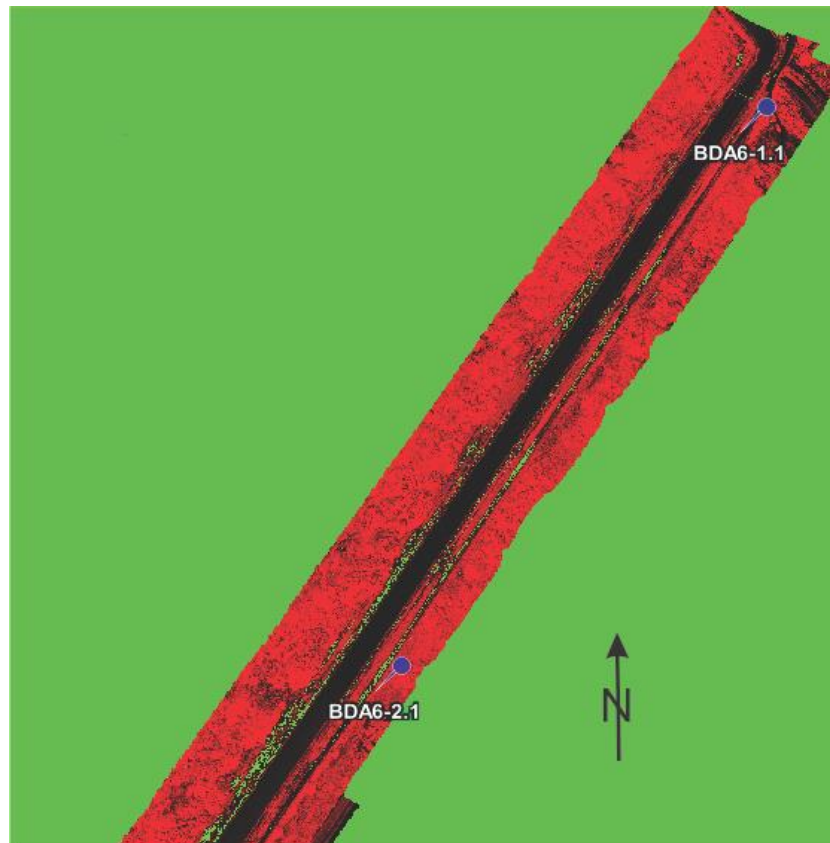
Transformed Normalized Difference Vegetation Index

Legend
● Hotspot identified by GNDVI process but not by TNDVI process.
TNDVI mask shown in green.

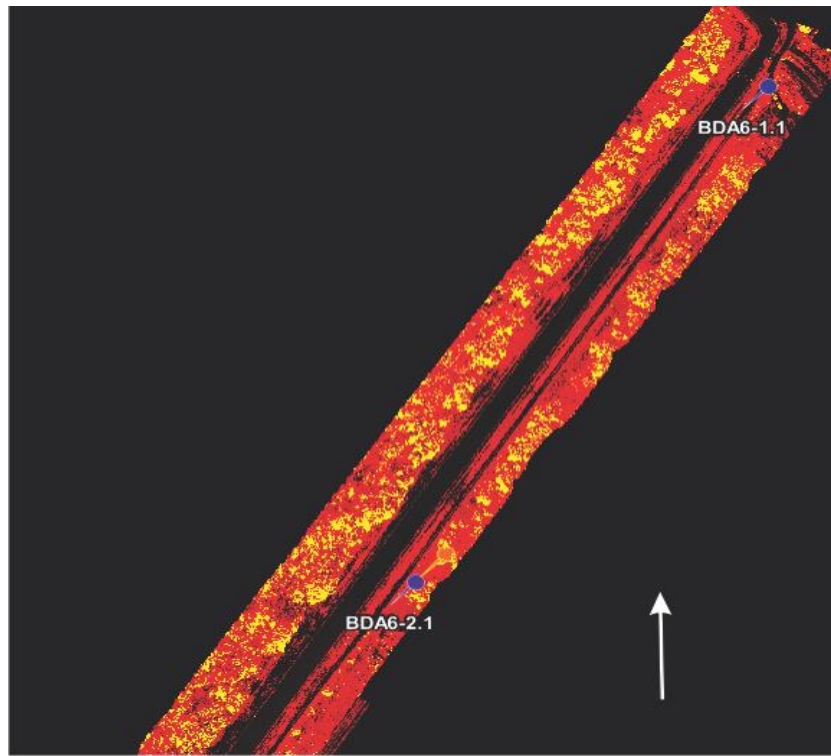
Soil adjusted vegetation index overlay

Legend
● Hotspot identified by GNDVI process but not by SAVI process.
SAVI mask shown in yellow.

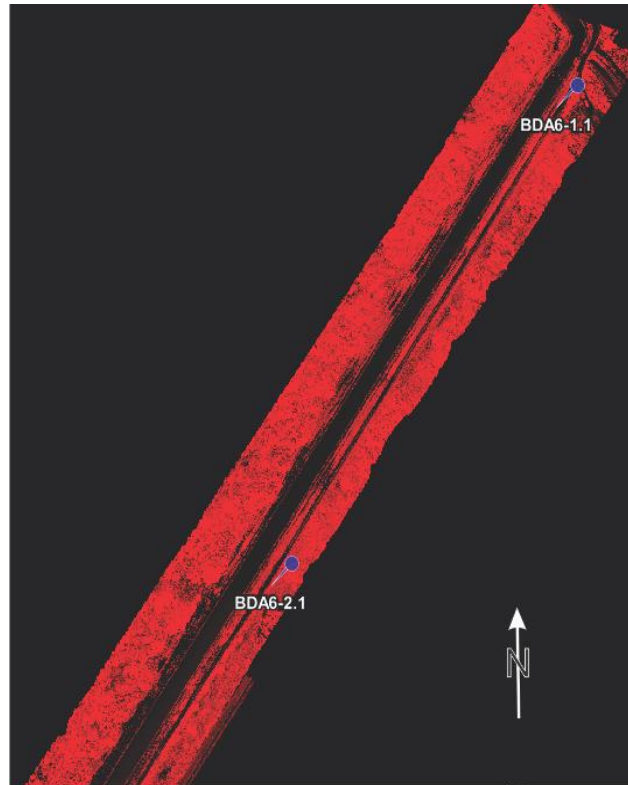
DVI Vegetation Index

Legend
● Hotspot identified by GNDVI process but not by DVI process.
DVI mask coloured yellow but is not visible.

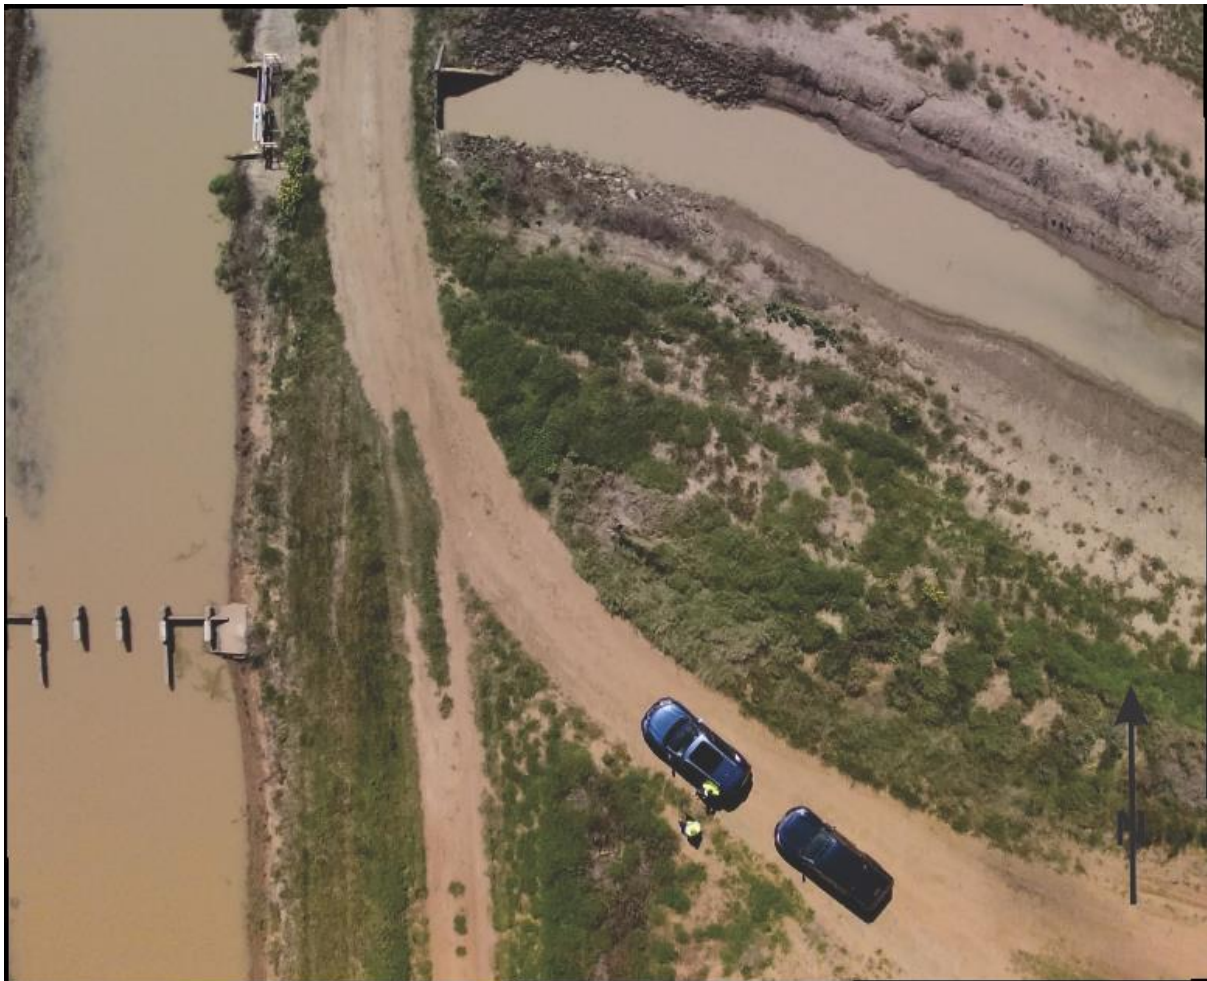
Phase 2, as shown in Figure 46 below, can be magnified from the opening scale of 1:4204 to a scale of 1:98.5 where individual plants and water weed patches are still visible.

Flight Path #6 Zoomed image to 1:98.5 with visible weed growth and people

The GSD of 3.9 cm/pixel used in Phase 1 may have caused the irregularity in the number of sites identified as potential leakage sites.
