Tunnelling and Underground Space Technology incorporating Trenchless Technology Research

Exploring the axial performance of protective sheathed rock bolts through large-scale testing

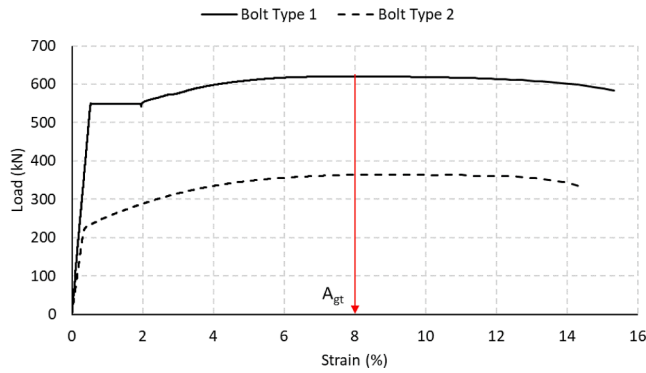
Fig. 4. Elongation behavior of the Type 1 and Type 2.

Type-2 bolts, respectively. The protective plastic sheaths exhibit two types of irregularities on their external surface: circumferential threads and embossed ridges. Additionally, the internal surface features dents. Fig. 3 provides an overview of the bolts and protective sheaths employed in the study, while Table 1 tabulates the geometric and mechanical attributes of these bolts. Additionally, Fig. 4 and Fig. 5 depict the tensile behavior of both the bolts and sheaths. The discrepancy in tensile strength between Type 1 and Type 2 bolts, shown in Fig. 4, is because of

differences in their structural design, manufacturing methods, chemical compositions, and fabrication processes, leading to distinct mechanical properties. For instance, the Type-1 bolt has a diameter of 26 mm, with yielding and ultimate strengths of 530 kN and 620 kN, respectively. In contrast, the Type-2 bolt features a nominal diameter of 21 mm, with yielding and ultimate strengths of 220 kN and 360 kN, respectively.

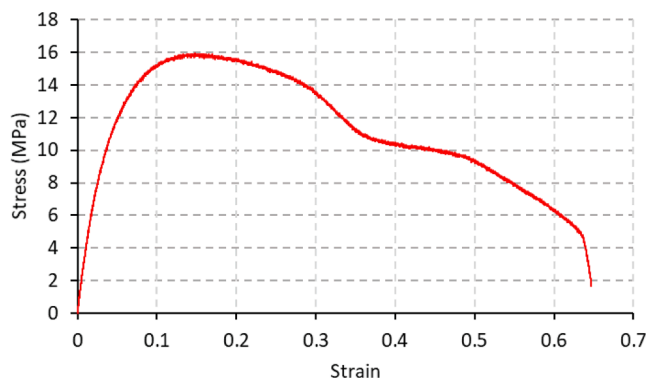
Fig. 5. Tensile behavior of the HDPE sheath used in the tests.

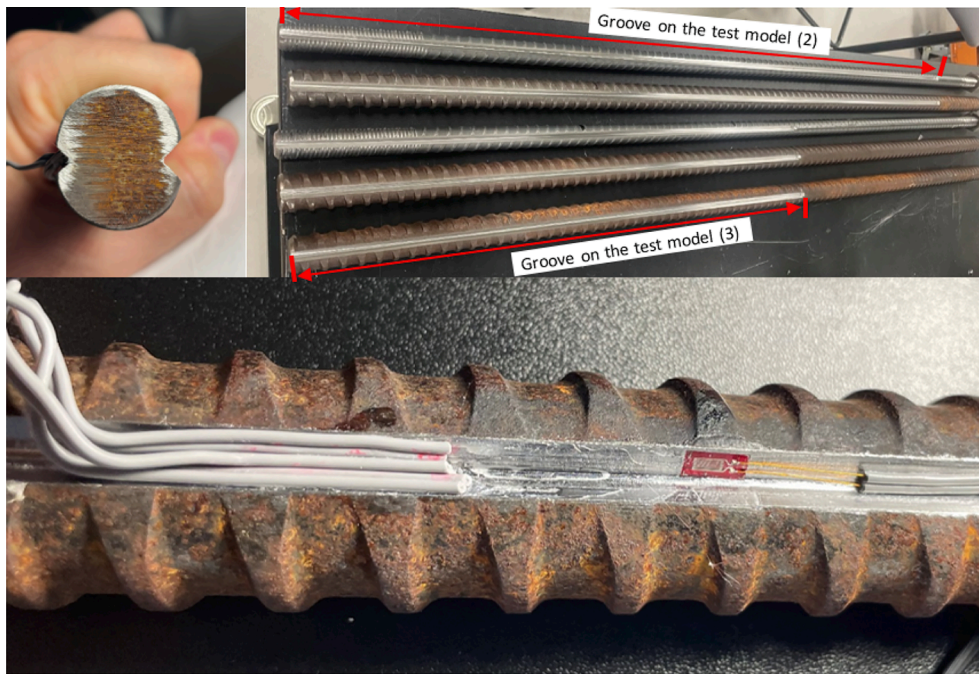
Fig. 7. Grooves, instrumentation, and mounting strain gauges on the steel bars.

A specialized approach was implemented to assess bolt deformation along the encapsulation length and to derive the axial load distribution and bond stress across this length. Specifically, the steel bars underwent design modifications for tests (2) and (3). These modifications involved incorporating double-sided triangular grooves, each covering an area of approximately 20 mm². The grooves were designed with the specific purpose of offering an optimal surface for the installation of resistive strain gauges. These gauges, with a length of 3 mm and a resistance of 120 Ω, were precisely mounted onto these grooves for accurate strain measurement. Figs. 7 and 8 illustrates both the arrangement of the grooves and the placement of the resistive strain gauges on the bolt.

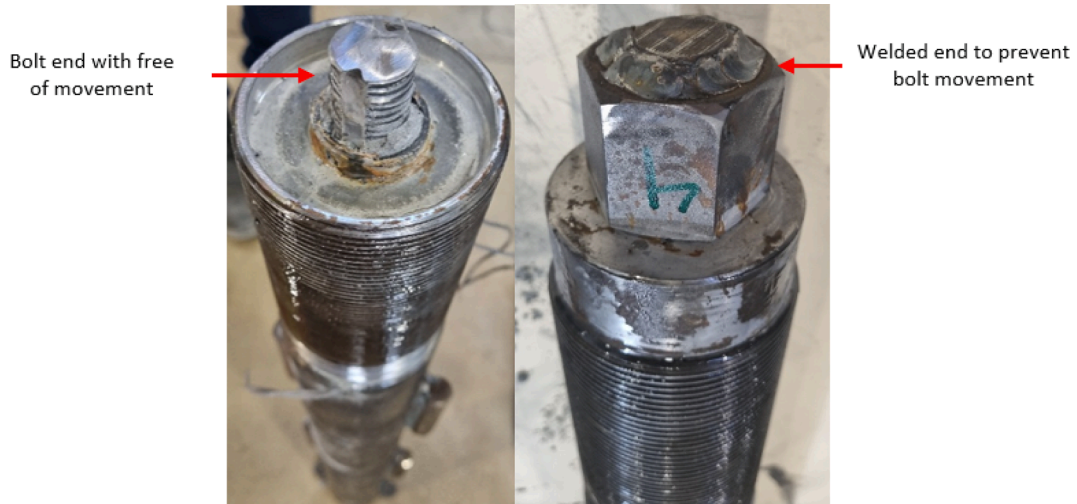
Fig. 10. Conditions of the bolt ends to fulfil the test objectives.

In the process of encapsulating the bolts within the hollow bars, a cementitious grout was employed. This grout was prepared by mixing it with water at a grout ratio of 22 %, and it was subsequently pumped into the samples to ensure the complete filling of the gaps between the bar and the plastic sheath, and also between the plastic sheath and the hollow bar. The compressive strength of the grout was determined to be approximately 53 ± 1.2 MPa. Fig. 9 shows the prepared specimen for testing model (3). As previously noted, the specimen arrangement in the testing model (1) was devised to allow movement of the bar at both ends. However, in the case of the testing model (2), one end of the bolt was permitted to move freely, whilst the opposite end was welded in order to restrain its movement. Conversely, testing model (3) involved welding the bolts at both ends, immobilizing any potential movement along the bolt's length. Fig. 10 illustrates the ends of the specimens according to test objectives.

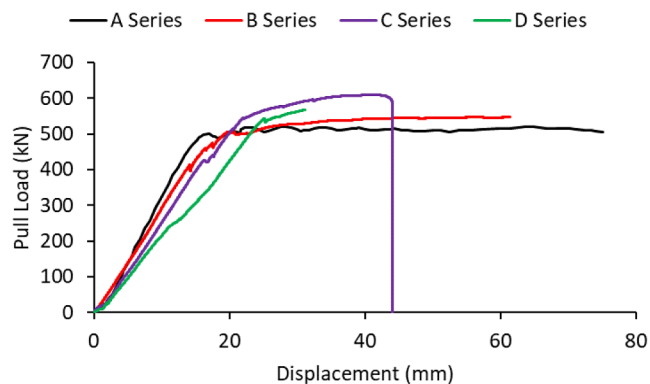
Fig. 13. Load-displacement relation for the tests conducted on the Type-2 bolts.

Fig. 13 illustrates the load–displacement curves derived from pull tests conducted on the Type-1 bolts using different testing models. Among the specimens, Tests A and B exhibited failures due to debonding at the grout-sheath interface, while specimen D experienced failure due to bar rupture. In specimen C, the test was halted at 2.5 % elongation to investigate the protective sheath conditions at this specific elongation.

In both series A and B, regardless of the loading arrangement, similar load–displacement behavior was observed. As depicted in Fig. 13, in Series A, the load increased linearly with displacement up to 498 kN at 16.2 mm displacement. Beyond this point, the load remained nearly constant with further displacement. This point (498 kN, 16.2 mm) marked the onset of global debonding within the system. The initial linear growth indicated elongation of the steel bar, potentially causing damage to the grouting materials near the loading point. The relevant literature suggests that conventional fully grouted rock bolts exhibit shear-off damage at the bolt-grout interface in such cases (Cui et al., 2020; Hyett et al., 1992). However, these tests yielded circumferential cracks within the grout-filled space between the bolt and the sheath, deviating from shear-off damage. These circumferential cracks most likely stemmed from induced tensile stress within the grout due to the elongation of the bolt. Cracks were initiated once this tensile stress approached the grout’s tensile strength. The bolt and grout column were

The load–displacement relationship in the series B test mirrors that of series A. Once the load reaches 502 kN at 19.9 mm displacement, the load increase relative to displacement drops, and further load increments occur only minimally. The variation in load and displacement values at which debonding of the systems initiates in series A and B can be ascribed to the plastic sheath’s efficacy in series B, slightly shifting the corresponding point to the right. Fig. 15 shows specimen B following the test. As depicted, the protective plastic sheath underwent rupture caused by considerable stretching. Nevertheless, monitoring the specimen’s conditions during the test revealed the plastic sheath remained intact until reaching a displacement of 27 mm. Additionally, there was an observable 47 mm slip at the free end, as illustrated in Fig. 15.

In contrast, the load applied to specimen C surpassed the yield strength of the bar, which is approximately 535 kN. This caused the bolt to deform plastically and reach the ultimate tensile strength, measured at 610 kN. This was followed by necking and eventually, the bolt ruptured at a displacement of 44 mm. During testing, it was observed that the sheath stretched alongside the bolt’s deformation. The sheath remained intact until the bolt ruptured, at which point the sheath was torn completely (Fig. 16). The results of test C highlight that the load levels in tests A and B remained below the bar’s yield strength. This indicates that the critical embedment length in this specific bolting system exceeds 1000 mm.

Test D followed the same approach as test C, yielding comparable results. However, the test was concluded at around 31 mm displacement, equivalent to a load of 568 kN. This was done to specifically monitor the condition of the specimen, particularly the state of the protective sheath, at this specific displacement. Fig. 17 illustrates that the sheath remained undamaged and intact, indicating that the corrosion protection measure effectively functions at this level of load and displacement.

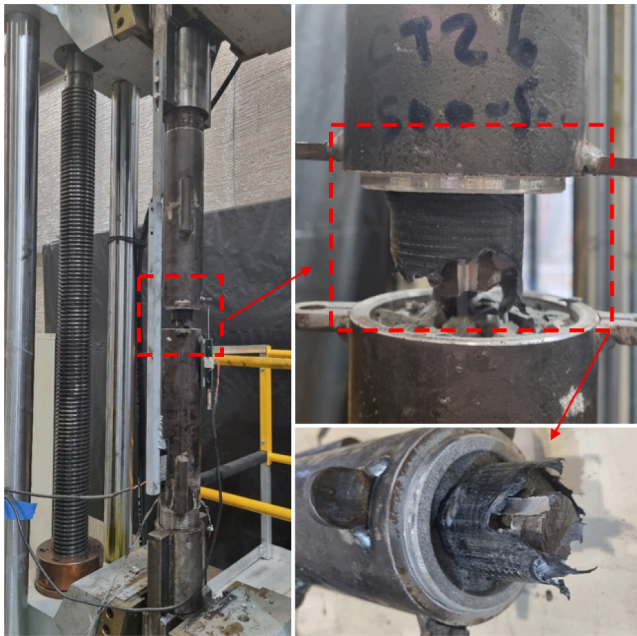
Fig. 16. The conditions of specimen C after testing.

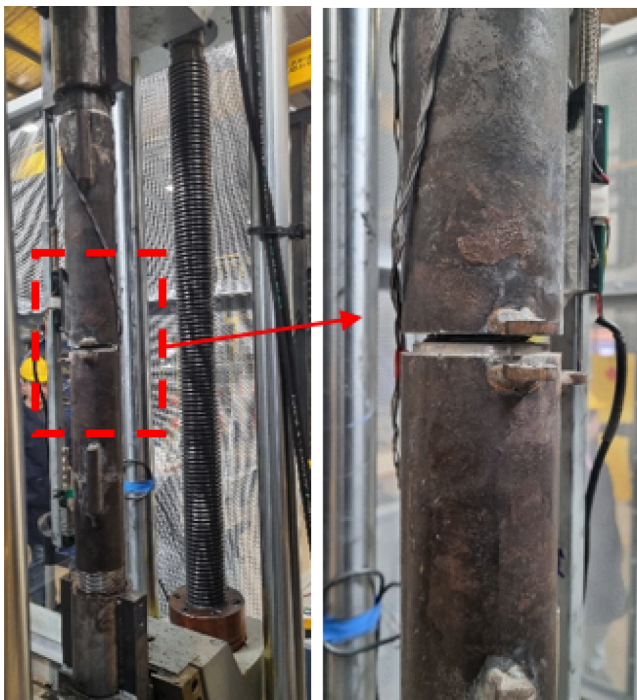
Fig. 17. The conditions of specimen D after testing.

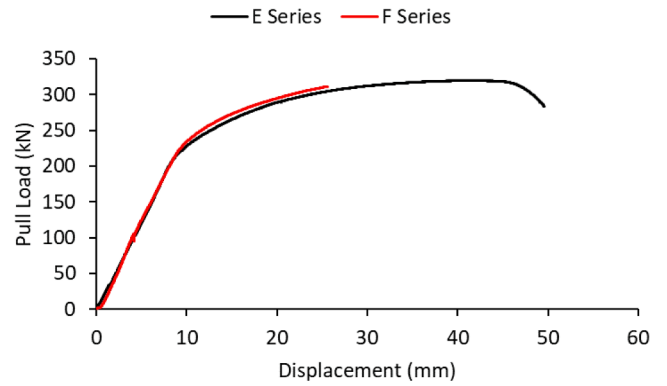
Fig. 18. Load-displacement relation for the tests conducted on the Type-1 bolts.

Fig. 18 displays the load–displacement curves from tests E and F. Despite differing specimen arrangements, the curves exhibit similar behavior. In test E, where the bar slip from the free end was allowed, the bolt’s encapsulation length was adequate to surpass its yield strength (230 kN at 10 mm displacement). Progressing further, the system reached its ultimate tensile strength (320 kN at 45 mm displacement), ultimately rupturing at 285 kN and a displacement of 50 mm. The conditions of the specimen post-test are depicted in Fig. 19a. Monitoring during testing revealed that the plastic sheath’s strength properties closely resembled those of the sheath utilized in Type-2 bolts. This similarity was evident as both sheaths sustained damage at a displacement of 28 mm.
