Investigating the performance of floodway in an extreme flood event

This research paper investigates the damage caused by the recent floods in Queensland on the floodway. Floodway in Lockyer Valley Regional council (LVRC) area in Queensland has been selected as a case study. LVRC has identified a major need to re-examine the design of flood-ways, which have to be designed to be submerged during a flood and return to complete functionality after the flood water subsides. In 2011 flood, about 58% of the floodway were damaged in LVRC area. Many of the flood-ways were damaged during the period of submergence and are currently the weakest links in Lockyer valley roads after a flood. There are no standard design guidelines for these structures accepted at national level.

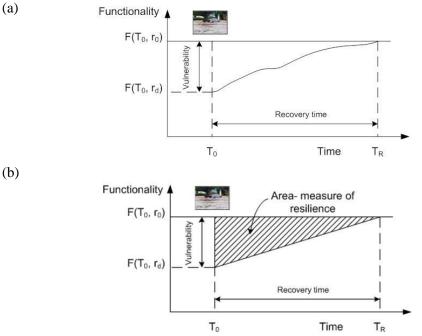
Figure 1: Representation of resilience and vulnerability (Lokuge and Setunge, 2013)

Figure 1 shows how an infrastructure will function when it is subjected to an extreme event. At time T_0 , the system was fully functioning $[F(T_0, r_0)]$ when the extreme event occurred. Functionality was reduced to $F(T_0, r_d)$ due to the damage to the infrastructure system. At time T_R , the system completely recovered and started functioning as it was at time T_0 . From Figure 1 (b) it can be concluded that resilience of an infrastructure can be improved if the shaded area can be reduced. Either damage to the infrastructure should be reduced or recovery time should be minimized in order to achieve a resilient system.

Resilience can be defined as the ability to maintain functionality and return to normality following an extreme event making sure that the damage is tolerable and affordable (Hudson et al., 2012; Lamond and Proverbs, 2009). It was defined as the ability of a system to reduce the chances of a shock, to absorb a shock if it occurs and to recover quickly after a shock (Cimellaro et al., 2010). According to the definition a resilient system should have low probability of failure, even if it fails, very low impact on the society in terms of loss of lives, damage and negative economic and social consequences and most importantly low recovery time. Vulnerability and resilience is represented in Figure 1 (Lokuge and Setunge, 2013).

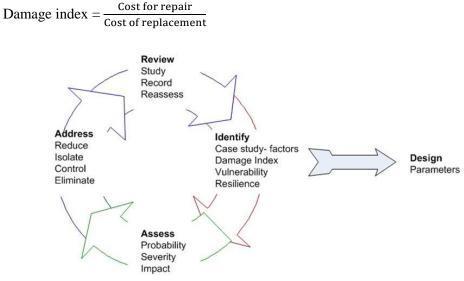
Figure 2: Delivering resilience

Delivering resilience is a cycle of identification, assessment, addressing and reviewing (Hudson et al., 2012). This research paper aims at the identification stage of this cycle as shown in Figure 2. At the identification stage, a case study should be selected to analyse the parameters that are affecting the functionality of the infrastructure and to find the impact of the element failure towards the overall performance of the infrastructure. Although resilience and vulnerability are widely accepted terms to decide the performance of a structure, the authors have investigated the use of damage index instead. Nishijima and Faber (2009) used a damage index to evaluate the performance of buildings and it relies on the construction cost per square metre and a replacement ratio which is approximately equal to the costs relative to the cost of replacing a median-sized family home. In this research damage index for the infrastructure is defined as:

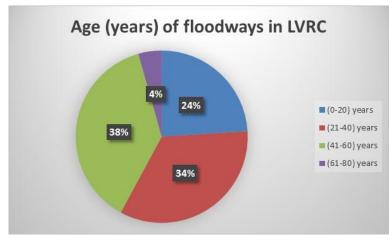
Figure 4: Age of floodway in LVRC area

There were 347 floodway all together in the Lockyer Valley Regional Council area and 64 of them were completely damaged and needed repair due to the 2013 floods. Majority of the floodway in the region are 20-60 years old (Figure 4).

- Most of the completely damaged floodway in the region are more than 60 years old. This possibly is related to a number of factors which require further research such as: construction practices adopted during the construction of the aging bridges, possible strengthening after a previous disaster event etc.
