Qualitative investigations into floodways under extreme flood loading

Abstract

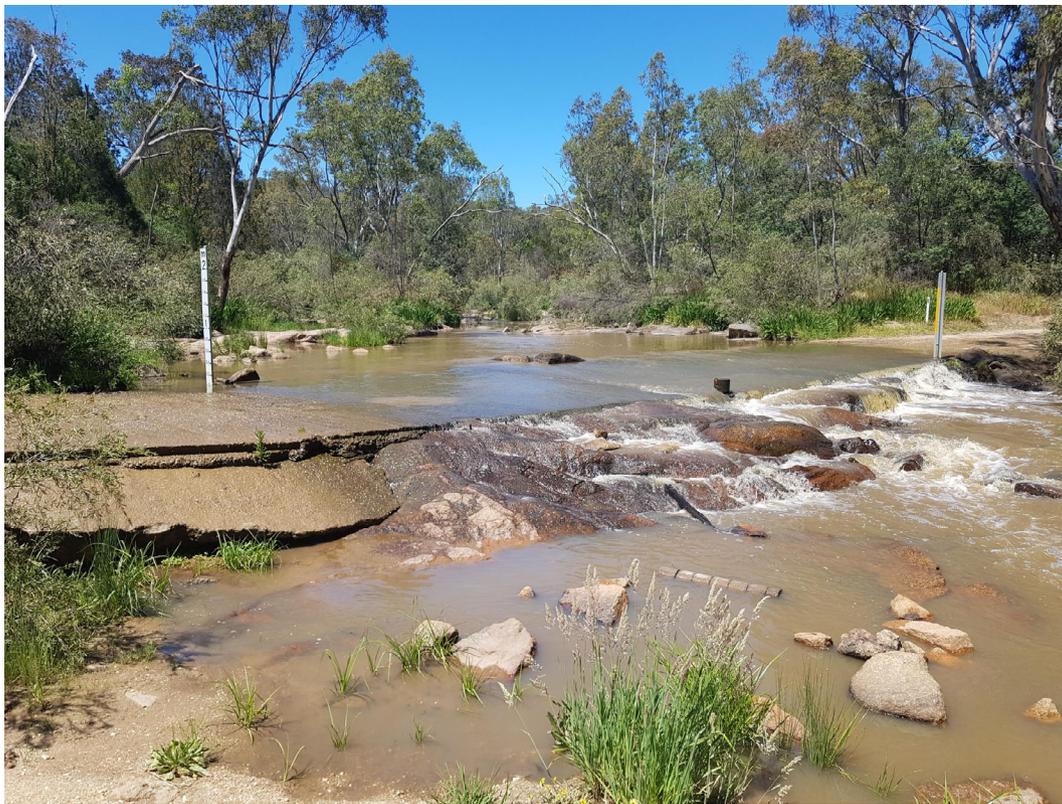
FIGURE 1 A typical concrete floodway structure.

Kuang & Liao, 2020). Floods are a frequently occurring and damaging natural disaster causing significant economic loss and damage to the built environment (Xiao et al., 2021). Small road structures, such as floodways (Figure 1), are designed to assist in the safe and expedient vehicular crossing of waterways, increasing the connectedness of rural communities. Well-connected

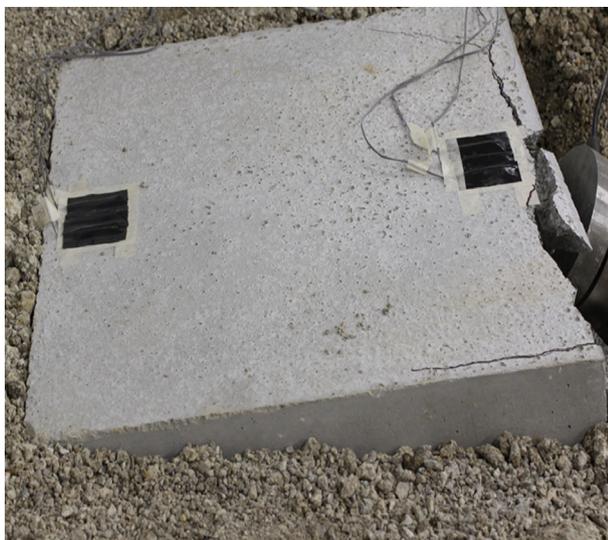
FIGURE 12 Vertical displacement of concrete floodway Specimen 2 at failure.

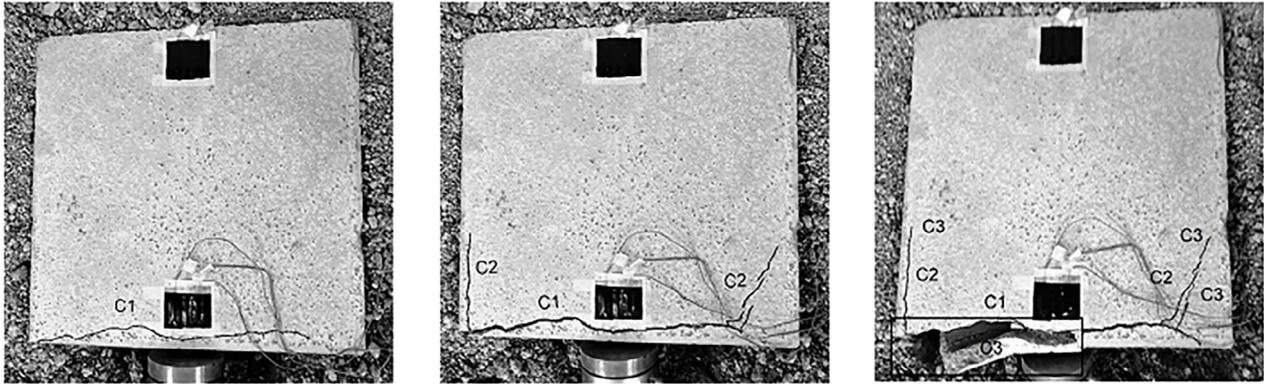
FIGURE 18 Comparison of crack propagation in experimental results with strain concentrations in numerical model.

Within the experiment, the visual crack propagation pattern of the concrete test specimens under a concentrated horizontally placed load correlated to the significant strain localizations observed within the numerical simulation results (Figure 18). For experimental scenarios, initial cracking was observed at the downstream cut-off wall and apron interface in Specimen 1 and at the loading point in Specimen 2. This was then followed by

crack propagation along the side cut-off walls and apron interface before complete failure of either the downstream or upstream cut-off wall or both were experienced. Similarly, in the numerical simulation results, significant strain localizations were observed first at the point of loading, followed by strain propagation to the side cut-off walls, which was closely followed by significant strain being recorded at the downstream cut-off wall.
