# DESIGN FEATURES AND BRUISE EVALUATION OF AN APPLE HARVEST AND IN-FIELD PRESORTING MACHINE

A. K. Pothula, Z. Zhang, R. Lu

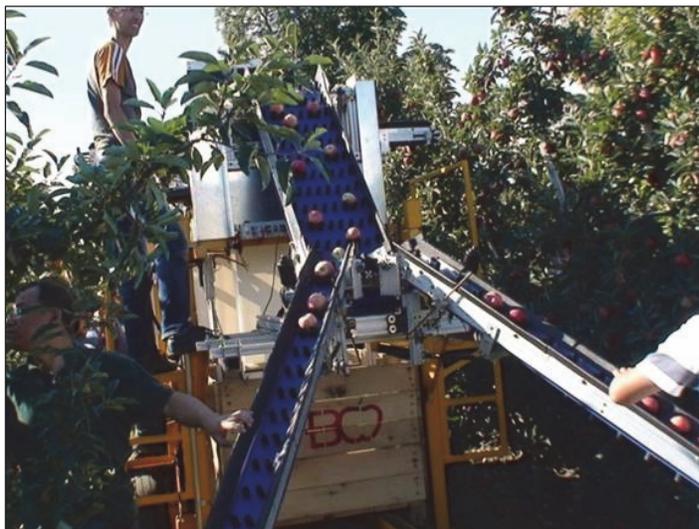
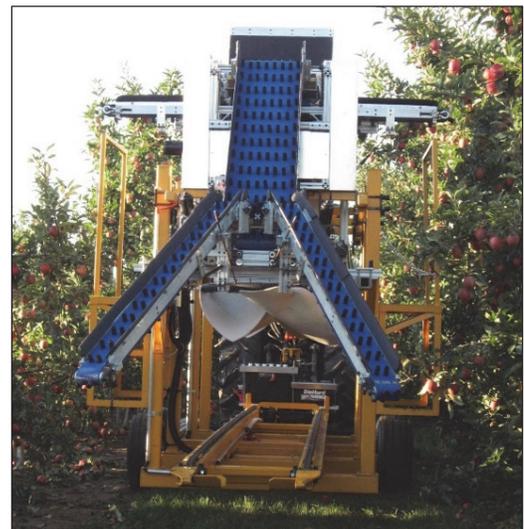
Figure 2. Field testing of the apple harvest and in-field sorting prototype during the 2013 harvest season.
