1 **Evaluation of Physical and Durability Characteristics of New Headed Glass-Fiber-**
2 **Reinforced-Polymer (GFRP) Bars for Concrete Structures**

25 **Abstract**

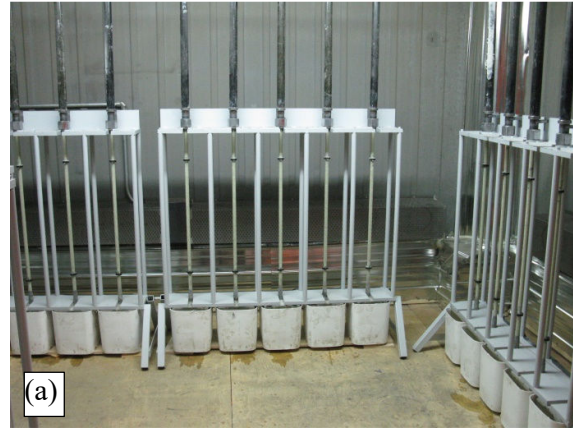
Figure 3. Headed GFRP bars conditioned in the alkaline solution under sustained loading, (a) Test setup and (b) schematic diagram

225 Three 15.9 mm diameter headed GFRP bars were cast in concrete blocks and then
226 conditioned in alkaline solution (pH of 12.8) under sustained tensile loading at 60°C for 60
227 days. This conditioning is quite similar to ACI440.3R, Test Method B.6 (2012). In this
228 method, moist concrete surrounds the headed GFRP bar. The concrete blocks were immersed
229 in the alkaline solution in 300 × 300 × 300 mm PVC tanks. During the conditioning, the
230 samples were set in a rigid-steel loading frame to induce a strain equal to 3000 microstrains
231 (CSA-S806-12, 2012). The test frames were designed so as not to induce torsional stress in
232 the samples. The imposed strain was controlled by glued stoppers and was checked daily.
233 Similarly, the temperature was monitored during the 120 days of conditioning. Figure 3
234 shows the test setup and schematic diagram of the headed GFRP bars conditioned in the

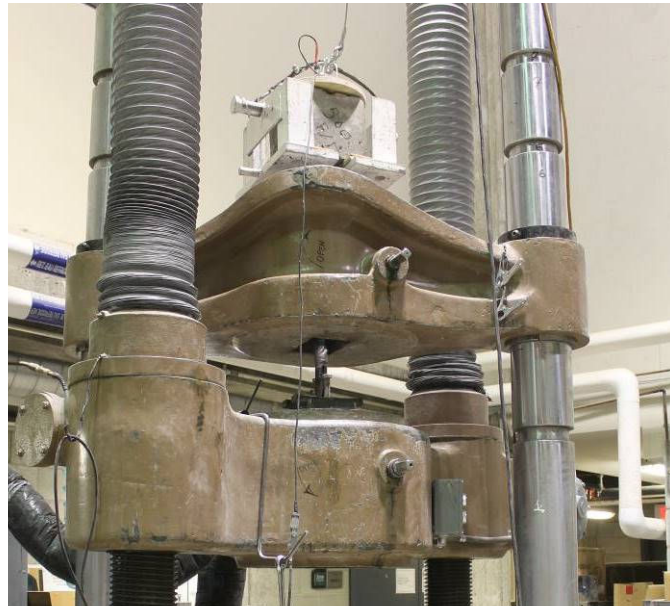
(a) CB

Figure 5. Failure mode of headed GFRP bars embedded in concrete blocks, (a) CB, (b) CSH, (c) BSH, (d) BSG

785 Figure 5. Failure mode of headed GFRP bars embedded in concrete blocks, (a) CB, (b) CSH,
786 (c) BSH, (d) BSG
