Case Studies in Construction Materials

Experimental and numerical analysis on the effectiveness of GFRP wrapping system on timber pile rehabilitation

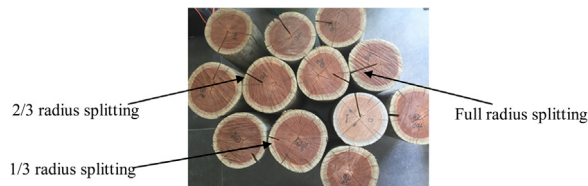
Fig. 3. Split defects.

A severe vertical split would be greater than 5 mm in width and extending more than a meter in length and the splits may be wider than 5 mm but have shorter length or vice versa [3]. This was the only information available from road authorities about splitting measurements. Splitting was introduced into all samples except the undamaged control sample. The splitting used in this research runs along the entire height of the sample (approximately 300 mm) with various depths of full radius, 2/3 radius and 1/3 radius as shown in Fig. 3. Even though the split damages in real-life timber columns are random and cannot be controlled, the proposed damaging technique can be relatively representative. According to previous studies [23,47,48], the longitudinal sudden splitting failure in timber fibres was the dominant failure mode of timber columns under

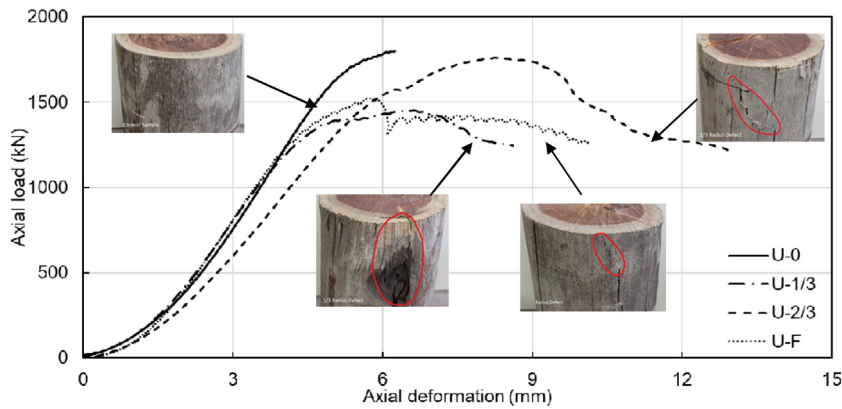
Fig. 5. Axial load-deformation curves of control samples.

Fig. 5 shows the load-deformation curves for the unwrapped samples including the undamaged, full radius damaged, 2/3 radius damaged and 1/3 radius damaged. This figure illustrates that the induced damages have reduced the axial capacity of the columns. The red circles in Fig. 5 show the crack initiation during loading of specimens.

The load-deformation curves show that all samples exhibited similar initial response until approximately 70% of the peak load. Afterwards, a descending response was observed by the defected samples up to the peak load. However, sample U-2/3 showed a lower stiffness compared to other samples. This indicates that defects in columns can definitely affect the overall behaviour of timber columns. Table 3 summarizes the experimental results for the unwrapped control samples. Sample U-1/3 had the smallest incorporated defect and results showed that it had the lowest axial yield and axial peak load capacities among all control samples and also, the energy absorption was lower than other defected samples. Unfortunately, this timber member had a knot close to the ends, which resulted in exhibiting a lower axial capacity and weakening in the lateral direction. It was observed that a split through the decayed knot along the grain with approximately 15 mm in width started to extend in the longitudinal direction as shown in Fig. 5. Gilfillan et al. [52] indicated that the strength capacity of timber structures is significantly reduced due to the presence of knots and other distortions in the grain. This effect is however more influencing for structures under tension than compression or bending. The unforeseen flaws in natural timber such as the knots in this experiments will be taken into consideration during the design process by considering the capacity reduction factors. Even though, specimen U-2/3 showed a slightly reduced stiffness compared to other control samples, it achieved the highest peak load capacity among the defected samples with highest energy absorption ratio. This energy absorption was 171% higher than the energy absorption of control undamaged sample and this was due to experiencing high deformation at failure. In addition, U-2/3 sample demonstrated higher yield strength and peak strength ratios compared to U-F. This indicates that the degree of splitting damage greatly influences the axial load-deformation behaviour. This influence can also be observed in the loads at failure, as the axial load dropped by 18% and 31% for samples U-F and U-2/3, respectively. Nevertheless, samples U-F and U-2/3 showed approximately similar ductility.

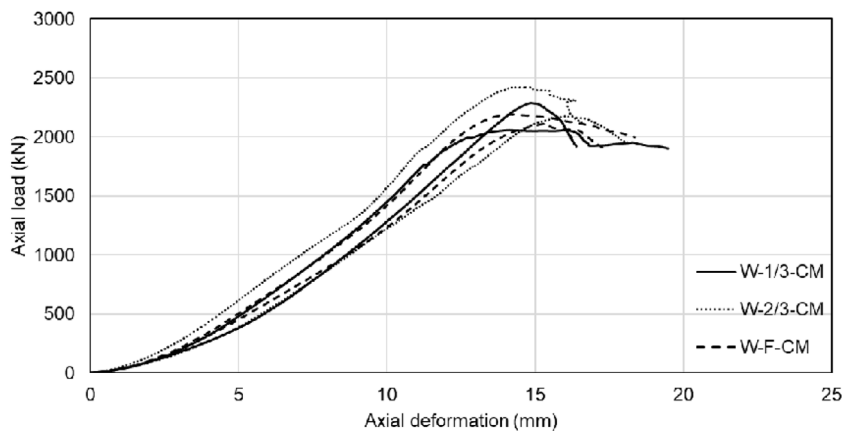
Fig. 6. Axial load-deformation curves of samples infilled with CM grout.

Fig. 6 depicts the axial load–deformation curves for samples wrapped by GFRP jackets with annulus infilled by CM grout. All samples in this group exhibited higher yield and peak strength ratios compared to the defected control samples and this indicates the effectiveness of GFRP wrapping confinement. The yield loads of wrapped defected samples exceed the yield loads of control defected samples with the highest average of 49 % observed in W-1/3-CM samples. The peak axial load capacities were increased by an average of 41 %, 31 % and 50 % for W-F-CM, W-2/3-CM, W-1/3-CM samples, respectively. In general, all wrapped samples with annulus infilled by CM grout showed a significant increase in energy absorption compared to the control unwrapped samples. This is due to exhibiting high deformations at yield and also achieving high peak loads.

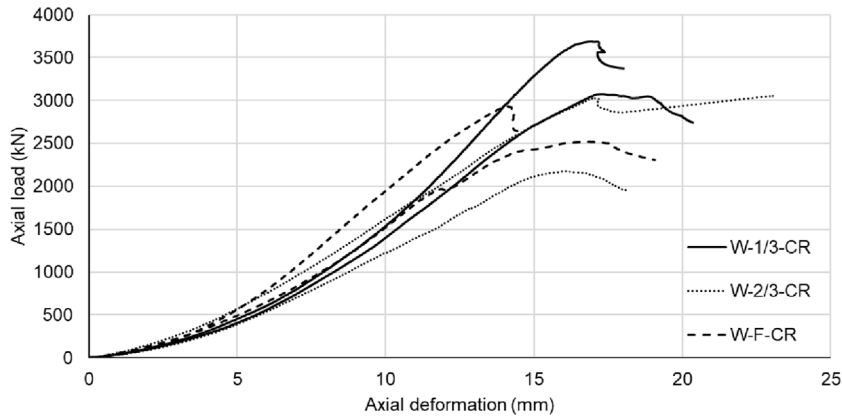
Fig. 8. Axial load-deformation curves of samples infilled with CR grout.

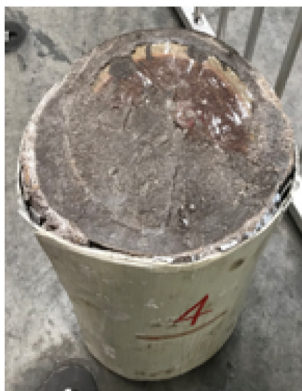
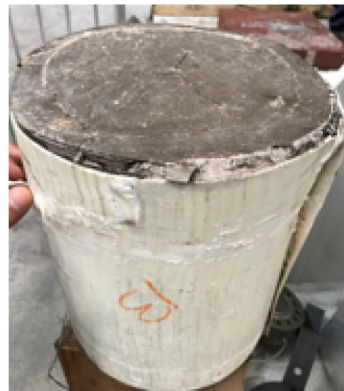
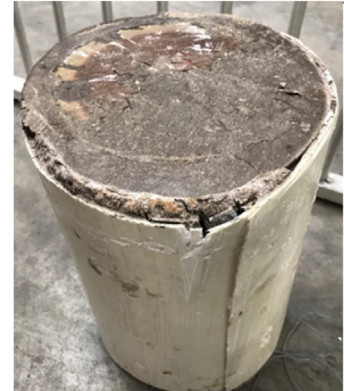
(a) Full radius split

(b) 2/3 radius split

(c) 1/3 radius split

Fig. 9. Failure modes in samples infilled with CR epoxy.

The failure of full radius, 2/3 radius defect and 1/3 radius defect samples (Fig. 9a-c) started by appearance of circumferential cracks near the top part of the tested cylinders followed by rapid propagation through the GFRP before final failure occurred by GFRP rupture. However, the failure of samples with 2/3 radius defect was accompanied with separation of the GFRP laminates over the overlapped region.

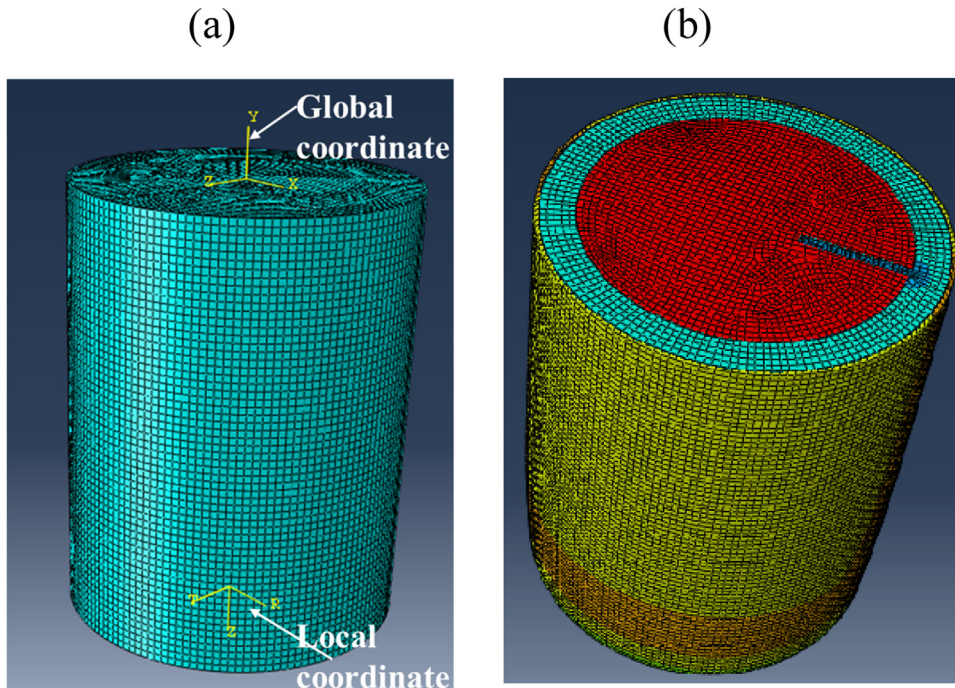
Fig. 11. Finite element model using ABAQUS: (a) FE model before analysis (b) Stress distribution of the FE model at a given time step.

To determine the confining stresses and compare with the experimental test results, 3D finite element models were developed in ABAQUS [40]. There are 10 models to represent the different configurations used as in experimental testing program. Solid 8-node linear brick elements were used to model all different materials (timber, GFRP laminate, CR epoxy and CM grout as shown in Fig. 11. Three levels of damage due to splitting were considered in this study as explained in experimental test procedure. The split depth was introduced to the model with three different depths as described earlier by changing the geometry of the timber sample. This FEM was validated with experimental results and the validated model was used to predict the structural status of rehabilitated timber without conducting extensive experiments.

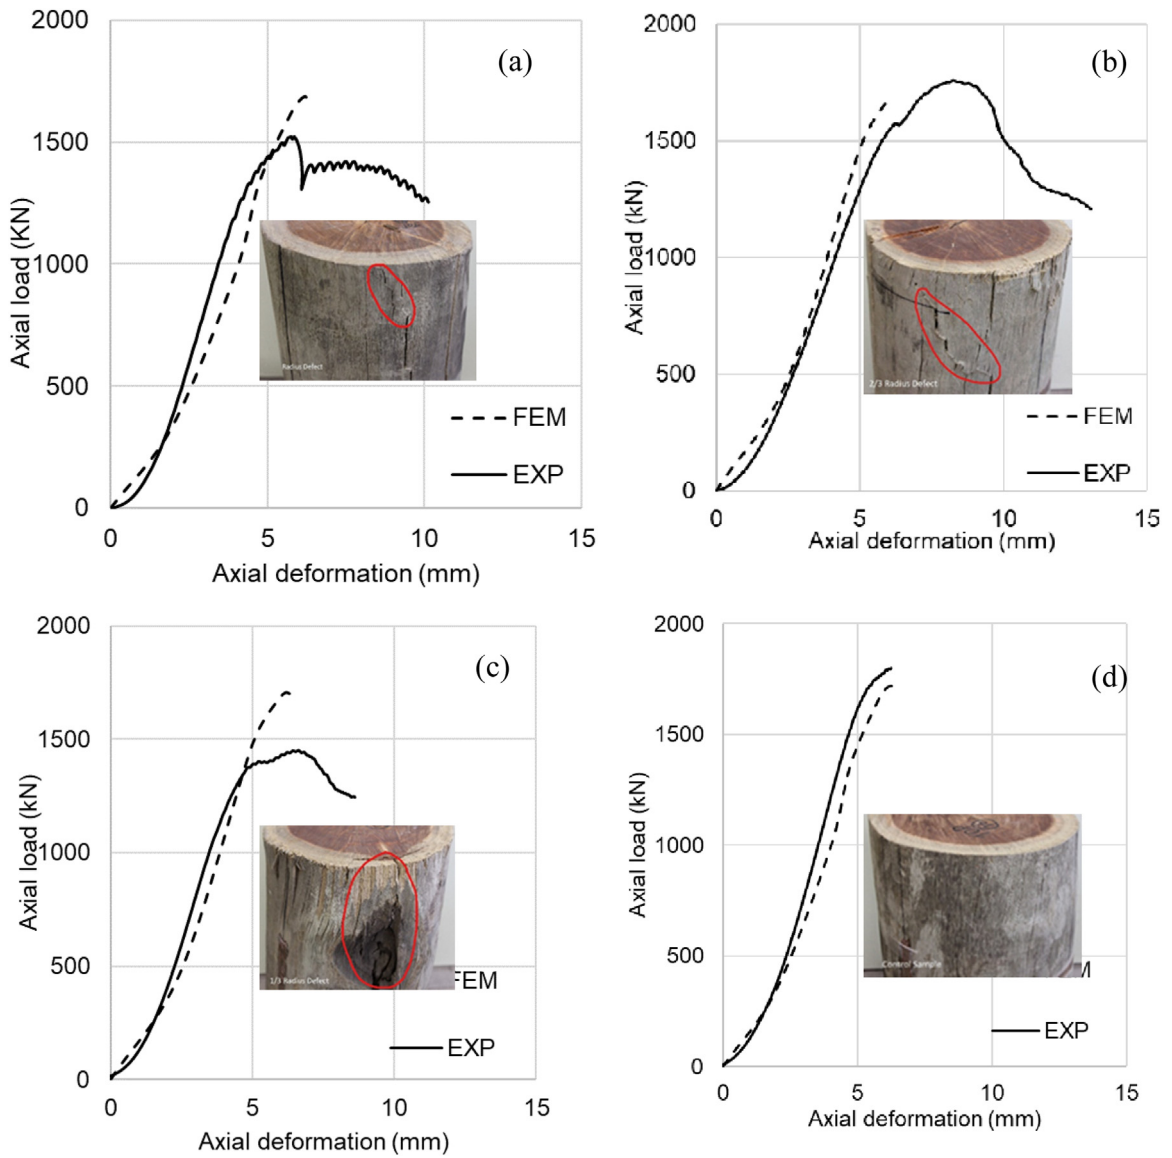
Fig. 12. Experimental and FEM model comparison of control samples: a) full radius splitting; b) 2/3 radius splitting; c) 1/3 radius splitting; d) no defect.

Comparisons of the experimental tests and numerical model are discussed in this section. The load versus deformation curves were plotted for each sample using the numerical model and behaviour of each sample was closely examined. The load- deformation curves compared with the experimental results for control samples, samples wrapped with cementitious grout and crane rail epoxy are shown in Figs. 12–14. The figures show that load deformation curves obtained from numerical model are closely correlated with those of the experiment results. As shown in Fig. 12, FEM simulations curves and experimental load deformation curves are in agreement in terms of the stiffness. As expected numerical results are showing reduced capacity when the defect level is higher. However, the experimental results for 1/3 radius splitting are the only outlier here and the reason is the obvious knot in the sample as shown in Fig. 12. Figs. 13 and 14 shows the comparison of force versus deformation relationship of the samples with CM and CR as the infill material in the annulus between the timber sample and the GFRP wrapping. These figures illustrate that the FEM simulations are in general agreement with the experimental curves in terms of stiffness and the general shape. However, there are some instances such as one sample for CR with 2/3 radius splitting which shows a much reduced capacity because it was failed due to the debonding of the GFRP wrapping.

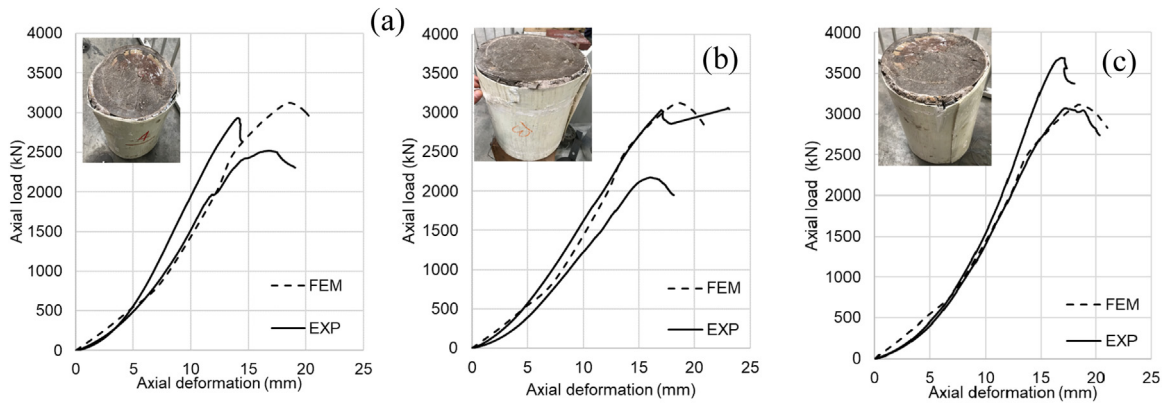
Fig. 14. Experimental and FEM model comparison of samples infilled by CR epoxy: a) full radius splitting; b) 2/3 radius splitting; c) 1/3 radius splitting.
