An Investigation into the Failure Characteristics of External PCB Traces with Different Angle Bends

Abstract

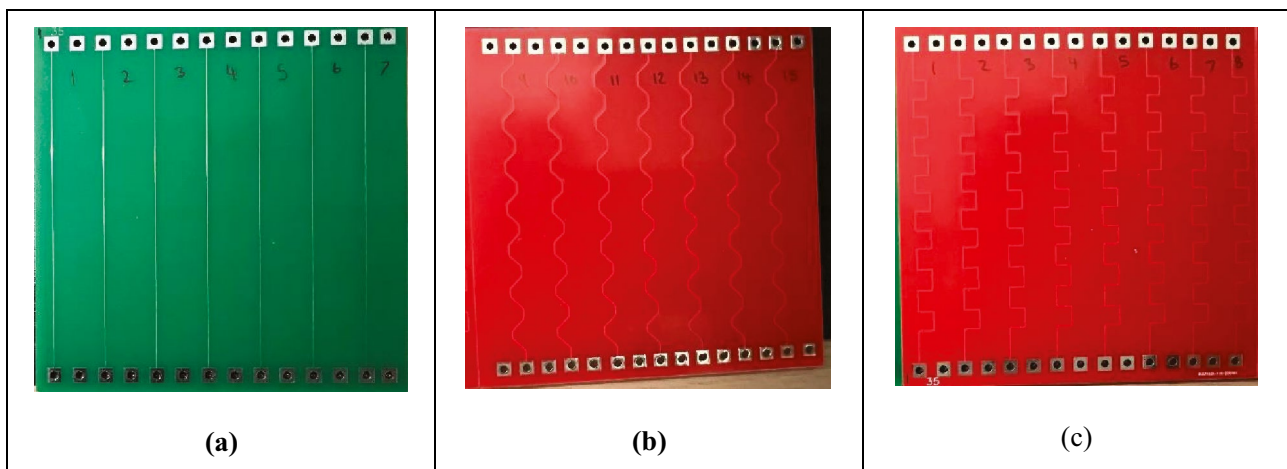
Fig. 1 Photos of PCBs with **a** Straight traces, **b**, Traces with 45° bends, and **c** Traces with 90° bends

Figure 1(a), (b) and (c) illustrate samples of the test PCBs with straight traces, traces with 45° bends and traces with 90° bends respectively.

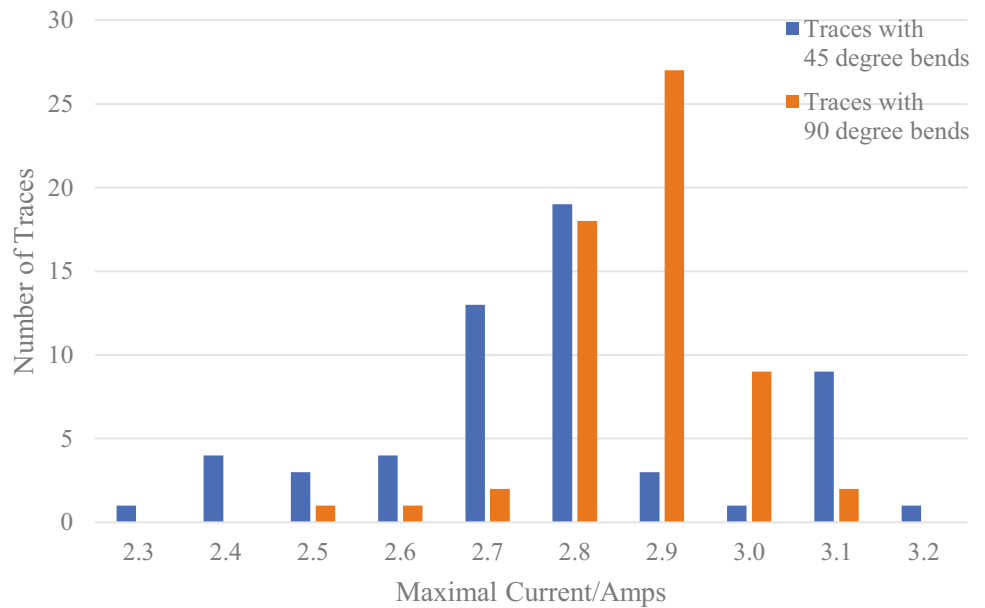
Fig. 2 Histogram of Maximal Currents for Traces with Bends

It is also beneficial to examine the distribution of the individual maximal currents, in particular to understand whether they have a Normal/Gaussian distribution. Figure 2 compares the histograms of maximal currents for traces with 45° bends and traces with 90° bends, each of which are formed from 60 measurements as illustrated in Table 2. In order to explain the histogram bin labelling, for an example bin of 2.7 A, the measurement in this bin had a maximal current of greater than or equal to 2.7 A, but less than 2.8 A. The distribution of maximal currents for the traces with 90° bends appears somewhat Gaussian, but is left skewed rather than symmetric. The distribution of maximal currents for the traces with 45° bends is clearly multimodal (i.e. having multiple local maxima) rather than Gaussian. For example,

looking at the histogram for traces with 45° bends, there are local maxima at 2.4, 2.8 and 3.1 A.

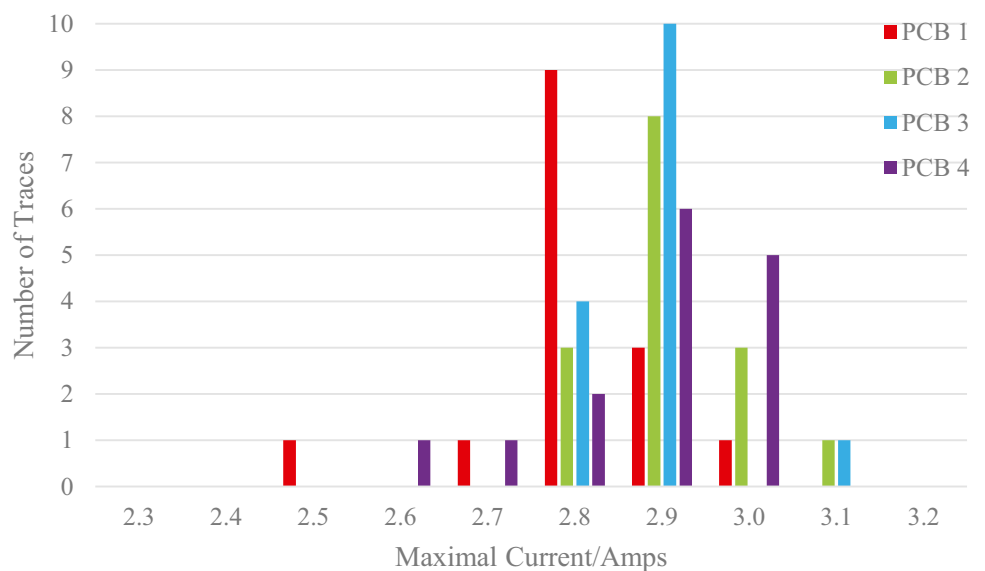
Fig. 3 Histogram of Maximal Currents for Traces with 90° Bends

A possible reason for these observations is differences between the PCBs produced for a given trace type. The 60 samples tested for each of the traces with 45° bends and traces with 90° bends were distributed across 4 PCBs, with 15 traces per PCB. Figure 3 compares the histograms of maximal currents for traces with 90° bends as a function of the PCB on which the trace was located. Table 3 illustrates the summary statistics, in particular the mean and the median, of the maximal currents for each such PCB. The distribution of maximal currents for each PCB considered individually is basically unimodal (i.e. has a single local maximum), but the individual distributions exhibit clear differences both in terms of their mean values and variance. PCB 3 has the “peakiest” distribution (i.e. lowest variance in maximal current), whereas some of the other PCBs (especially PCB1 and PCB4) exhibit a relatively large variance in the maximal currents. This demonstrates that PCBs ostensibly made according to the same specification (and in the same manufacturing run) can exhibit significantly different electrical characteristics. From the perspective of characterising the electrical properties of traces with different bend angles, it suggests we not only need to consider a large number of such traces overall, but also a large number of PCBs

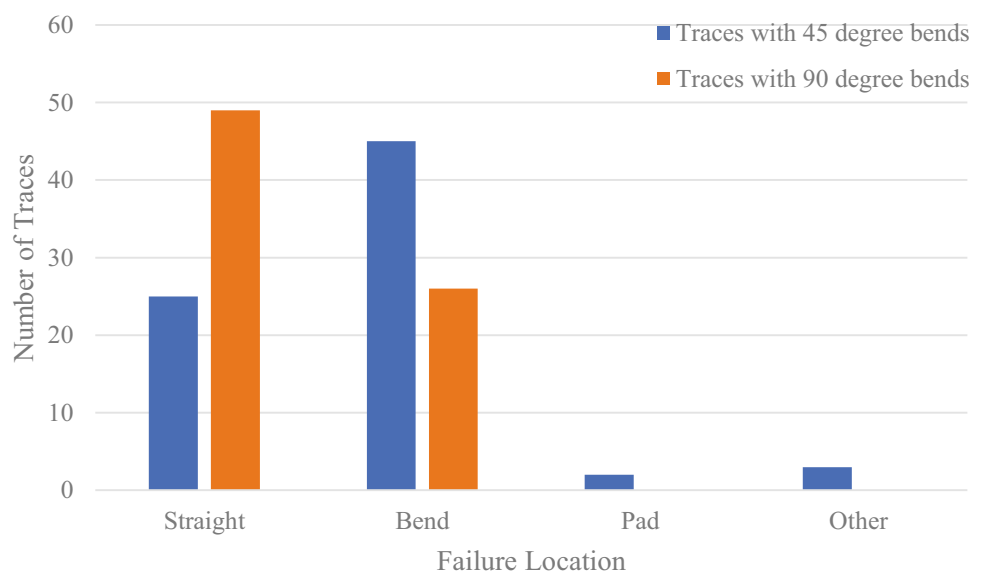
Fig. 4 Histogram of Failure Locations for Traces with Bends

Figure 4 compares the histograms of failure locations for traces with 45° bends and traces with 90° bends, each of which are formed from 60 measurements. There are significant differences between the results for the two types of traces. In particular, traces with 45° bends are more likely to fail at the bend than traces with 90° bends. Conversely, traces with 90° bends are more likely to fail on the straight segments of a trace than traces with 45° bends.

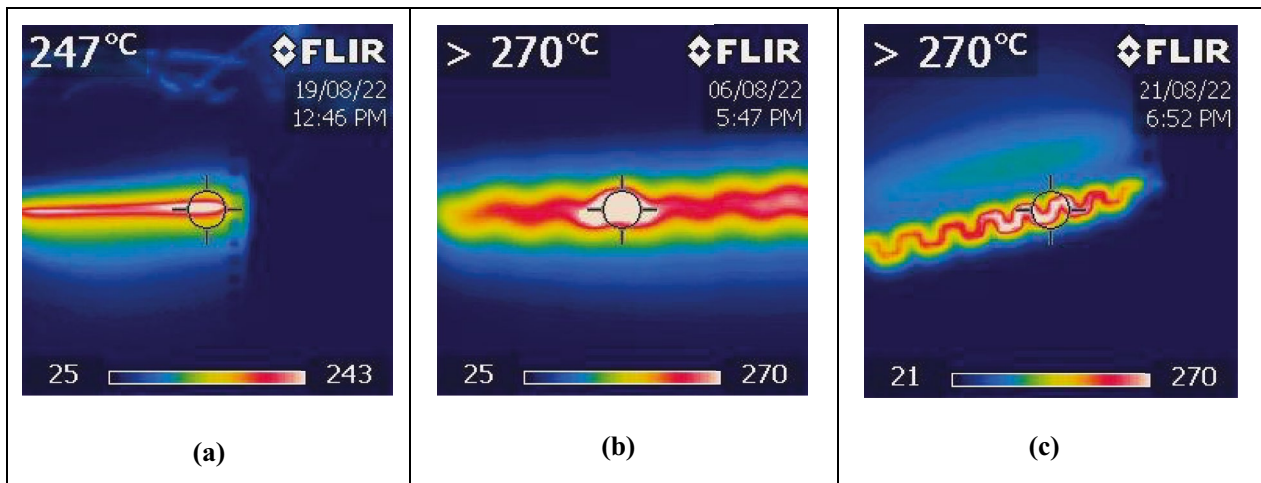
Fig. 5 Thermal Images of Traces Shortly Before Failure **a** Straight traces, **b** Traces with 45° bends, and **c** Traces with 90° bends

Figure 5(a), (b) and (c) show thermal images of straight traces, traces with 45° bends and traces with 90° bends respectively shortly before failure occurs due to overcurrent. These illustrate that the temperature at the hotspot or point of failure generally exceeds the maximum measurement temperature of 270 °C for the thermal camera in use when the failure occurs. Note that the failure location was not determined based upon these thermal images because the temperature distribution resolution along the trace is too low; instead, the methodology described in Sect. 3.4 was used to determine the failure location.
