Sunlight to heal mortar cracks: Photocatalytic self-healing mortar

Yiming Zhou^{a,b}, Mohamed Elchalakani^{b,**}, Peng Du^{a,*}, Chuanzhi Sun^c, Zuhua Zhang^{d,e}, Hao Wang^e

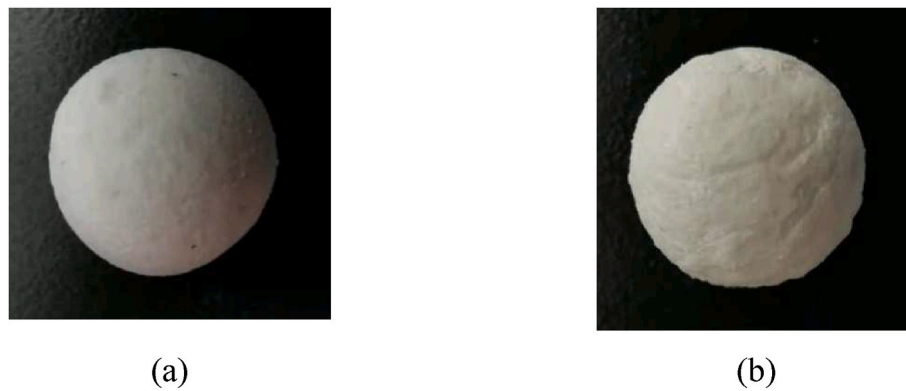
Fig. 3. (a) Spherical mixture of NaHCO_3 , Ca(OH)_2 and $\text{C}_6\text{H}_8\text{O}_7$ and (b) photocatalytic self-healing capsules.

indentations on the surface of the capsules. This was possibly caused by the uneven shrinkage of PE materials at room temperature [57]. Finally, the PE shell thickness and weight were measured. The PE shell thickness was obtained by the difference between the diameters of the spherical mixture of NaHCO_3 , Ca(OH)_2 and $\text{C}_6\text{H}_8\text{O}_7$ and photocatalytic self-healing capsules. The diameter was defined as the average value in ten different directions. According to the measurement results, the average diameter of the six spherical mixtures is 8 mm, and the average diameter of the six photocatalytic capsules is 8.4 mm. Thus, the thickness of the PE shell is approximately 0.2 mm. The average weight of the six photocatalytic capsules is 6.9 g.

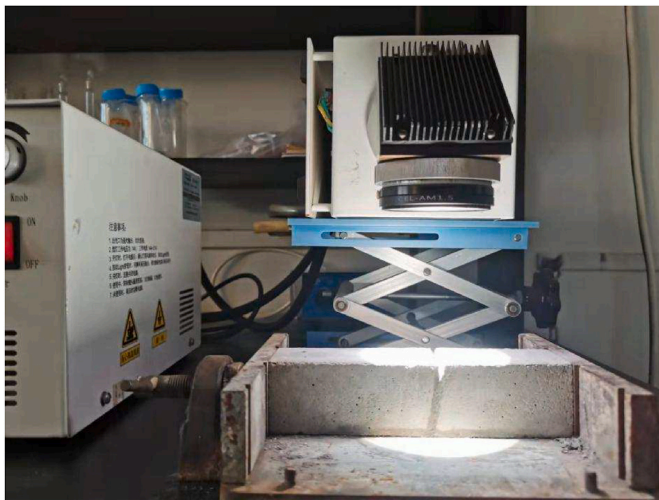
Fig. 6. Irradiation directed to the concrete cracks.

Because the mass ratio of PE and TiO_2 was 6:4 when the capsules shells were made, the irradiation time of this study was assumed to be much shorter than 300 h. Thus, the irradiation time was set to 100 h. Because the mortar cracks investigated in this study were thought to be caused by ageing and creep and did not require immediate repair, 100 h was considered to be acceptable. For the light source, a 500 W xenon lamp (Beijing China Education Au-light Co., Ltd., China) with an AM1.5 daylight optical filter was selected since the light from the xenon lamp is very similar to real sunlight [71]. Xenon lamps emit black body radiation, and the colour temperature of xenon lamps is as high as 6000 K, which is very similar to that of the Sun [72]. Therefore, xenon lamps have been used in many PE photocatalytic degradation experimental studies due to the advantages mentioned above [73,74]. Based on the discussion above, the irradiation system was set as shown in Fig. 6. As shown in Fig. 6, the sample was placed under the xenon lamp, and the light ray was aligned with the crack.

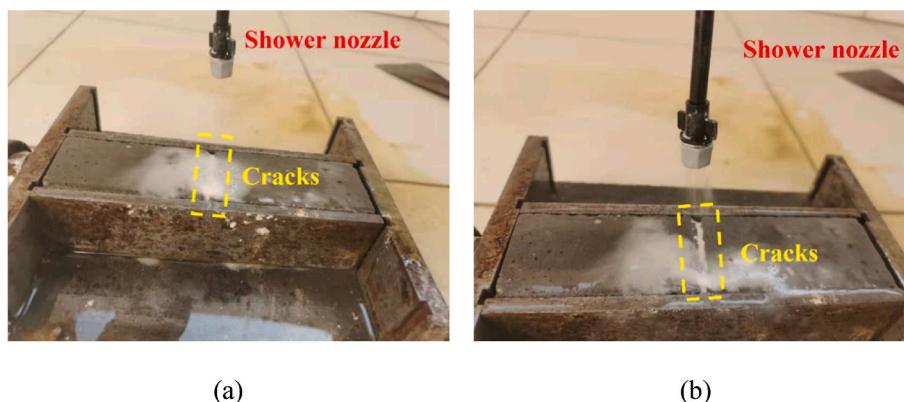
cm above the crack to provide a gentle water stream. The water flow of the shower nozzle was 0.8 L/h. As shown in Fig. 7(a), many bubbles were generated in the cracks, and some even gushed out of the cracks when water went into them. According to Eqs. (1)–(8), bubbles should be generated from the chemical reaction of NaHCO_3 and $\text{C}_6\text{H}_8\text{O}_7$ and the reaction of Na_2CO_3 and $\text{C}_6\text{H}_8\text{O}_7$. We observed many bubbles being generated at the moment in which the automatic irrigation system was activated, which indicates that bubbles were formed by the direct reaction of a large number of reactants.

Fig. 7. Cracks (a) at the beginning of spraying and (b) after 3 min of spraying.

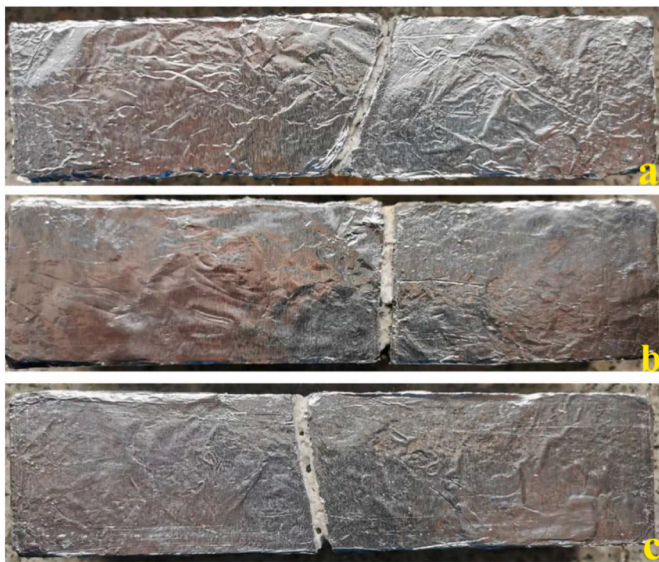
Fig. 9. Samples prepared for the water permeability tests.

between the sample and container sides. The alphabetical order of the three samples in Fig. 9 corresponds to that in Fig. 8. Then, the sample was placed into a container. Water was added into the container quickly, and the height of water in the container was 5 cm, recorded as H. A water tank was placed under the container to contain water, as shown in Fig. 10. Finally, the weight of the water in the water tank was weighed and recorded every 2 min. The results of water permeability tests are

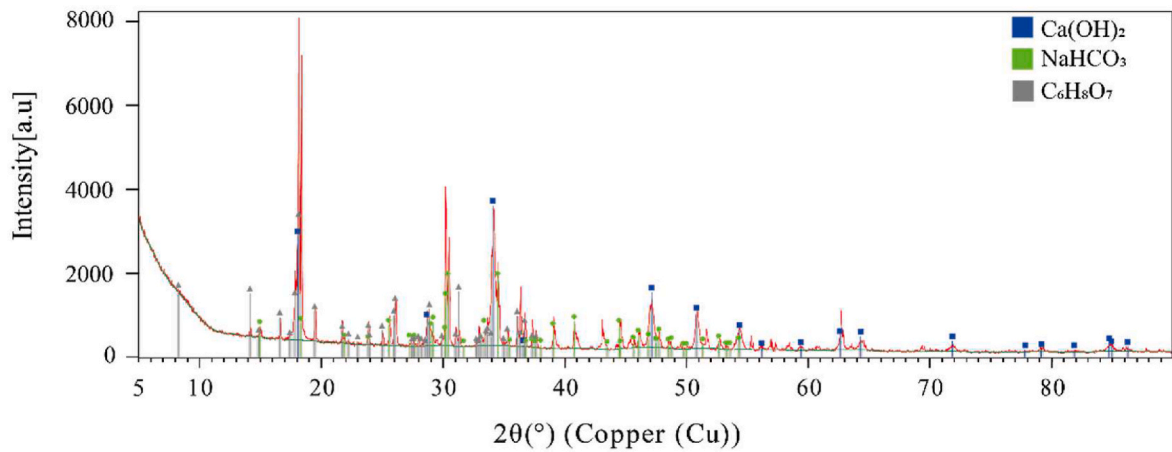
Fig. 13(a) and (b) show the XRD characterization of the powder from the interior and surfaces of the white substance, respectively. As shown in Fig. 13(a), three crystalline phases, NaHCO_3 , $\text{C}_6\text{H}_8\text{O}_7$ and Ca(OH)_2 , exist on the inner layer (internal surface) of the white substance filling the cracks, while there is only one crystalline phase, Ca(OH)_2 , formed on the outer layer (external surface). This result shows that unreacted Ca(OH)_2 existed on the outer layer of the white substance filling the cracks, which is likely the reason for the generation of the viscosity of the white substance filling the cracks. We hypothesize that when the healing process started, part of the Ca(OH)_2 was not involved in the chemical reactions and was dissolved in water to possibly form a viscous lime slurry [78]. Lime slurry is a common adhesive and is widely used to fill the cracks of construction materials [78,79]. The lime slurry made the healing materials stick to the cracks, which helped repair materials combined with concrete better. Although the above result was not expected when we designed the self-healing mechanism, it is beneficial. In the next section, the existence of lime slurry is justified by the SEM results.

Fig. 13. XRD characterizations of the powder from (a) the inner layer and (b) outer layer of repairing materials.

actually soluble but consists of agglomerates of Ca(OH)_2 particles [82]. The lime slurry is left in the cracks because of its cohesion, and Ca(OH)_2 particles inside the agglomerates remain in a crystal phase. After evaporation of the free water between agglomerates, Ca(OH)_2 agglomerates solidify. If the solid Ca(OH)_2 agglomerates are ground into powder, its crystal structure is essentially the same as before. Thus, as seen in Fig. 13(a) and (b), the crystal structure of Ca(OH)_2 does not change.
