### Vulnerability assessment of bridges subjected to extreme cyclonic events

**Natural Hazards**

# Vulnerability assessment of bridges subjected to extreme cyclone events

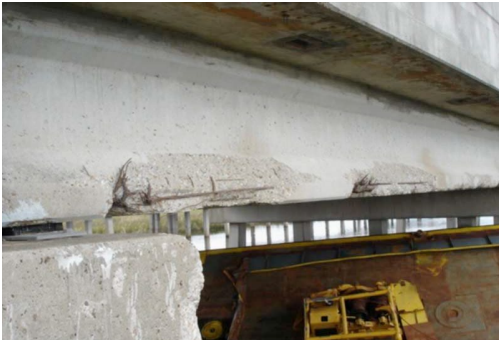
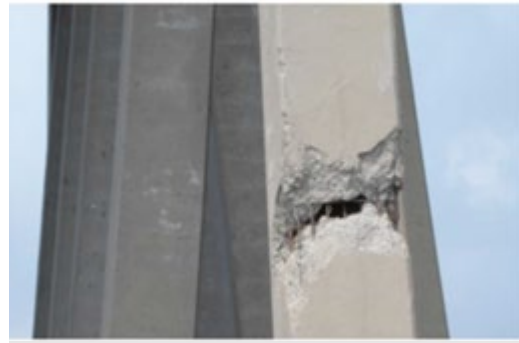
450 Figure1: Damage due to impact (Padgett et al. 2008)

58 Impact damage is quite common for bridges associated with large water ways. It is generally caused by floating  
59 objects such as debris, boats Pitchard (2013) or any other items that are transported due to flooding resulted  
60 from the intensive rainfall caused by cyclones (Figure 1). Post disaster inspections revealed that in most  
61 occasions, impact damage contributed to the superstructure as well as substructure failure of a bridge (Padgett et  
62 al. 2008).

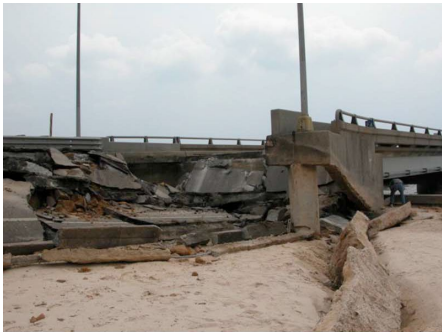
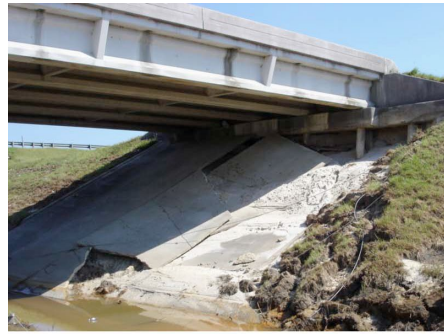
Figure 2: Damage caused by scouring (Padgett et al. 2008)

77 Observations reveal that damage due to scour may come together with other cyclone induced damage modes or  
78 it may not be the case all the time (Padgett et al. 2008). Damage to a bridge due to scouring is normally  
79 associated with the erosion of abutment and the approaches or relieving slab (Figure 2).

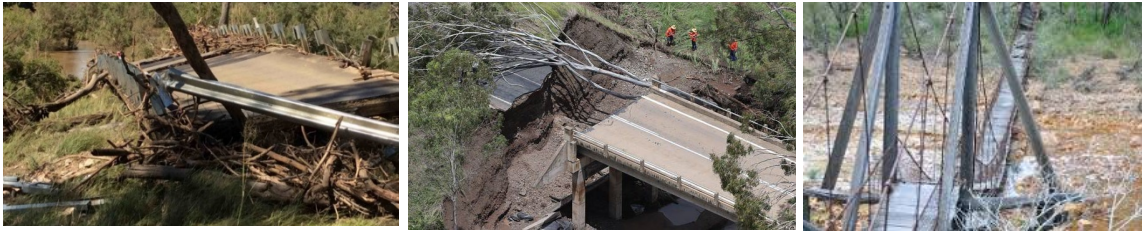
Figure 3: Damaged bridges during Cyclone Marcia

92 Cyclone Marcia was expected to reach category 5, however when it reached the landslide, it has reduced to  
93 category 2/3 (James Cook University Cyclone Testing Station 2015). Despite lowering its intensity, the damage  
94 bill of Cyclone Marcia approached to \$53.4 million after a weeks' time, at least 1000 houses suffered structural  
95 damage from the disaster, and 385 properties have been deemed uninhabitable. It destroyed numerous properties  
96 in Yeppoon and road infrastructure including bridges in Monto, Gladstone Biloela Road and in Mount Morgan  
97 (Figure 3).

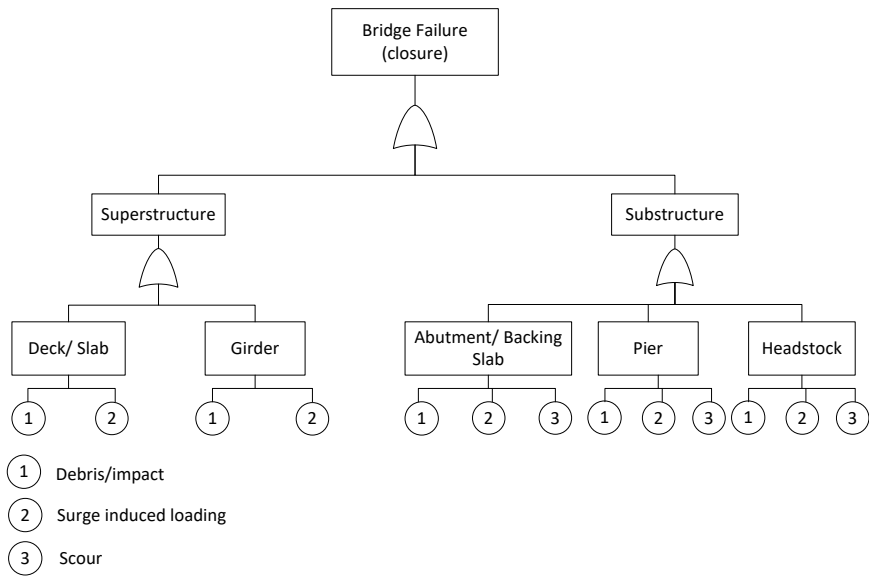
Figure 4: Fault tree diagram for bridge failure during a cyclone

158 Considering the basic events described in the previous section, using the analysis of bridge inspection data, and  
159 referring to the models used by previous researchers (Davis-McDaniel et al. 2013; Johnson 1999; Zhu 2008), a  
160 fault tree diagram was developed for concrete and timber bridge failure during cyclone Marcia (Figure 4).

163 Bridge failure (closure or reaching Condition State 5) can occur due to either superstructure failure or  
164 substructure failure. Girder or deck/slab failure are the main reasons for the superstructure to have less  
165 functionality. Debris/impact loading or the surge-induced loadings are the reasons for deck/slab or girder  
166 damage during a cyclonic event. On the other hand, possible reasons for substructure damage/ failure are debris/  
167 impact loading, surge-induced loading as well as scour. These events are connected using OR gates to the main  
168 event (bridge failure) because any of these event will contribute to the main event as shown in Figure 4. In  
169 order to use this FTD for the purpose of finding the probability of failure of bridges, it is important to find the

216 From the previous section, the probability of the girder failure was calculated as 0.0729. In the fault tree  
217 diagram (Figure 4) the girder failure can happen due to two basic events, debris/ loading or surge induced  
218 loading. Top to bottom method was used to find the probabilities for basic events.

229 In the fault tree diagram developed (Figure 4) OR gate was used to connect the basic events to the girder failure.

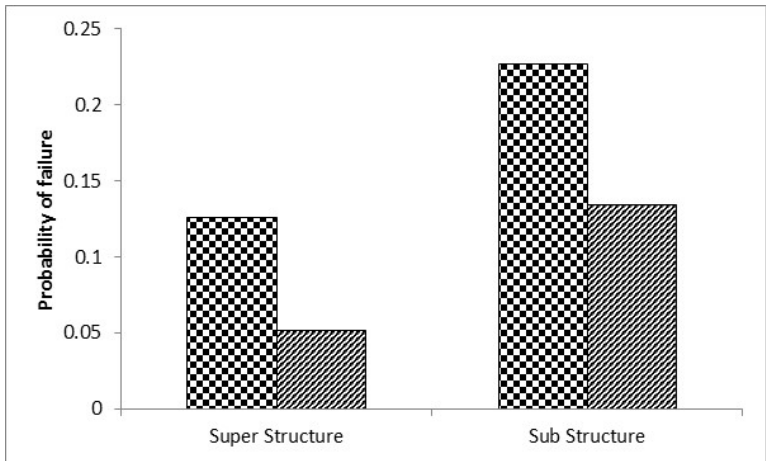
Figure 2: Damaged behavior based on FTA analysis for bridges during cyclone

298 Results indicated that substructure of timber bridges is more sensitive to surge induced forces compared to those  
299 of concrete bridges (Figure 6). The main contribution for this failure comes from the surge induced loadings to  
300 the piles and abutment. The exposure conditions must be playing an important role for this major contribution.

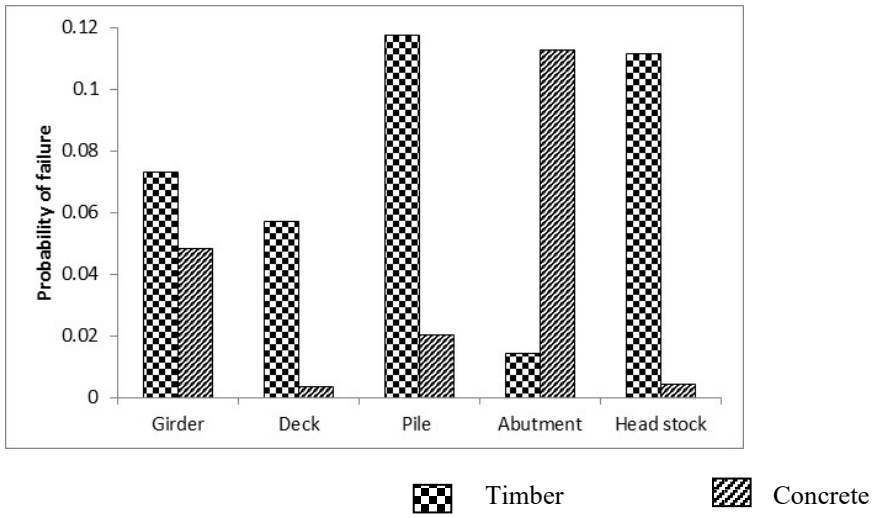
Figure 7: Element failure of bridges during a cyclone

302 Load distribution in timber bridges are different to that of concrete bridges and hence it impacts on the piles of  
303 concrete bridges (Eberhard et al. 1993). Results (Figure 7) indicated that the majority of the elements of timber  
304 bridges have low resilience to cyclonic events compared to that of concrete bridges. However there was a  
305 marked variation in the probability of abutment failure in concrete bridges, which impacted overall response of  
306 the substructure.
