Performance of the corrugated metal pipe sliplining method using FRP pipes

School of Engineering, Centre for Future Materials (CFM), University of Southern Queensland, Toowoomba, Queensland 4350, Australia

Corrugated Metal Pipes (CMP) have been extensively used in culverts for decades. Currently, there is a significant growing demand for CMPs to be either replaced or rehabilitated due to their deterioration caused by corrosion. Sliplining is one of the simplest and cost-effective methods of CMP culvert rehabilitation. This paper examined the structural performance of CMP sliplined by Fibre Reinforced Polymer (FRP) composites considering the effects of host pipe and the grout infill. In this research, CMP, FRP pipe and FRP sliplined CMP were subjected to parallel plate load test (PPLT) and the load deflection behaviour and failure modes were examined. A low strength flowable mortar mix was used as the Controlled Low Strength Material (CLSM) to fill the annular space between pipes. It was observed that the core failure of the FRP pipe governs the failure of the sliplined CMP. A change in load deflection behaviour of the host pipe of sliplined CMP system was also observed with refer

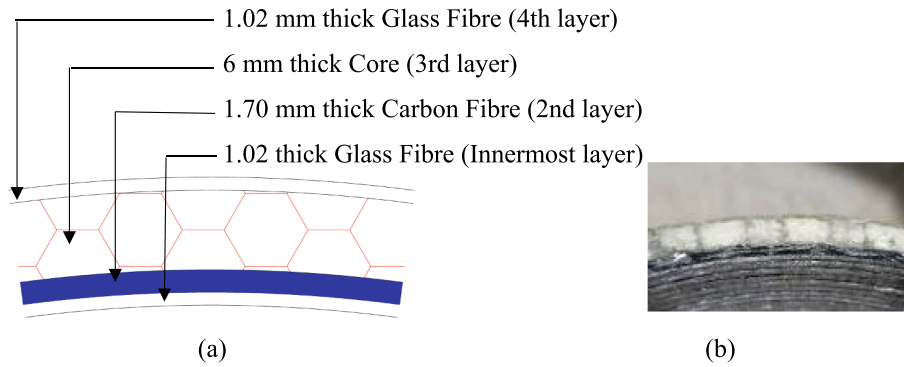
Fig. 1. (a) Cross section; (b) Close up image of StifPipe wall.

StifPipe®, the pipe used to retrofit the corrugated metal pipe comprises four layers of composite material (Fig. 1). The first layer (i.e., innermost layer) and fourth layer are identical and made of 1.02 mm thick Glass Fibre Reinforced Polymer (GFRP) composites. The second layer is a 1.7 mm thick Carbon Fibre-Reinforced Polymer (CFRP)

composites. Both CFRP and GFRP layers are fabricated by saturating carbon fibre and glass fibre fabrics in epoxy resins respectively. A 6 mm thick core, lightweight honeycomb layer is sandwiched between the second and fourth layers. GFRP lamina comprises bidirectional glass fibres which are present in both circumferential (0°) and longitudinal (90°) directions of the pipe whereas CFRP lamina is unidirectional, and fibres are oriented and distributed only along circumferential direction. In this testing program, GFRP and CFRP lamina were characterised in each direction as individual laminas using tensile, compression and shear tests. Further, the laminate was also characterised to determine the effective properties of each direction using the same test method.

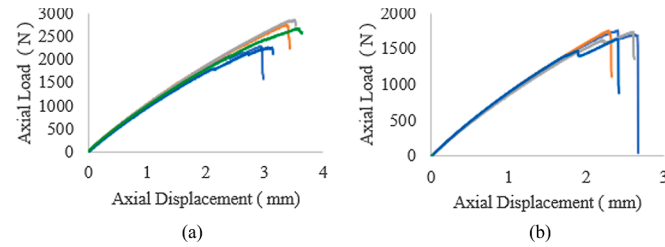
Fig. 4. (a) GFRP $[0^\circ]$ load deflection curves; (b) GFRP $[90^\circ]$ load deflection curves.

The tensile load-displacement curves of the tested coupons are shown in Figs. 4 & 5. Generally, the load-displacement responses of all coupons exhibited a linear behaviour up to the peak load except the 0° direction CFRP coupons which showed a gradient reduction before its failure. Further a sudden load drop at the failure load was common to all load displacement curves. The average failure loads were determined to be 230 MPa and 139 MPa for GF coupons in circumferential and transverse directions, respectively. A significant difference was observed in the failure loads in each direction for CFRP coupons. The average failure loads of 0° direction CF coupons were 960 MPa whereas the average failure load of 90° direction samples was as low as 7 MPa. Elastic modulus and failure stress of each lamina and the laminate were calculated by plotting the stress against the strain and results are tabulated in Table 2. The tensile failure occurred within the gauge length with no signs of end slips (Fig. 6).

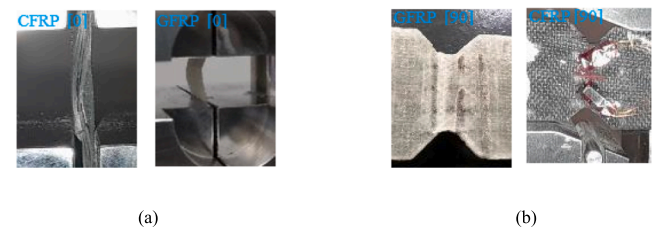
Fig. 7. (a) Failed compression specimens; (b) Failed shear specimens.

Compressive strengths of each structural layer and the FRP laminate was determined based on the peak load. CFRP specimens and FRP laminate specimens failed in compression whereas GFRP specimens reached its peak load due to buckling invalidating the experiments (Fig. 7(a)). Therefore, the compressive strength of the GFRP lamina was estimated based on the ratio between compressive and tensile strengths by comparing the same ratio of similar material from the available

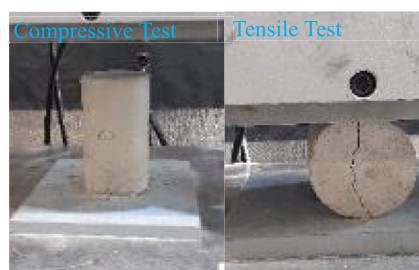
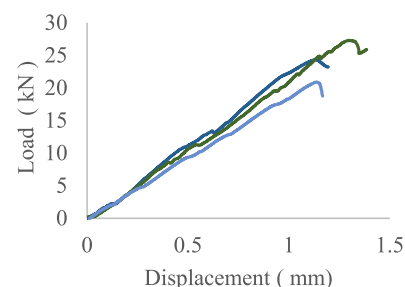
Fig. 8. (a) CLSM test specimens; (b) Compressive test load–displacement curves.

The load–displacement responses of all cylinders exhibited an approximate linear behaviour up to the peak load (Fig. 8(b)). All the samples failed in similar manner crushing the bottom third portion of the cylinder. The compressive stress was calculated dividing the failure load by the cross-sectional area of the cylinder. The average failure stress was 3 MPa. Split tensile strength was calculated using maximum applied load indicated by the testing machine. All the samples were failed by splitting the sample into two parts. Tensile stress was calculated following section 9 of ASTM C496 (ASTM International, 2017). Average tensile failure stress of CLSM cylinders was 0.38 MPa Results are tabulated in Table 3.

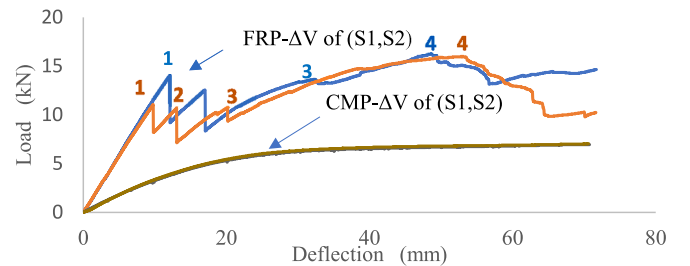
Fig. 11. Load deflection curves.

Load-deflection relationship of the FRP pipe was linear up to the pipe failure. Load-deflection curves of both samples were reasonably

consistent even though the failure loads are slightly different (Fig. 11). Failures of the pipes were marked as '1', '2', '3', and '4' on the load–deflection curves, where '1' represents the first failure, with subsequent numbers indicating progressive failure stages, respectively. Both samples failed at the invert due to core failure and delamination (Fig. 13(a)). Failure loads were 13.95 kN and 10.7 kN for sample 1 and 2 respectively. Failure locations are shown by an arrow. The displacement of the movable cross head of UTM was continued even after the absolute failure (1st failure) as pipe samples exhibited more load carrying capacity. The second failure occurred at the crown and the invert simultaneously by cracking of honeycomb layer at the crown in addition to the delamination (Fig. 13(b)) while delamination at the invert further propagated. Locations of the 3rd failure were not the same for the two pipe samples. However, the damaged layer was common for both pipes. Two inner most layers of the pipe sample 1 failed at the 10-clock position while the same layer of sample 2 failed at the invert (Fig. 14(a)).

The peak load of the pipe sample 1 was 16.1 kN whereas it was 15.0 kN for the pipe sample 2. The fourth failure of the sample 1 occurred at the 10–4 clock positions due to the yielding of carbon fibre layer. Further, the reversal of curvature was initiated at the invert. Similarly, the fourth failure of the sample 2 occurred at the 8–2 clock positions by yielding the carbon fibre layer. In addition to those two locations another failure was observed at the invert due to the reversal of curvature. Final failure modes are shown in Fig. 14 (b). Load deflection behaviour of two CMP samples was identical (Fig. 11). Unlike FRP samples, no significant failure was observed rather than an excessive deformation (Fig. 15). UTM load reading reached to its peak value of 7.05 kN with the ductile deformation (Fig. 10). Both horizontal (ΔH) and vertical (ΔV) diameter changes due to load for both types of pipes were plotted in Fig. 12. Diameter changes curves were plotted from zero load up to the first failure load of the FRP pipe. As diameters of FRP pipe and CMP are different, percentage diameter change was considered for the comparison. Sample 1 and 2 curves were coincided for both type of pipes.

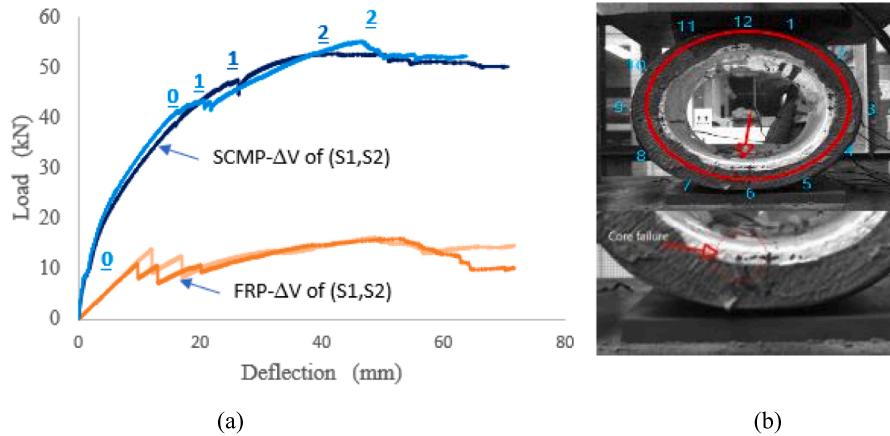
Fig. 16. (a) Load deflection curves; (b) Failed sliplined pipe sample.

The load–deflection relationship is shown in Fig. 16(a), while Fig. 16 (b) displays the sample after failure. A nonlinear load deflection relationship was observed for both samples. The load deflection curves from stage I were also added for the purpose of comparison. The load deflection curves of two samples coincided until 6.5 kN load. After the sudden gradient change at 8.5 kN load, sample 2 curve gradients were slightly higher than the sample 1 until load reached 16.6 kN. '0' marked on the load deflection curves represents sudden gradient change or minor drops prior to FRP pipe failure. The failure load of the sample 1 was recorded as 47.5 kN whereas sample 2 failed when load reached 44.0 kN. The peak load for Sample 1 was recorded at 52.7 kN, whereas Sample 2 exhibited a slightly higher peak load of 55.2 kN. '1' and '2' marked on the load deflection curves denotes the failure load and the peak load respectively.

Even though minor drops were present at 41.4 kN load, FRP pipes remained intact until load reached its failure loads mentioned above.

Fig. 21(b) is a comparison of the parallel plate load test conducted for the sliplined corrugated metal pipe and the FE Model 3 results. A close agreement between the experimental and numerical results up to the 1st failure of FRP pipe was observed even though minor drops were not captured. The FE model also captured the non-linear load–deflection relationship of the sliplined pipe system. The failure loads of pipe samples 1 and 2 are 47.5 kN and 43.1 kN, respectively, whereas the failure load of the FE model was recorded as 44.0 kN. On the other hand, the predicted failure load from the FEM is reasonably close to sample 2. The load drop after failure seems comparatively higher. This may be due to the assumed fracture energies being slightly higher. The vertical deformations of samples 1 and 2 in relation to the failure load were 26.3 mm and 21.8 mm, respectively, while the FEM model failed when the deflection reached 20.9 mm. The sudden load drops in the experimental results indicated the FRP pipe core failures. The failure location is shown in Fig. 16(b). FE Model 3 pipe also failed at the same location as the load test.

The failure loads and deflection of the sliplined pipe were distinctly different from those of the FRP pipe itself (Fig. 16 (a)). The sliplined pipe system could resist more loads than the FRP pipe itself and it could deflect more than FRP pipe itself before the core failure. Based on the above observations, it can be concluded that the CMP and the grout provide a positive contribution to the structural performance of the sliplined pipe system. However, the actual contribution of remaining strength of CMP may be less than these figures as intact CMP was used in this study. Therefore, further studies are required to quantify the contribution of the CMP and grout and will be investigated as an extension to this study. The purpose of using FE models is to eliminate the necessity of conducting a series of pipe tests for different diameters which is time consuming and not economically viable. Since all the FE models were validated using the experimental results, these models will be used in parametric study of the ongoing study. On the other hand, unlike simple cylindrical pipe, the CMP or sliplined pipe system deflection calculation is not practicable without using FE analysis software due to the complex shape of the CMP and the non-linear behaviour of the grout CMP and the CLSM grout.

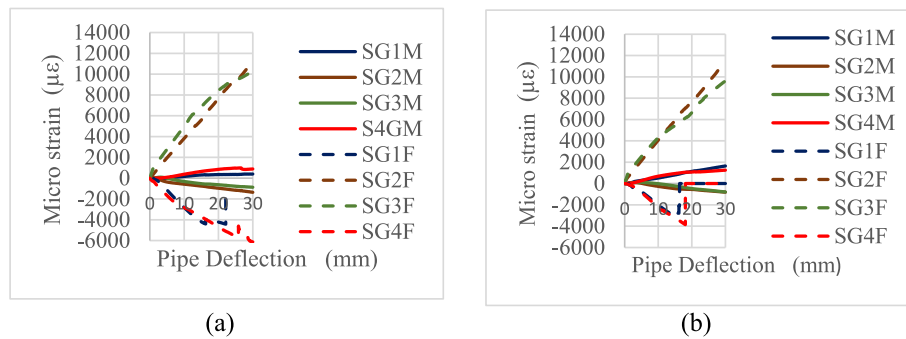
Fig. 17. Strain gauge reading for (a) sample 1; (b) sample 2.

The reason for these drops and gradient change mentioned above could be due to the grout failure. This is evidenced by the strain gauge reading SG2F and SG3F (Fig. 17) which exceeds their limiting tensile strain of 1000 $\mu\epsilon$. The pipe failure moments were captured by the DIC video whereas grout failures mentioned above could not be captured as they were not at the grout face. Both FRP pipes (carrier pipes) of the sliplined pipe sample failed due to core failure and delamination at the invert which is the same failure location when PPLT carried out for FRP pipes alone mentioned in section 3.2.1 (Fig. 16(b)).

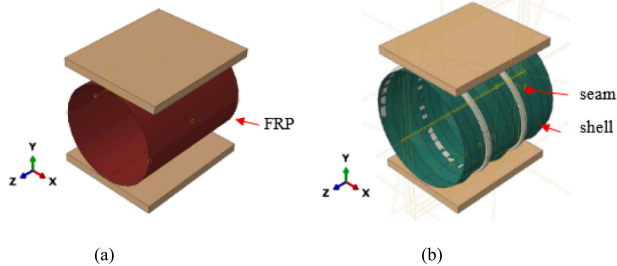
Fig. 18. (a) FE Model 1 for FRP pipe; (b) FE Model 2 for CMP pipe.

The second FEM was created to simulate the PPLT of CMP alone. The second model used the same boundary conditions, steps, contact method, and loading as the first model, but with different pipe geometry and properties. The CMP was created as a homogeneous shell element, along with a solid spiral to simulate the lock seam area of the pipe (Fig. 18(b)). The solid part and the shell part of the pipe were connected using shell-to-solid coupling constraints. Load deflection curves from the experiment and FEM were plotted together for comparison (Fig. 20(b)).

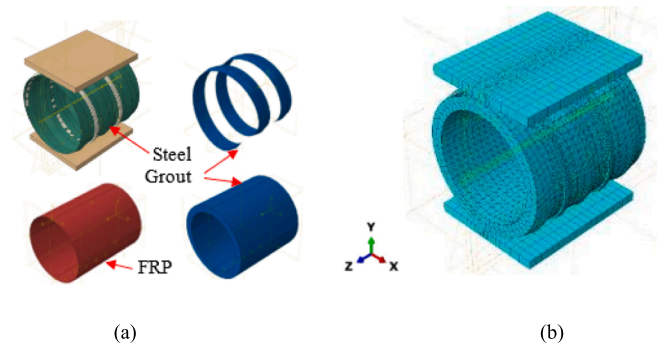
Fig. 19. (a) Parts of FE Model 3; (b) FE Model 3 for SCMP.

and the FRP pipe from the first model (Fig. 19). The CLSM grout layer between the CMP and FRP pipe was created as a 3D deformable part. Due to the complexity of the shape two parts were created. These two parts were combined using tie constraints instead of merging into a single part as the merged part led to convergence issues due to the complexities in the mesh. 10-node quadratic tetrahedron element type

(C3D10) mesh was assigned to the solid parts mentioned above. CMP, CLSM grout layer and FRP pipe were connected to each other by tie constraints.

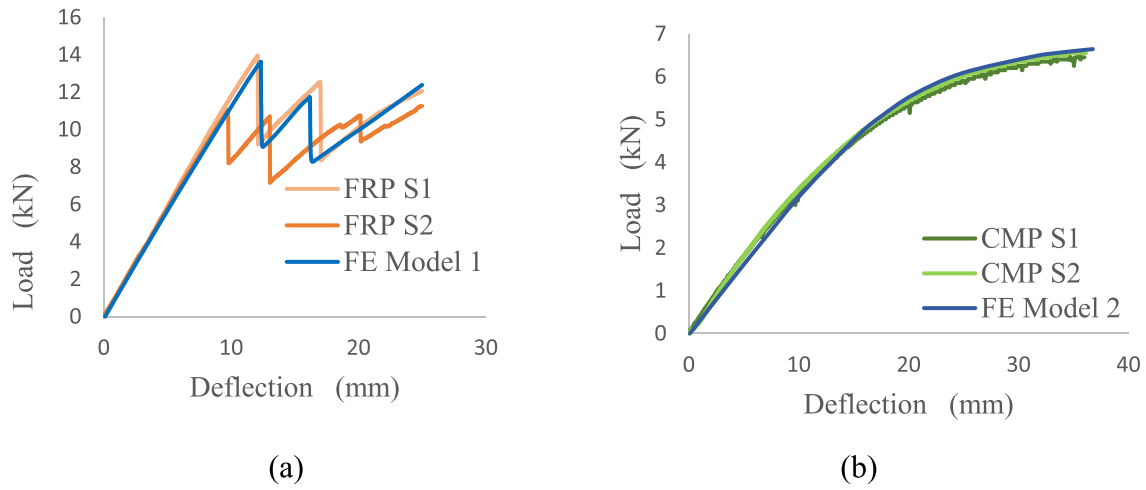
Fig. 20. (a) Validation of FEM 1; (b) Validation of FEM 2.

correlation with the experimental results in the linear elastic region (Fig. 20(a)). The sudden load drops in the experimental results indicated the pipe failure. The core closer to the pipe invert failed first due to the formation of angled transverse shear crack through the layer followed by delamination. Secondly the core near the crown failed following the same failure modes. The FE model also captured the same failure modes, and the load-deflection relationship was very close to the sample 1 experimental results.

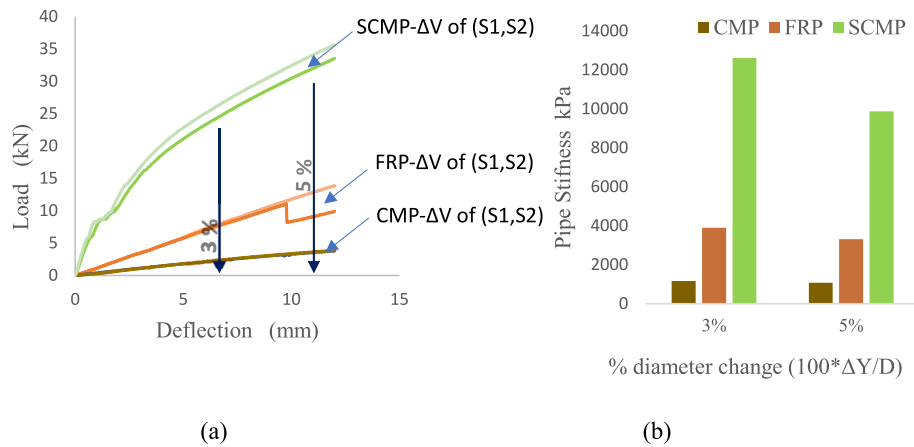
Fig. 24. (a) Load deflection curves; (b) Pipe stiffness comparison.

buried flexible pipe design which is used to assess the overall performance of the buried pipe system in presence of surrounding soil. Pipe stiffness for any given deflection is defined as $F/\Delta Y$ where F is the load in kN/m and ΔY is the vertical deflection in m (ASTM International, 2021). 3 % and 5 % vertical diameter change of the FRP pipe was selected for PS comparison (Fig. 24). Even though pipe stiffness is mainly used in flexible pipe design it was used in this study to compare the load carrying capacities of pipes before and after sliplining since SCMP exhibited some flexibility in comparison with rigid pipes. The average PS of CMP and FRP pipes when deflection reached 3 % vertical diameter change was 1168 kPa and 3896 kPa, respectively. The average pipe stiffness of a sliplined pipe system was 12623 kPa. Due to the sliplining, load-carrying capacity was increased by 981 %. The average PS of CMP and FRP pipes for 5 % deflection was 1077 kPa and 3319 kPa, respectively. The average pipe stiffness of a sliplined pipe system for the same deflection was 9882 kPa which is an 818 % increase in the load-carrying capacity. These increased load carrying capacities can be considered as the upper limit of the pipe stiffnesses because these values can come down in real life due to the reduced stiffness of corrugated metal pipes due to the deterioration and the varying grout strength from 1 MPa to 3 MPa. Further investigation is to be done to quantify the effects from the remaining strengths of corrugated metal pipes as an extension to this study. In this study intact CMP and 3 MPa grout was used, and FEM was created and those will be used as control samples.

Vertical Arching Factor (VAF) is one of the benefits which can be used to reduce the design loads of buried flexible pipes. When pipe is not stiffer than the surrounding soil VAF is less than 1 due to the arching action of the soil (Dhar et al., 2002). This mechanism is also known as positive arching action (Kang et al., 2013). Pipe flexibilities of the sliplined pipe system was compared with another parallel plate load test results available in the literature as sliplined pipe system stiffness was significantly higher than the FRP pipe stiffness. The results of PPLT conducted on a rigid pipe and a flexible pipe was selected for the comparison. The pipe stiffness of 66 mm thick concrete pipe (internal and external diameters are 518 mm and 584 mm respectively) was 450 MPa (Kraus et al., 2014). However, this stiffness relates to the crack initiation of the pipe for 0.07 % diameter change. The pipe stiffness for 5 % deflection was not available as pipe cracked when the vertical deflection reached to 0.07 % of the mean diameter. The pipe stiffnesses for 5 % deflection of a concrete lined CMP were approximately 2 MPa and 3 MPa for 20 mm and 40 mm concrete linings respectively (Kang and Davidson, 2010). The pipe stiffness for 5 % deflection of a 9 mm thick, 300 mm diameter solid wall FRP pipe was 718 kPa (Park et al., 2014). The pipe stiffness of the FRP sandwich pipe used in the study was 3.3 MPa whereas the same calculated for the sliplined pipe system was 9.9 MPa (Fig. 24(b)). While the rigid pipe failed upon reaching a 0.07 % diameter change, the tested SCMP maintained its structural integrity even after a
