EFFECT OF ECCENTRICITY ON THE BEHAVIOR OF PULTRUDED FRP BOLTED JOINT

R.M. Hizam, A.C. Manalo and W. Karunasena

Centre of Excellence in Engineered Fibre Composites,
Faculty of Engineering and Surveying, University of Southern Queensland,
Toowoomba, Queensland 4350, Australia.
E-mail: mohammadhizamshah.rusmi@usq.edu.au

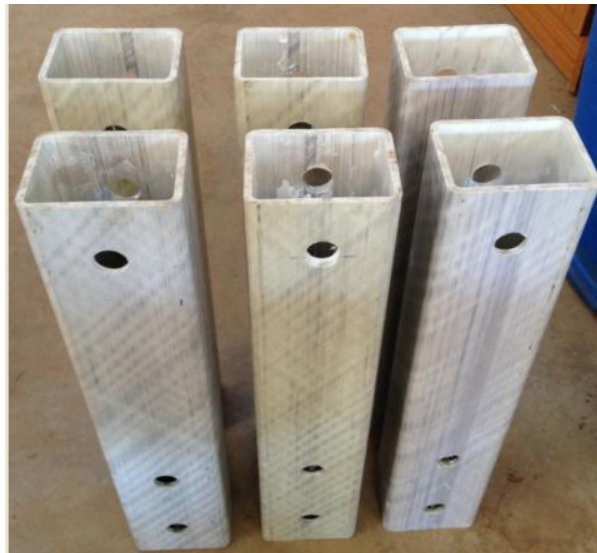
Figure 1. Disassembled specimens of pultruded GFRP closed profile.

The experimental program of this study involved a total of six (6) pultruded GFRP T-joint specimens had been assembled and were tested to failure in the tensile direction. There were two (2) experimental models prepared which corresponds to the specimens 1B, and 2B. The description of the specimens is listed in Table 1. One bottom chord specimen was used to create eccentric case, while two bottom chords is the typical configuration use in the industry (Figure 2).

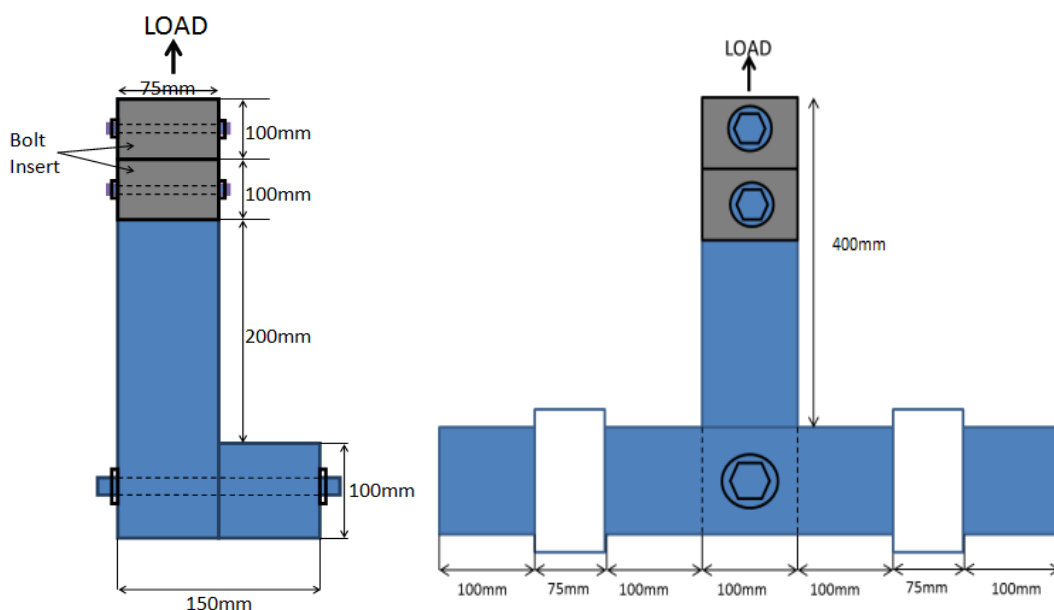
Figure 2 illustrates the geometrical configuration of the pultruded GFRP T-joint and the test fixture used in this experiment. At the connection area between the steel test fixture and test equipment, two (2) M20 stainless bolts and mechanical inserts were used. The mechanical fasteners used to connect the T-joint were stainless steel (SS) 316 M20 (A325) together with SS washers and nuts. A tightening torque of 25 N.m was used to provide clamping pressure as recommended in (Manalo and Mutsuyoshi, 2011). Approximately 22 mm nominal bolt hole diameter was drilled using a special diamond-tipped bit and the edge distance from the bolt hole to base material is approximately 39 mm (2 times bolt diameter).

Figure 2. Geometrical configuration of pultruded GFRP T-joint

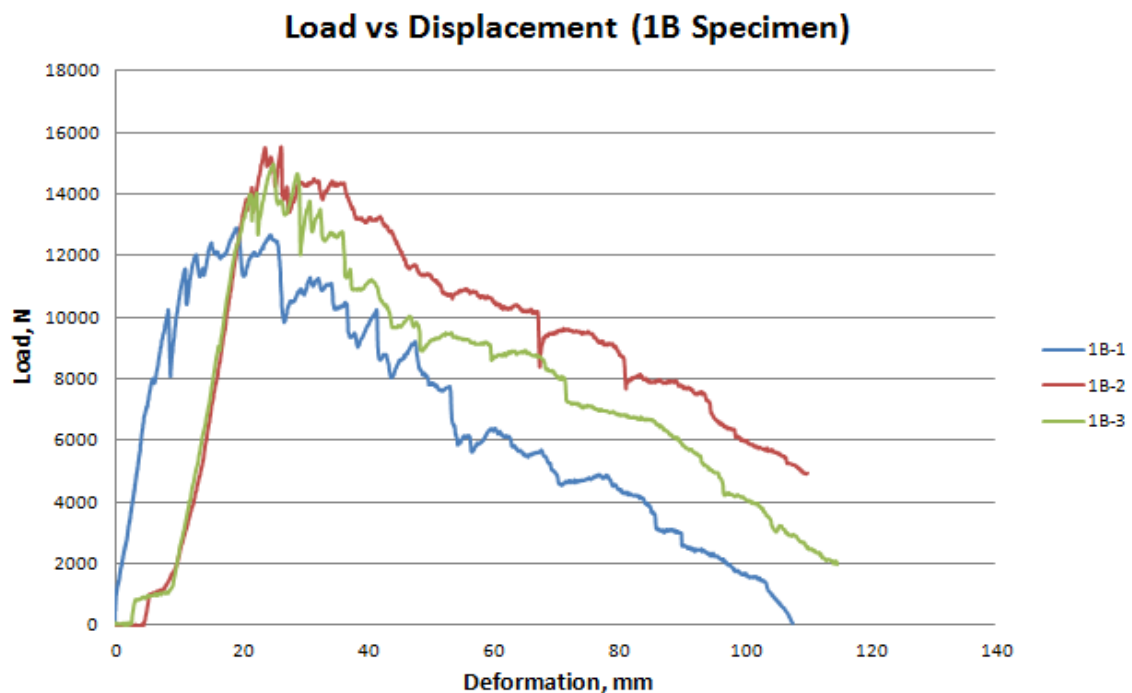
The load and displacement relationship of 1B specimens is presented in Figure 4. All specimens showed almost linear behavior which occurred up to around 10-13kN with displacement between 20-25 mm. After this region, the curve became non-linear until failure. The first cracking sound could be heard at as low as around 8 kN which may indicates that the bolt was starting to slip into bearing. The highest failure load was

obtained by 1B-2 specimen at 15.53 kN. Subsequently, the joint strength slowly decreased and the displacement continued to increase. It was noticed that, after the maximum load, the specimens did not fail abruptly suggesting that the members of T-joint were still intact. This is due to the lateral restrained produced by the bolt axial force (tightening torque). As the load was continued to apply, the contact pressure from the washer had progressively damaging the fibres and had caused local failure.

Figure 4. Load-displacement of 1B specimens

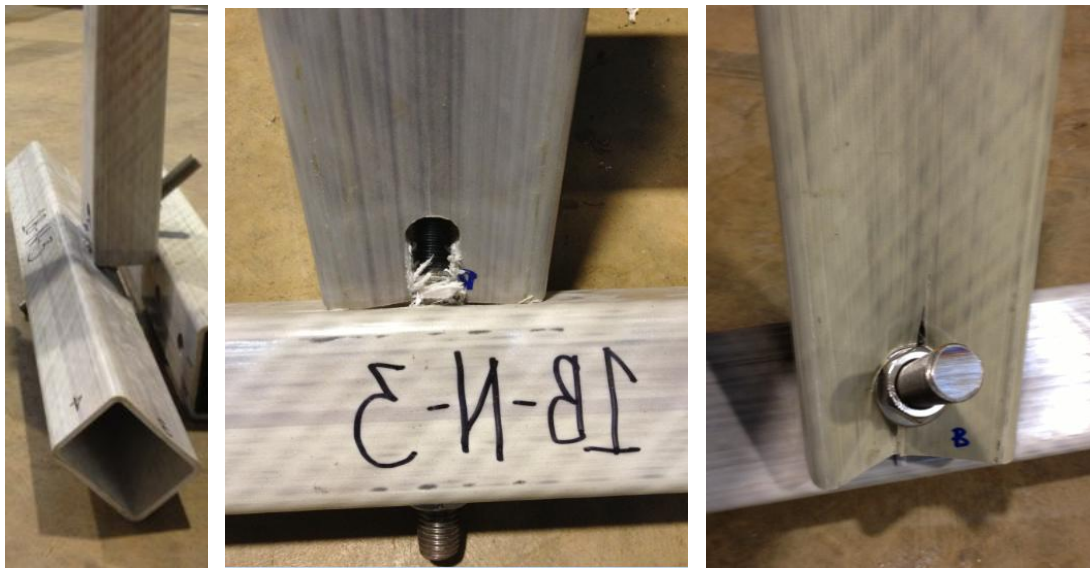
In order to further investigate the failure behavior at the connection area, the T-joint components were disassembled. The failure modes of pultruded GFRP T-joint 1B specimens (at connection area) were presented in Figure 5. During the application of the load, the specimens exhibited large rotation at the bottom chord due to moment created. This eventually had caused punching shear on the pultruded GFRP thin-walled which

developed due to the eccentricity of the load applied on the connection. This has significantly affected the joint strength. Providing that the material is relatively low material stiffness and lower strength in the transverse direction (Bai and Yang, 2012), it also prone to fail in that manner. On the opposite plane which is facing the bottom chord, the final failure mode of shear-out was identified. The end distance (approximately 39 mm) to bolt diameter (20 mm) ratio is slightly below the minimum recommended parameters (which is 2) for lap joint connections (Bank, 2006). Since the material possesses low in-plane shear strength and together with the small edge distance in the direction of the load applied, it triggered the shear-out failure to occur. No sign of failure in the bolt was seen for the 1B specimens.

Figure 5. Failure modes of 1B specimens

Six specimens of pultruded GFRP bolted joint had been tested in two cases, with and without eccentricity. The results showed that the joint strength is significantly decreased due to the effect of eccentric loading. For 1B specimens, different mode of failure from the typical FRP connection failure modes was observed. The local punching shear was developed at one side of the connection area due to eccentric effect and resulted in reducing bolted joint strength.

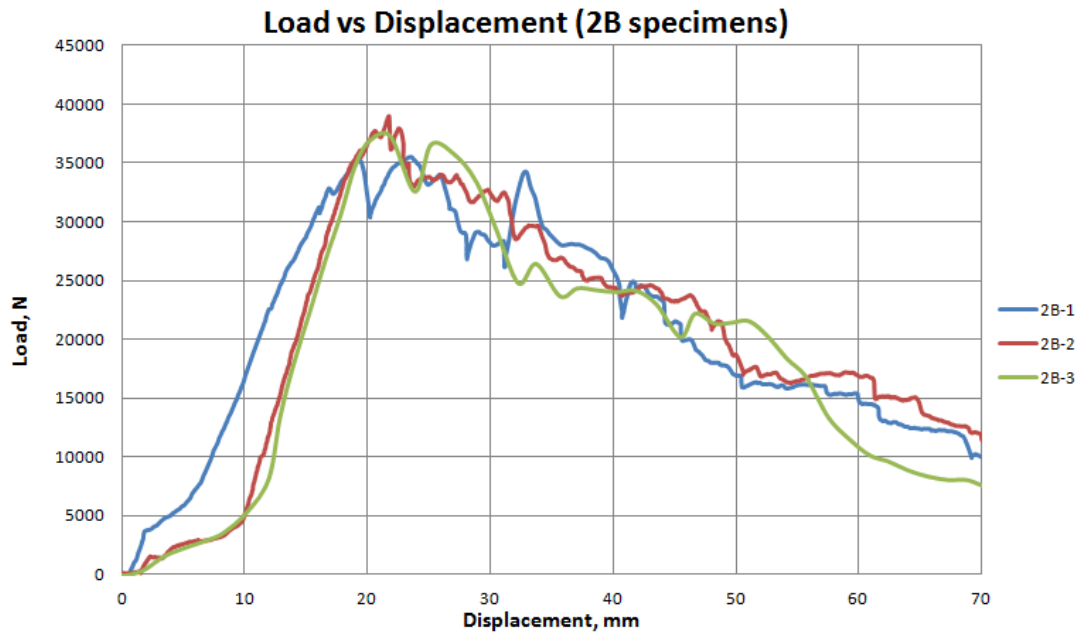
Figure 6 shows the load-displacement behavior of 2B specimens. At an applied load of approximately 5 kN, the graph showed linear behavior up to final failure. At this stage, the load was transferred to the stainless steel threaded bolt, progressively damaging and shearing the thin wall of the pultruded GFRP. The average maximum load obtained for 2B specimen was 37.24 kN with a displacement of 22.38 mm. At the peak of the graph, there were several knees (in non-linear fashion) which may indicate some internal damage had occurred as the joint capacity decreased. After maximum load, the specimens were still capable to carry some loads, even though at a decreasing capacity, possibly due to the lateral restrained from both bottom chords which were obtained from the tightening torque of the bolt. After the loading was released, the specimens were disassembled and close visual inspections were made at the connection area to identify mode of failure. Figure 7 shows the failure modes of 2B specimens. All the 2B specimens failed in the same manner. The specimens failed due to shear-out at both sides and marginal bearing (local crushing) was observed at the bottom chord members. In the 2B specimens, the load applied were evenly distributed at both sides of connected area and developed identical failure mode. It was also observed that, the pultruded material in direct contact with the threaded bolt was heavily crushed and delaminated. With the thread, a significant reduction of joint strength identified when compare to the plain pin joint strength (Matharu and Mottram, 2012).

Figure 6. Load and displacement behavior for 2 bottom chord specimens

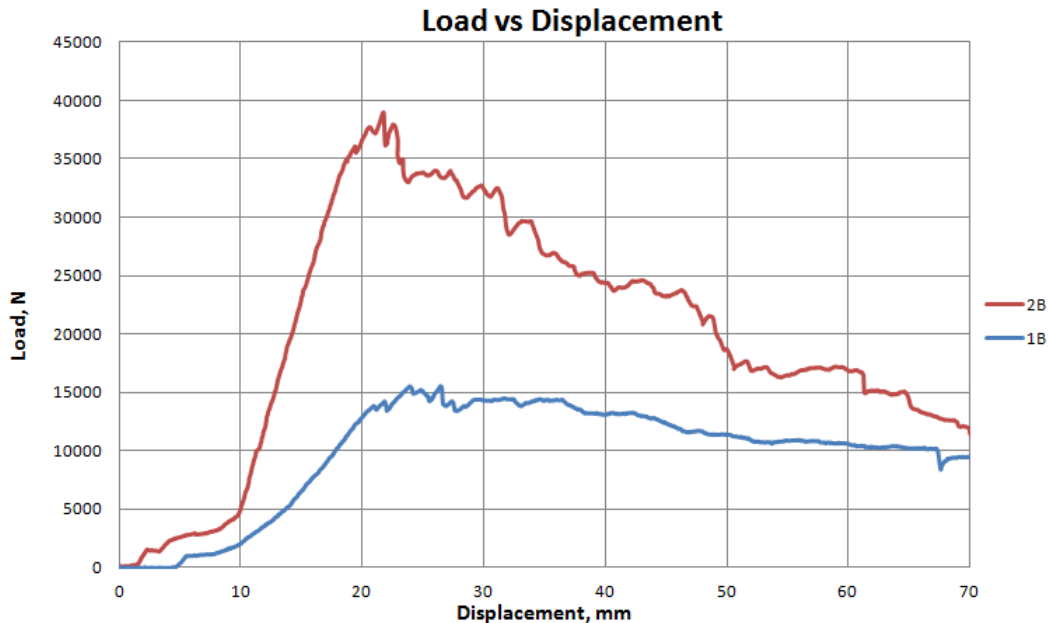
Figure 8 shows the comparison of load-displacement behavior between 2B specimen and 1B specimen. According to the experimental results, the 2B specimen recorded more than twice the strength of bolted joint of 1B specimen. Contribution of two bottom chords have created concentric loading path, while eccentricity on 1B specimen significantly reduced the bolted joint capacity. The shear-out failure was observed on both 1B and 2B specimens. It developed predominantly due to combination of low end distance to bolt diameter ratio and low in-plane shear strength of the material. Local punching shear was observed at 1B specimen due to the moment created by eccentric loading. This could be improved if the rotational at the connection area due to eccentricity could be restrained. Closed profile (rectangular shapes) of pultruded GFPR was chosen because it can improve the torsional rigidity, stiffness and the weak axis strength (Smith et al, 1998), however in this study, the eccentricity spacing is too big to endure. By introducing some type of filler inside the hollow section especially at the

connection area, it might help to improve the joint strength, rigidity and restrict rotational movement.

Figure 8. Load-displacement relationship between 2B and 1B specimen
