# Engineering Science and Technology, an International Journal

## Review

# State-of-the-art of prefabricated FRP composite jackets for structural repair

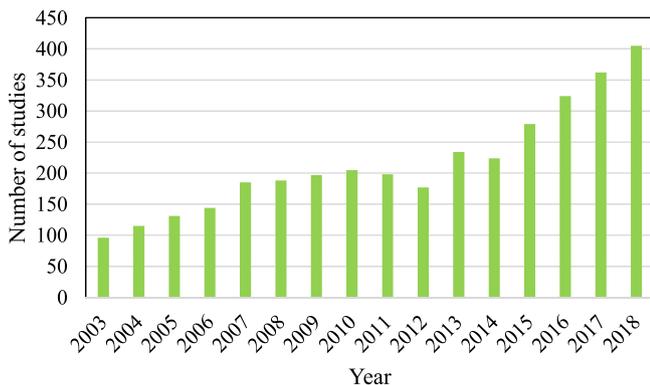
Fig. 1. Demand increase on structural repairs from 2003 to 2018 based on Scopus.

Across the globe, civil infrastructure, including highway bridges, roads, railways, ports, and airports is critical for economic development and progress. However, keeping this infrastructure in an efficient working condition is costly and challenging. Steel, timber and concrete structures are vulnerable to harsh weathering attacks including chloride and sulphate penetration, especially in marine or mining environments, that affect their integrity and cause their performance to deteriorate significantly [1,2]. For example, many coastal bridges experience corrosion after only 30 years of service, which is early, considering that they are designed for a service life of about 100 years [3]. A report on the durability of concrete structures cited in Nkurunziza et al. [4] stated that the cost of repairs and restoration constitutes a high percentage of infrastructure expenditure in many countries including Australia, the USA, Canada, and European Union countries. The Commonwealth Scientific and Industrial Research Organisation (CSIRO) reported that corrosion damage costs the Australian economy more than \$13 billion per year [5]. In the USA, around 40% of the 575,000 country's bridges are structurally and/or functionally defective due to steel corrosion [4]. The same problem exists in Canada wherein it is estimated that more than 40% of bridges constructed 40-years ago are suffering from significant steel corrosion [4]. Jumaat et al. [6] indicated that investments in maintenance and repair works on existing buildings represent about 50% of the total expenditure in construction. In most applications, repairing the damaged structures is preferable and more economical than replacing them due to the high cost of the new design, material, machinery and labour, plus the long extended service life of the effectively repaired structure. Hence, many industries and research agency are trying to optimise the current repair techniques and develop more effective ones. The Scopus database search conducted using the keyword "structural repair" was limited to engineering as a subject area and to article as a source type. It showed that the number of studies conducted on structural repair has been significantly increased from 2003 to 2018 (Fig. 1), highlighting the demand and necessity for an effective repair technique.

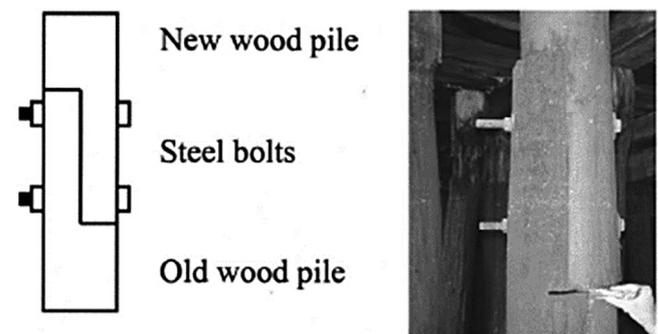
Fig. 2. Splicing of timber piles [21].

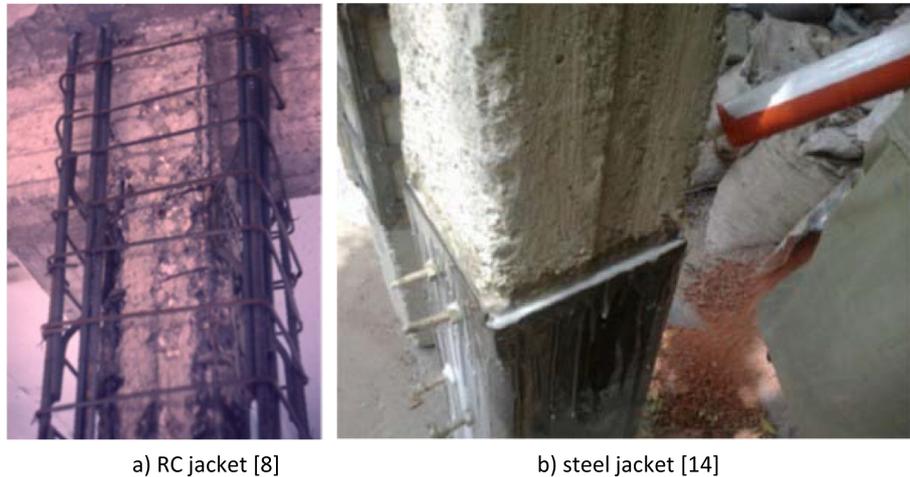
Fig. 3. RC columns repair using RC and steel jackets. a) RC jacket [8] b) steel jacket [14].

Fig. 3 shows RC and steel jackets in actual practice. Concrete jacketing is one of the earliest and most popular rehabilitation techniques for poorly detailed or deficient concrete and steel structures. RC jacketing/encasement has been utilised as a repair method for corroded steel and damaged wooden piles suffering from significant section loss [37]. Hawkswood [37] listed several cases of corroded steel piles successfully repaired using RC jackets including the 14 tubular steel piles (610 mm diameter) used in Cork, Ireland and the 84H steel piles used on a fishing jetty in Lunenburg, Canada. For repairing the damaged structure, steel angle reinforcement was welded at the required location prior to concrete encasement. On the other hand, steel jackets normally consist of steel angles or plates and batten with different thickness, width and spacing [38] have been mostly used for strengthening square or rectangular sections. They are relatively easier to install, and have smaller thickness in comparison with the RC jackets. Cement or epoxy mortar fills the gap between the jacket and column. Several studies have been conducted investigating the effectiveness of steel jackets for repairing and strengthening RC structures [39–43]. Abdel-Hay and Fawzy [14] repaired the damaged RC columns with steel jackets wherein the corrosion was simulated by eliminating the stirrups in the middle third of RC columns. The jacket was anchored to the column using 10 pieces of 6 mm diameter anchor bolts on each side and an injection plaster was used to fill the gap between the steel jacket and the retrofitted column. The results showed that the repaired columns failed by concrete crushing outside the strengthened part at load of at least 90% of the ultimate load of the original columns.

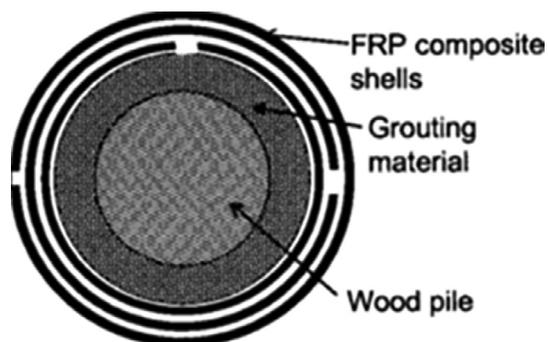
Fig. 4. Wood pile repair [21].

Lopez-Anido et al. [21] suggested the use of 3.3 mm thick pre-fabricated FRP composite shells as a repair system to protect and restore the structural integrity of circular damaged wooden piles in Portland Harbor, Maine, USA (Fig. 4). The proposed repair system comprised a minimum of two FRP prefabricated shells which were kept together by straps or temporary strips along the circumferential direction. Another prefabricated FRP repair system consisting of woven mat and chopped strand fabrics with single seam FRP shell was used to repair waterfront structures in New York City as shown in Fig. 5 [66]. In addition to the strength contribution, both systems served as an environmental protective shield to the core pile and a permanent formwork to the grout.

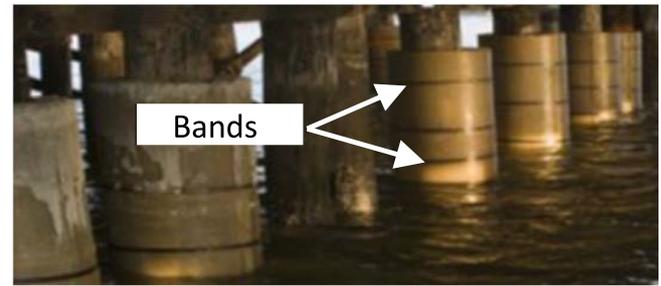
Fig. 5. Waterfront structure repair, New York [66].

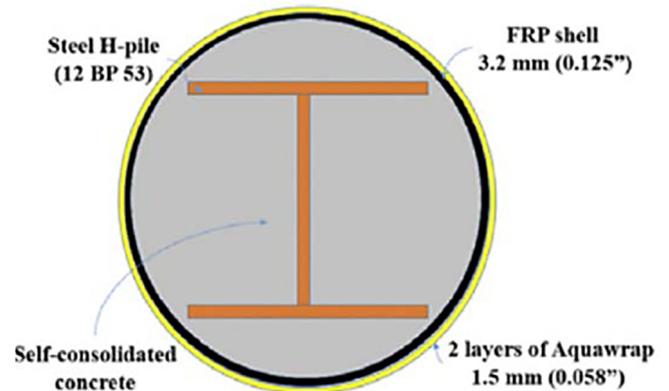
Fig. 6. Steel bridge pile repair [23].

Vijay et al. [23] used both pre-cured FRP shells and prepreg fabrics to repair the corroded H-steel piles of East Lynn Lake Campground Bridge in Wayne County, West Virginia USA (Fig. 6). Self-consolidating concrete was used to fill the gap between the FRP shells and the H-steel piles where the FRP shell worked as a permanent formwork to the grout. The installation process for this repair system required the prefabricated FRP shells to be installed first before applying the prepreg fabrics which needed a few days to cure prior to grouting. Hence, extended installation time and high manpower costs were incurred in this practice. Ehsani [67] developed the FRP seamless jacket PileMedic™, which consists of thin and flexible fabric laminates up to 1500 mm wide for pile repairs. However, it did not serve as a formwork in the construction of columns or piers because of their spiral wrapping method as shown in Fig. 7. Beddier et al. [68] used a GFRP prefabricated jacket consisting of three identical shells connected together by stepped lap joints with shrinkage-compensating cement mortar as infill between the shells and the square column. The experimental results demonstrated that the axial load capacity and ductility increased by 31% and 74%, respectively, compared to the unjacketed concrete specimens. However, this came at the expense of 100% increase in the cross sectional area. Karagah et al. [69] implemented a large-scale experimental study to demonstrate the structural performance of submerged corroded I-shaped steel bridge piles repaired using two different types of grout-filled FRP jackets. The first one consisted of two plies of prefabricated flexible CFRP wrapped around the piles and bonded using an underwater curing adhesive. The second type consisted of a two-layered FRP system wherein the first layer was fabricated using two plies of GFRP

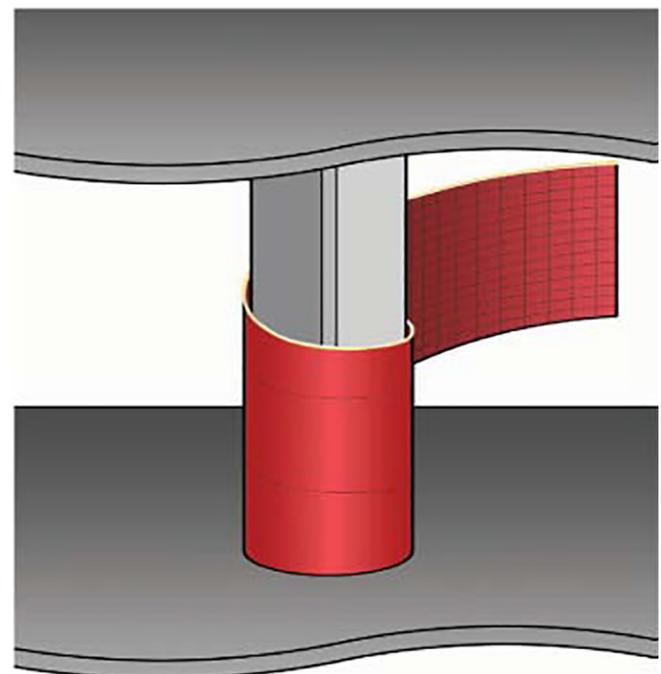
Fig. 7. PileMedic™ [67].

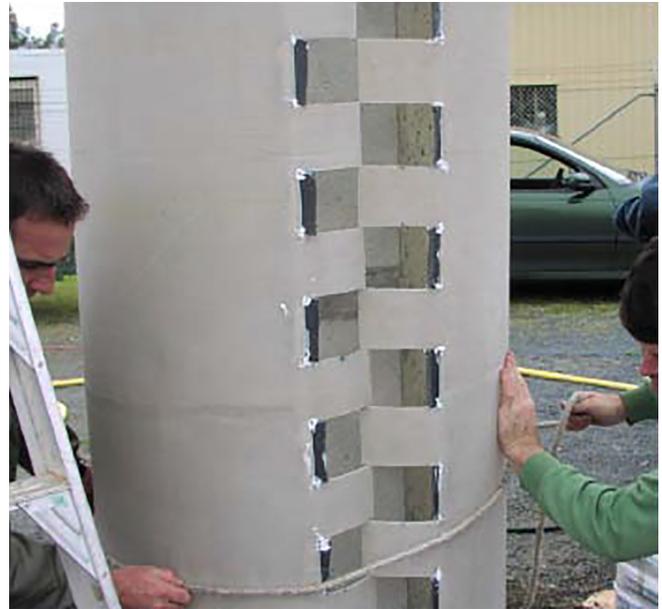
Fig. 9. GFRP composite pile repair system [70].

Wu and Pantelides [25,26] proposed a rapid seismic repair method for RC bridge columns, which designed were designed under current codes, with minimal intervention. The repair method involves a CFRP cylindrical shell, epoxy-anchored headed steel bars, and steel collar with studs around the original column as shown in Fig. 8. The CFRP shell, consisting of unidirectional laminates in the hoop and vertical direction, encloses the headed bars and is filled with non-shrink concrete to shift the location of column plastic hinge. Vertical fibres were provided in the CFRP shell to increase tensile capacity of the shell in the axial direction to avoid the circumferential cracks [25,26,50]. Steel collar with shear studs improved the bond between original column and repair concrete to increase structural integrity of the whole CFRP “donut”. Fig. 9 shows a prototype of a GFRP composite pile repair system

that was successfully utilised for underwater repair trials of piles at the Missingham Bridge in Northern NSW, Australia in 2005 [70]. Fig. 10 depicts another FRP repair system with a tongue and groove joining system installed around bridge piles with metal screws being bolted through the joints. As shown in the summary of the existing prefabricated FRP repair systems presented in Table 1, the tongue and groove joining system with metal screws is the most common technique in the actual applications of the FRP repair system due to its ease and rapid fitment. However, the durability of the use of metal screws in the technique is always a concern as they do not have the same characteristics as the FRP shell in resisting the severe environmental conditions. The failure of the joining system results in opening of the jacket leading to its functional loss. Hence, the effectiveness of the prefabricated FRP composite jacket for repair of structures depends mostly on the joining technique as it is responsible to provide complete continuity for the repair system. Therefore, there is an urgent need to innovate an effective joining system for the prefabricated FRP repair system that can assure the structural continuity along the hoop direction.

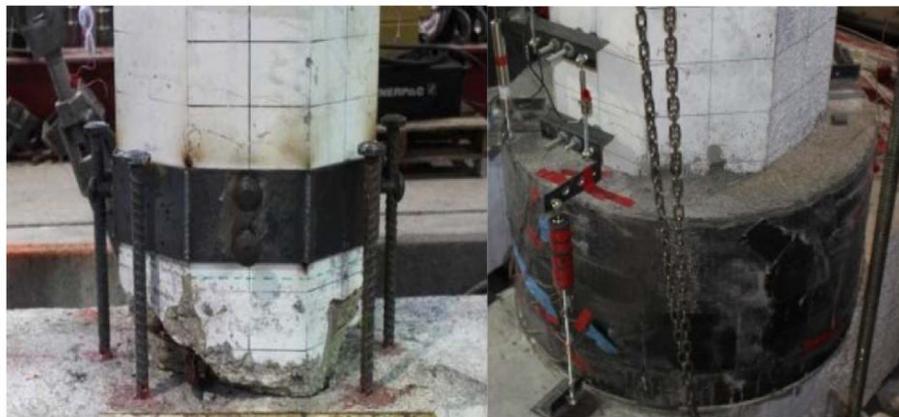
a) Steel collar and anchored steel

b) CFRP jacket

Fig. 8. Seismic repair method [26].

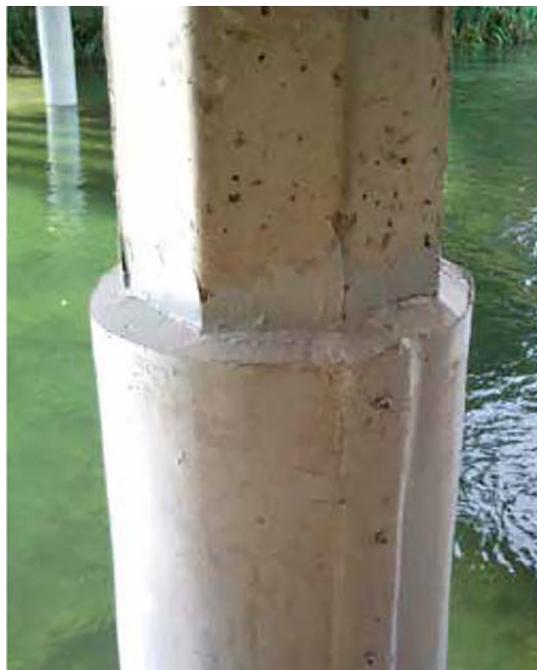
Fig. 10. GFRP jacket [71].

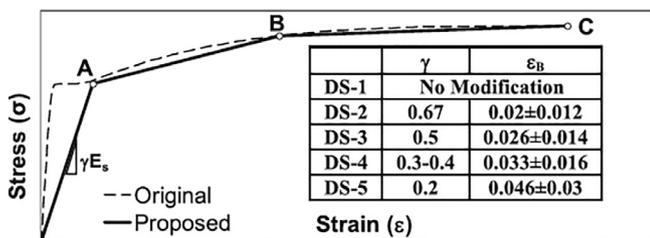
**Fig. 11.** Stress–strain curves.

trilinear stress–strain relationship (Fig. 11) to estimate the existing strain in the longitudinal bars of damaged columns based on five visual damage states (DS) that were defined as follow: DS-1 (flexural cracks), DS-2 (minimal spalling and possible shear cracks), DS-3 (extensive cracks and spalling), DS-4 (visible lateral and/or longitudinal reinforcing bars), and DS-5 [compressive failure of the concrete core edge with only a few longitudinal bars may exhibit slight buckling (imminent failure)]. A reduction factor was used, based on the damage state, to modify the original slope of the first branch of Fig. 11. In the same figure, Point A represents the yield stress and the strain associated with the modified stiffness, Point B is associated with the maximum strain in the longitudinal steel at a given damage state, and Point C is the modified ultimate point accounting for strain rate effect. Another important factor to consider in the repair is the bond slip effects of the existing steel bars if they were still embedded in the damaged concrete [99], or directly interact with new and confined concrete [100]. Harajli [99] developed a bond-slip relationship predicting the bond degradation response of bond-critical regions in reinforced concrete members when retrofitted using external FRP jackets including the effects of steel bar diameter, ratio of concrete cover and concrete compressive strength. Moreover, Wu and Pantelides [100] incorporated the effect of bond-slip in the model they developed to accurately simulate the seismic performance of repaired column-to-cap beam/footing connections using CFRP jacket.

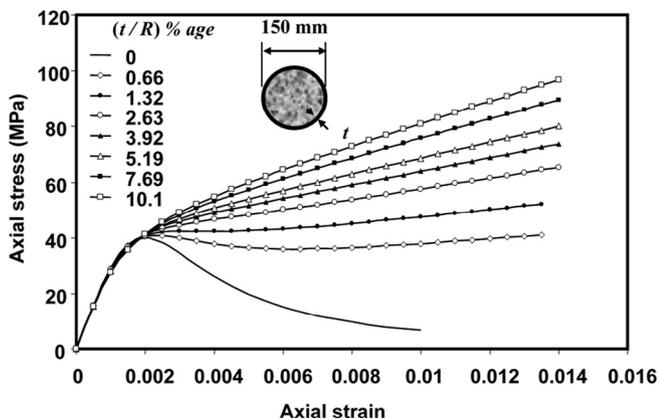
Fig. 12. Stress–strain curves of confined concrete with FRP tubes of various thickness [115].

increased because they are inversely related [110,111]. This effect was also demonstrated by Fam and Rizkalla [112] as shown in the Figs. 12 and 13. Increasing the FRP jacket thickness has the same effect on steel and timber structures because the exerted confining pressure is what matters the most [63,113]. However, for hollow steel tubes, Teng et al. [113] indicated that once the thickness of jacket reaches a specific threshold for which the dominant behaviour is the inward buckling deformations of the hollow steel tube, an additional increase in the thickness of jacket will not result in noteworthy further benefits as the jacket does not provide good resistance to inward buckling deformations [113].

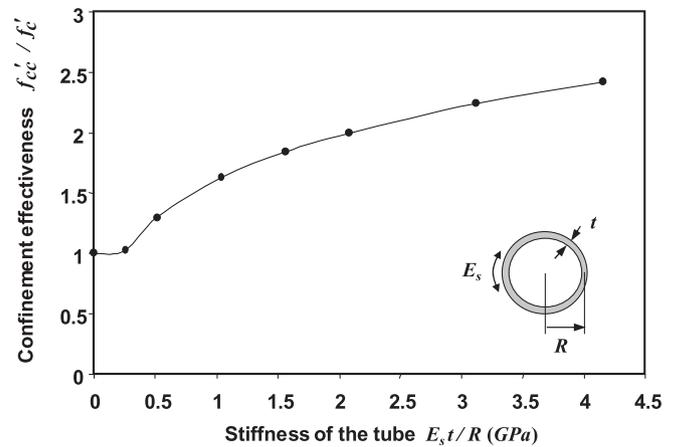
Fig. 13. Confinement effectiveness of FRP tubes with various stiffness [115].

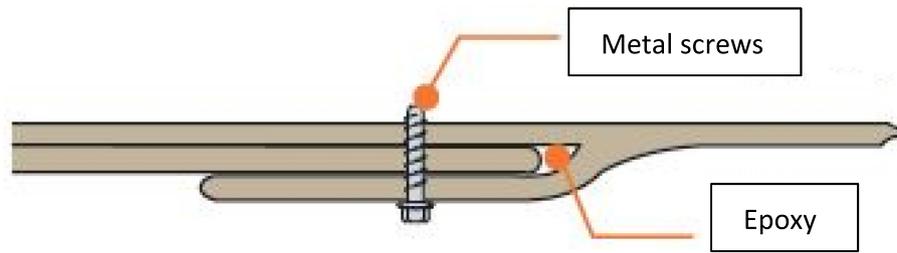
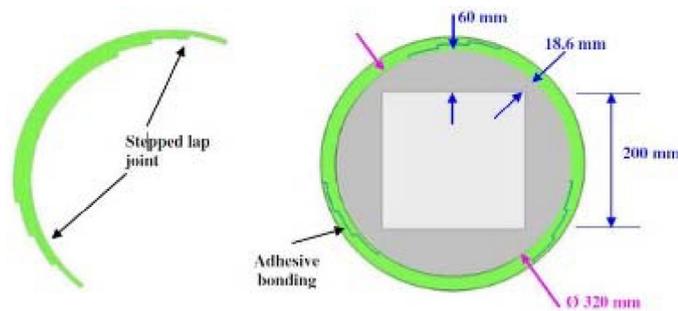
a) Tongue-and-groove joining technique [121]

b) Stepped lap [68]

Fig. 14. Joining systems.

can affect the durability and the utilisation limit of the repair system. For example, the joint will have different capacities to resist the weathering and environmental attack if it was made from materials different to that of the jacket body. The premature jacket failure limits the full utilisation of the FRP repair system. Many joining systems were proposed and designed in a way to address the aforementioned concerns; however, their performances varied significantly from each other.

In the repair system proposed by Lopez-Anido et al. [21], the splits in FRP shells were aligned away from each other to avoid a weakness line along the entire height of the shell. The interior surface of each shell was glued to the outer surface of the next shell using epoxy. Circumferential metal straps or temporary bands were then used to hold the shells together and achieve the structural restoration. As shown in Fig. 14a, slip-joint/tongue-and-groove is another popular joining technique to connect the ends of the FRP jacket [121]. Epoxy and self-taping metal screws were also used to hold the tongue in the groove and increase the reliability of the joint. This technique was adopted to repair waterfront structures in New York City [66]. In addition, steel bands were used in the adopted repair system to hold the jacket and contain the infill. The metal screws damage the FRP shell and affect the stress flow by developing stress concentration regions which eventually affect the fatigue resistance and the lifespan of the FRP shell. Another method is that used by Vijay et al. [23] where additional water-curable GFRP prepreps were applied on the outer surface of the FRP shell to keep jacket ends together and prevent them from opening. An alternative seamless FRP repair system was proposed by Ehsani [67] consisted of flexible FRP laminates that can be spirally wrapped around the damaged member. Finally, a stepped lap joint technique was proposed and used by Beddiar et al. [68] to join the FRP jacket ends together (Fig. 14b). Each step was measured to be 40 mm in length to provide sufficient overlapping for the jacket ends in addition to being glued together using epoxy.

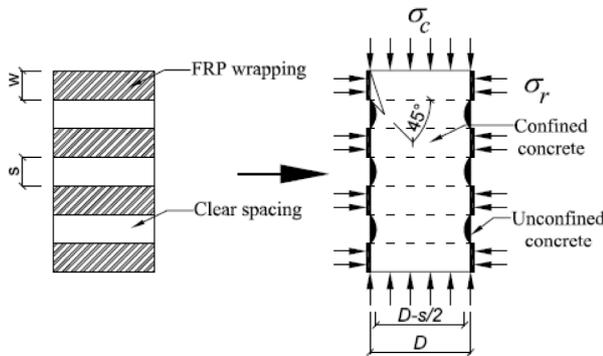
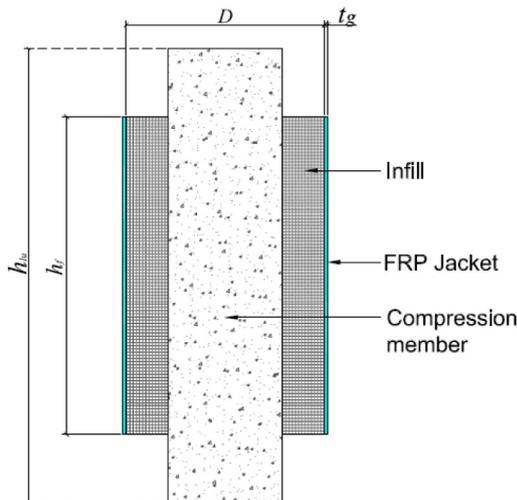
a) Concrete column partially confined with FRP strips [153]

b) Concrete column partially confined with one FRP segment [161]

Fig. 15. Confinement mechanism.

Moreover, the model developed by Mohammed et al. [161] considered the level of damage in the original structure while predicting the axial strength of the repaired column as detailed in Eq. (4)

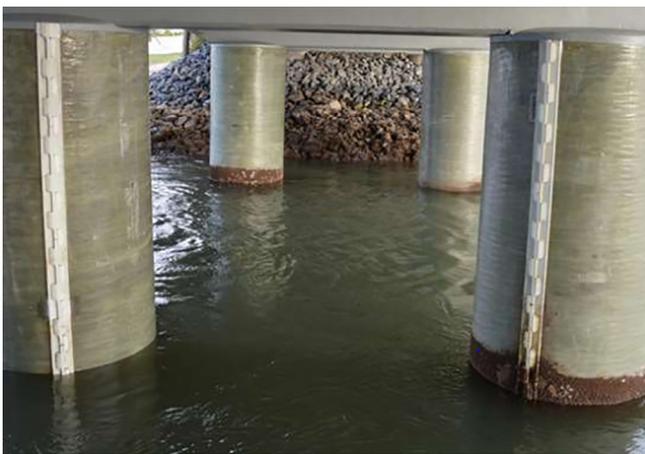
Fig. 17. Bridge piles repaired with FRP jacket [166].
