**Report to the Toowoomba Regional Council**

**On slope instabilities in the Toowoomba escarpment**

**FANTAIL and FIRETAIL TRACKS**

**21 November 2011**

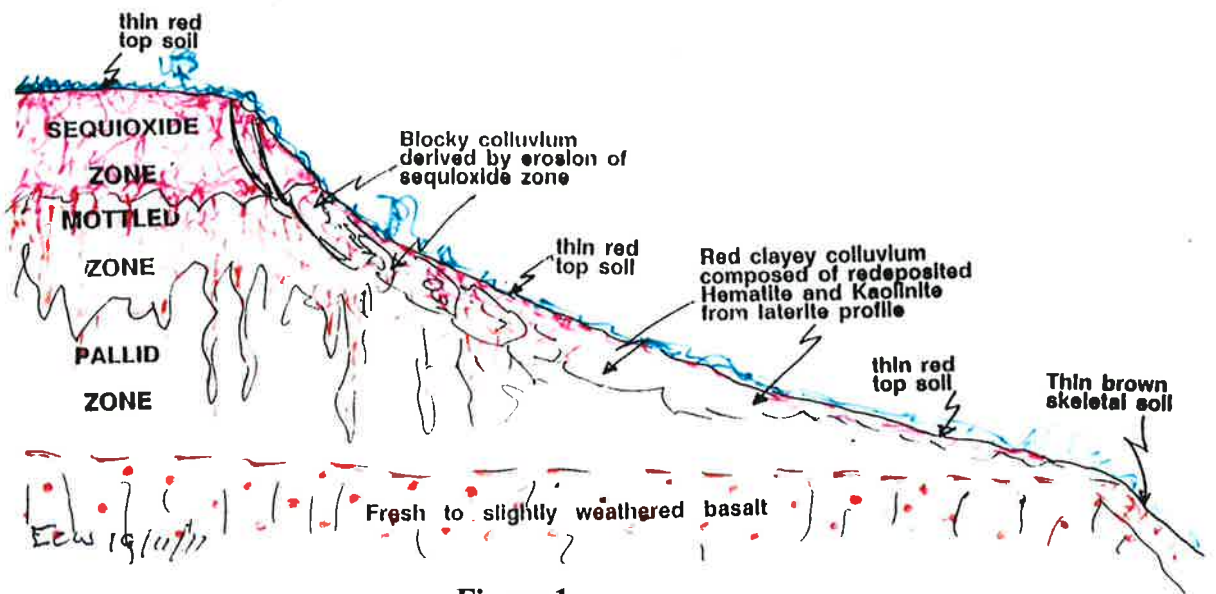
Any water (from rain or springs) reaching the impermeable lower two zones will cause runoff and result in erosion of the materials of these zones. The process, if continued, undercuts the permeable sesquioxide zone, which now breaks off in large masses by rotational slips in the underlying plastic clays of the pallid zone. Over time, the masses of sesquioxide zone breakdown into small fragments, which are carried down slope and forms a colluvial mantle over the exposed pallid and mottled zone (see Figure 1).

will reach an equilibrium, creating an upper lip corresponding to the top of the degraded edge of the sesquioxide zone, and, some 15 to 30 m lower down, a lower lip corresponding to the top of fresh basalt beneath the lateritic soil profile (see Figure 1). A concave land-surface, steeper near the upper lip and almost horizontal at the lower lip, will typically occur between the two lips. This concave zone has a mantle of red colluvium derived by the degradation of the sesquioxide zone; this mantle conceals the underlying impermeable and clay-rich mottled and pallid zones, which are the main concerns regarding ground instability and mass movements

**Figure 1**  
Features of the degraded edge of lateritic soil profile formed on the Main Range Volcanics
