## **Factors Influencing Failure of Bank Protection Embankment of Surma River**

### **Abstract**

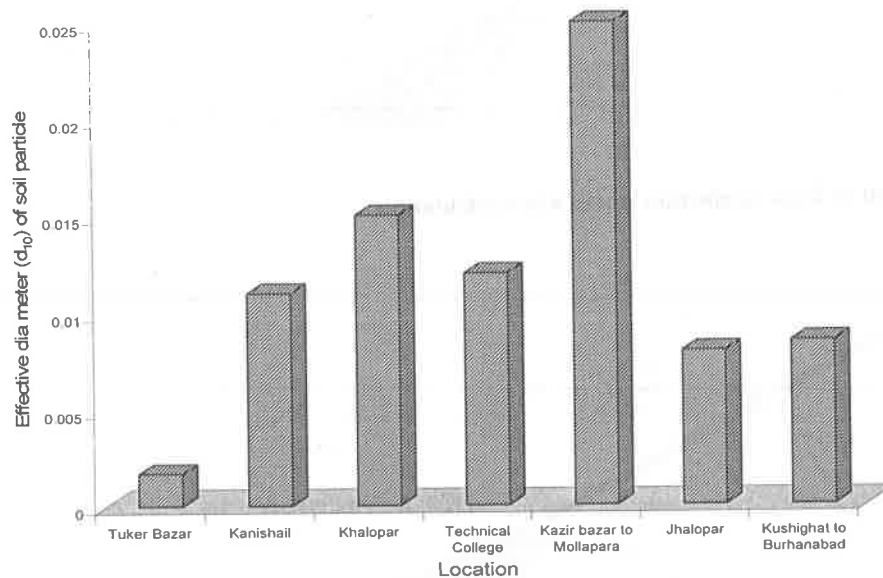
**Figure-4: Presentation of effective diameter of particle according to the location**

The above comparison depicts that this design for the left bank of Kanishail to Ghashitula differs significantly from the estimated design of BWDB. As a consequence, the thickness of cover layer, grading size of stone, specifications of geotextile used in the bank protection works didn't satisfy the actual requirement. From the experimental results, it has been found that the soil carries significant amount of clay, fine silt and fine dust. This represents that the soil of such areas are subjected to be eroded, which poses a great risk to the safety of this city. In consequence of this the scour depth will more than the calculated one. The test results are shown in the Figure-4 and the Figure-5 represents photographic view of bank protection failure.
