# Investigation into the Strength of Lego Technic Liftarms and Brick Beams, and of Liftarm Pin Connections

*Tristan Lostroh*

*January 2012*

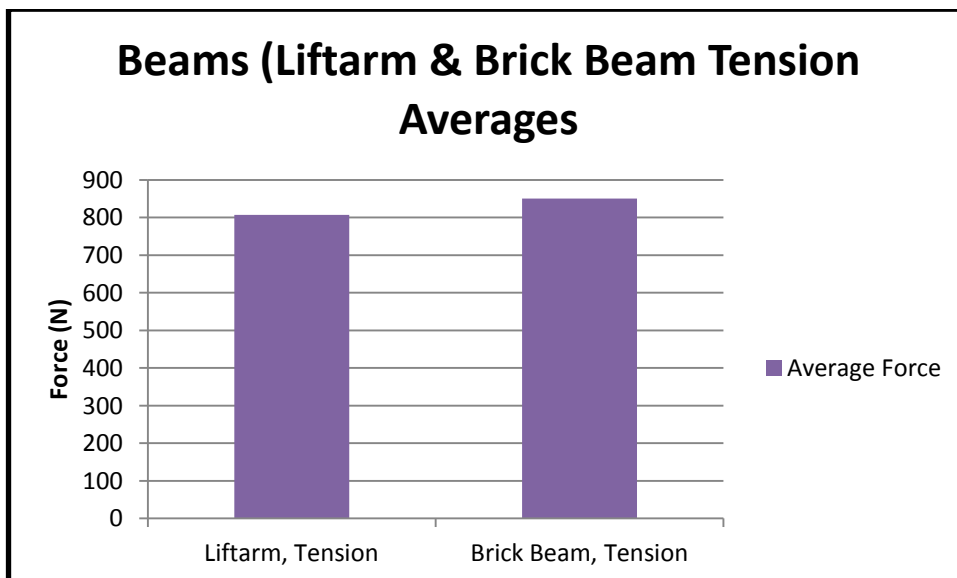
Although not very clear, overall the Brick Beam is marginally stronger than the Liftarm. The difference is about 40N which is ~5% of the overall strength. To put this into more meaningful units, the average

force of a Beam is about 84.5kg on Earth. That's a grown man (on the light side though, not a football player). I should point out that this is the ultimate breaking strength; the force at which plastic deformation is obtained is much less.

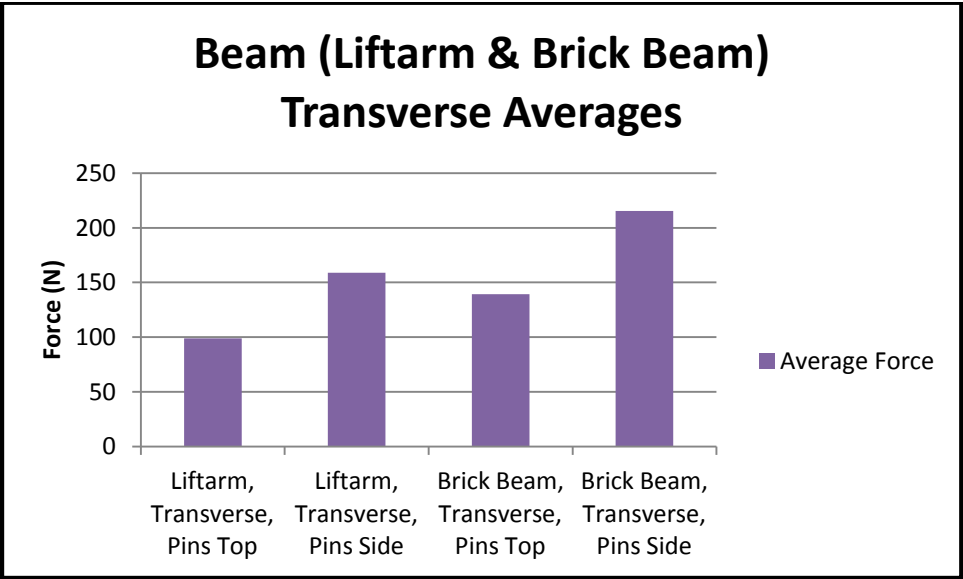
With this graph, the transverse strength of the Beams is varied. The rotation of the Beam matters greatly as does the style of Beam chosen. In a transverse situation a Brick Beam is superior in every way. This makes a lot of sense as there is more plastic per Beam.

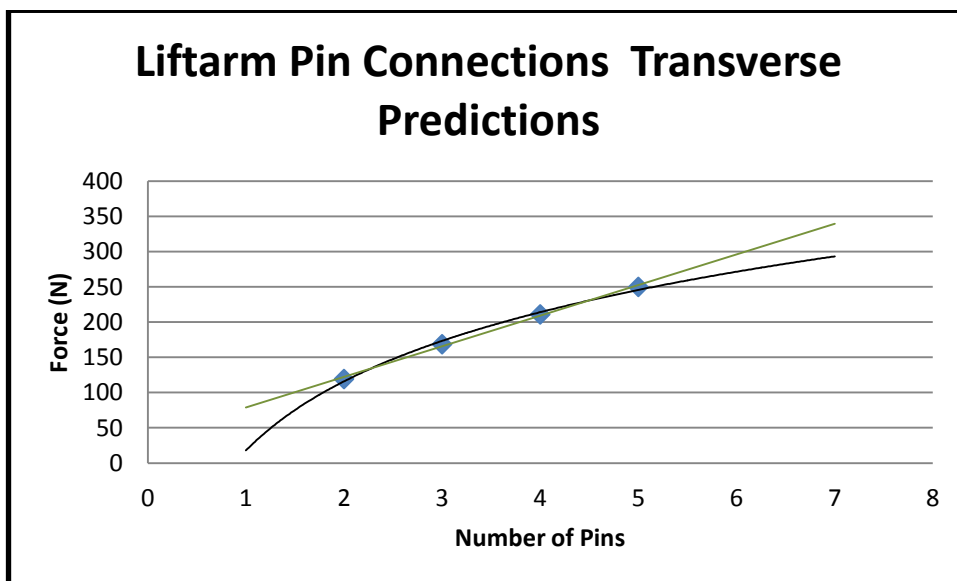
This graph shows the average force for each connection. The black line is a logarithmic trend line. When compared to a linear trend line (green), the logarithmic is a better fit. This then implies that after a certain number, there will be no big increase in strength from the connection.

If the pin connection results are compared to the Beam results, we see that a connected Liftarms is much stronger than just a basic Liftarm. This makes a fair amount of sense. At the point of application of the force is the joint, there is an overlap of the Liftarms. This means that the force is being dissipated by two Liftarms rather than one.

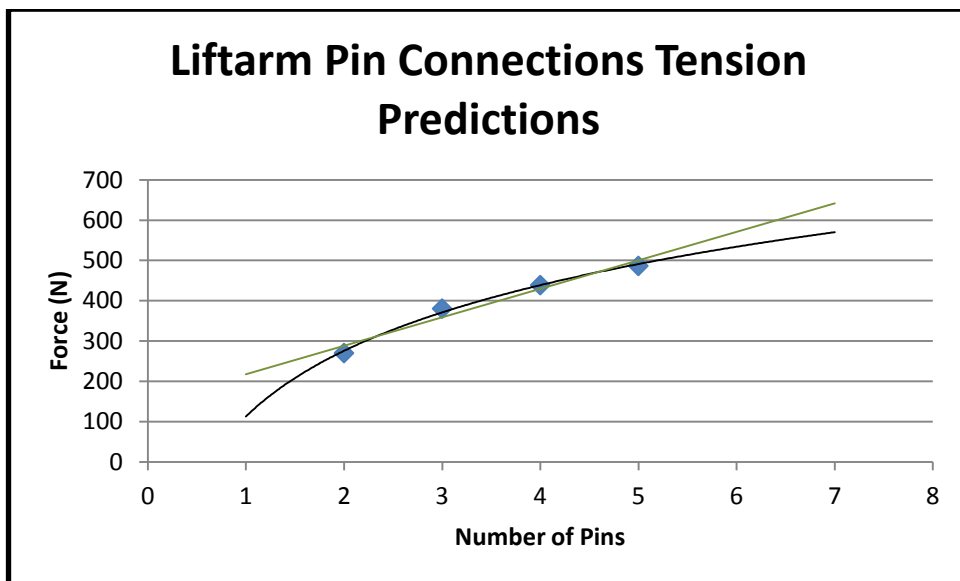
The results from the tension tests reflected those of the transverse tests. The logarithmic trend line is again the best fit. It is interesting that the shapes of the lines are quite similar. This implies that the difference in strength is fixed, i.e. the ratio is the same regardless. It is quite clear that pin connections are much better in tension than transverse. It would be interesting to see if using Brick Beams would change the result. This however is outside the scope of the testing and would have to be completed by other people.
