# Rehabilitation of timber bridge piles using a wrapping system

R. Borzou & W. Lokuge

*School of Civil Engineering and Surveying, University of Southern Queensland, Springfield, QLD4300*

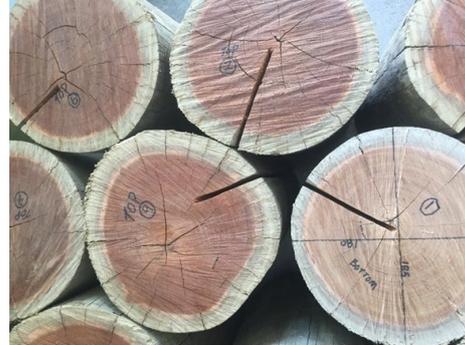
through inspection of deteriorated timber piles. The length of split gained from inspection extends greater than 1 m. Therefore, the split used in this research runs the entire length of the sample ( $\approx 300$  mm). These two parameters will be maintained throughout experimental procedure. Split depth will be adopted at depths of full radius,  $2/3$  radius and  $1/3$  radius Figure 2.

Figure 2. Defect induced samples  
Samples were then wrapped by the FRP laminate (Figure 3) and the filler was introduced into the annulus (Table 3)

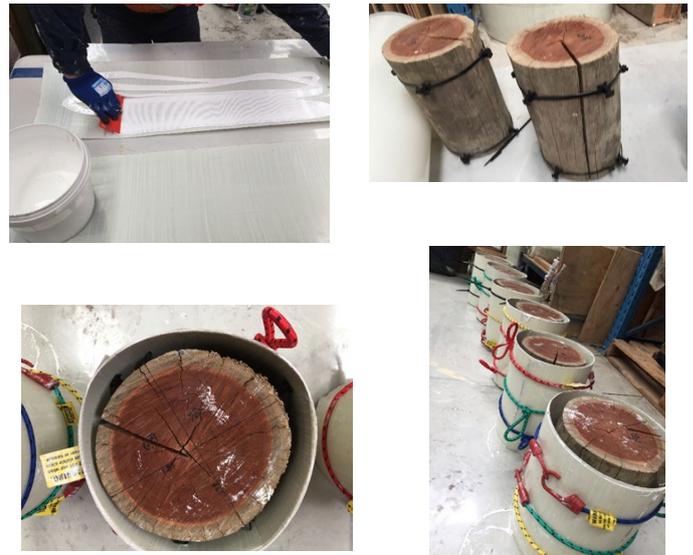
Figure 3. FRP wrapping process

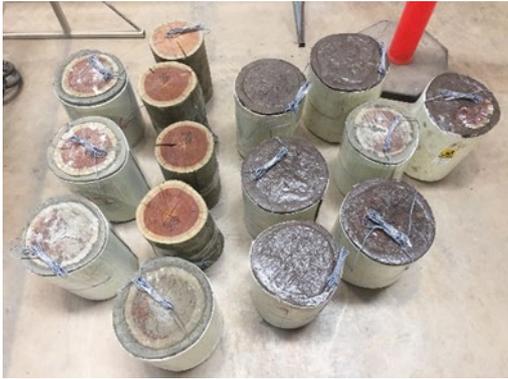
All the samples ready to be tested are shown in Figure 4 and they are to be tested using the SANS compression testing machine to find the maximum

Figure 4. Samples ready for testing

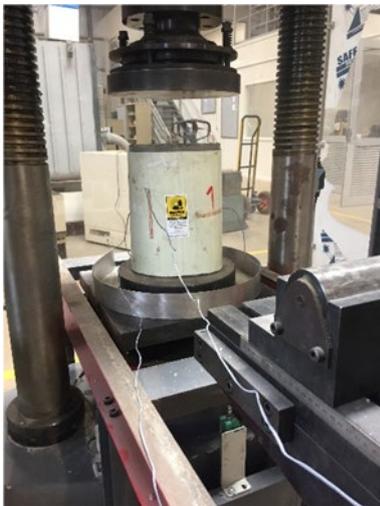
load/stress of the timber piles. Samples were attached with the strain gauges too to get the strain values in addition to the strains getting from the machine. A sample ready to be tested in the machine is shown in Figure 5.

Figure 5. Sample in the compression-testing machine

Recorded data included the load and the displacement from the testing machine and the strain values from the data acquisition system 5000.
